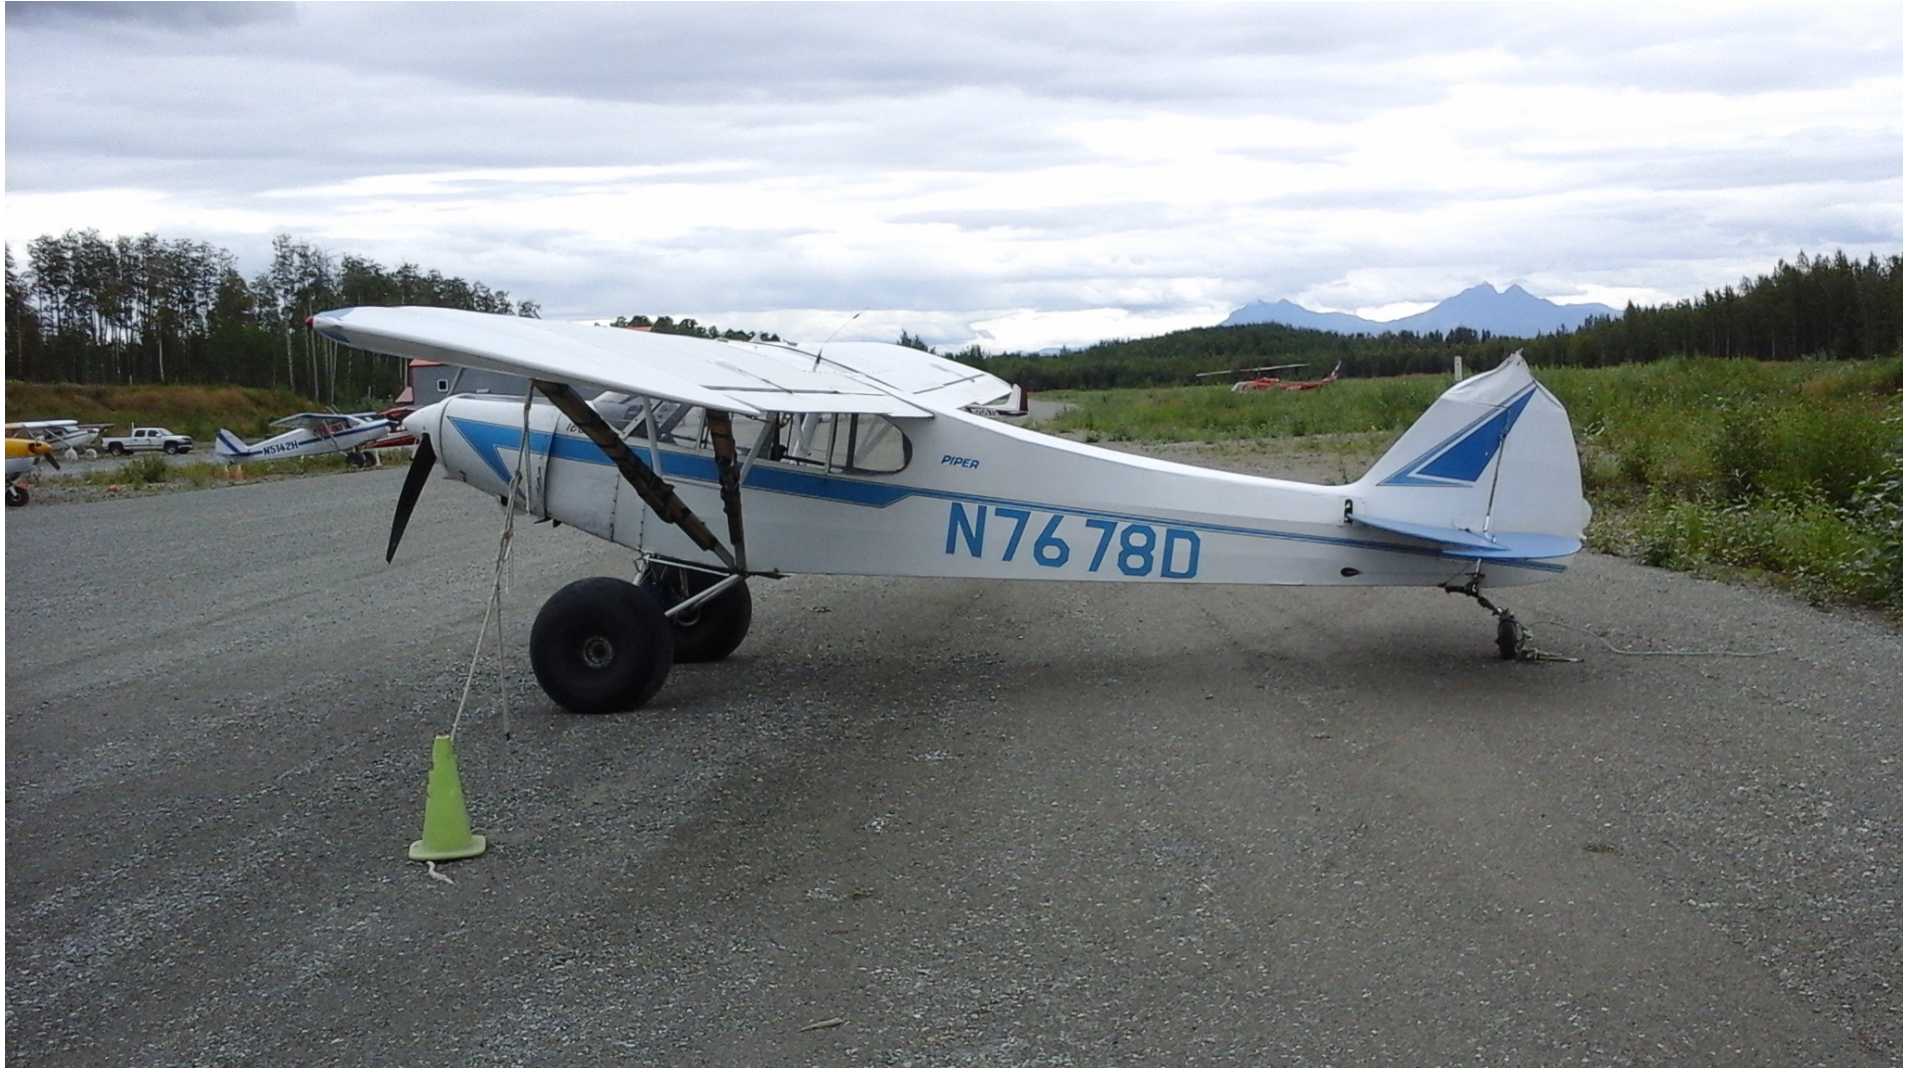
**Photo 1 – View of damaged left wing lift struts and rudder (photo courtesy of the pilot)**
