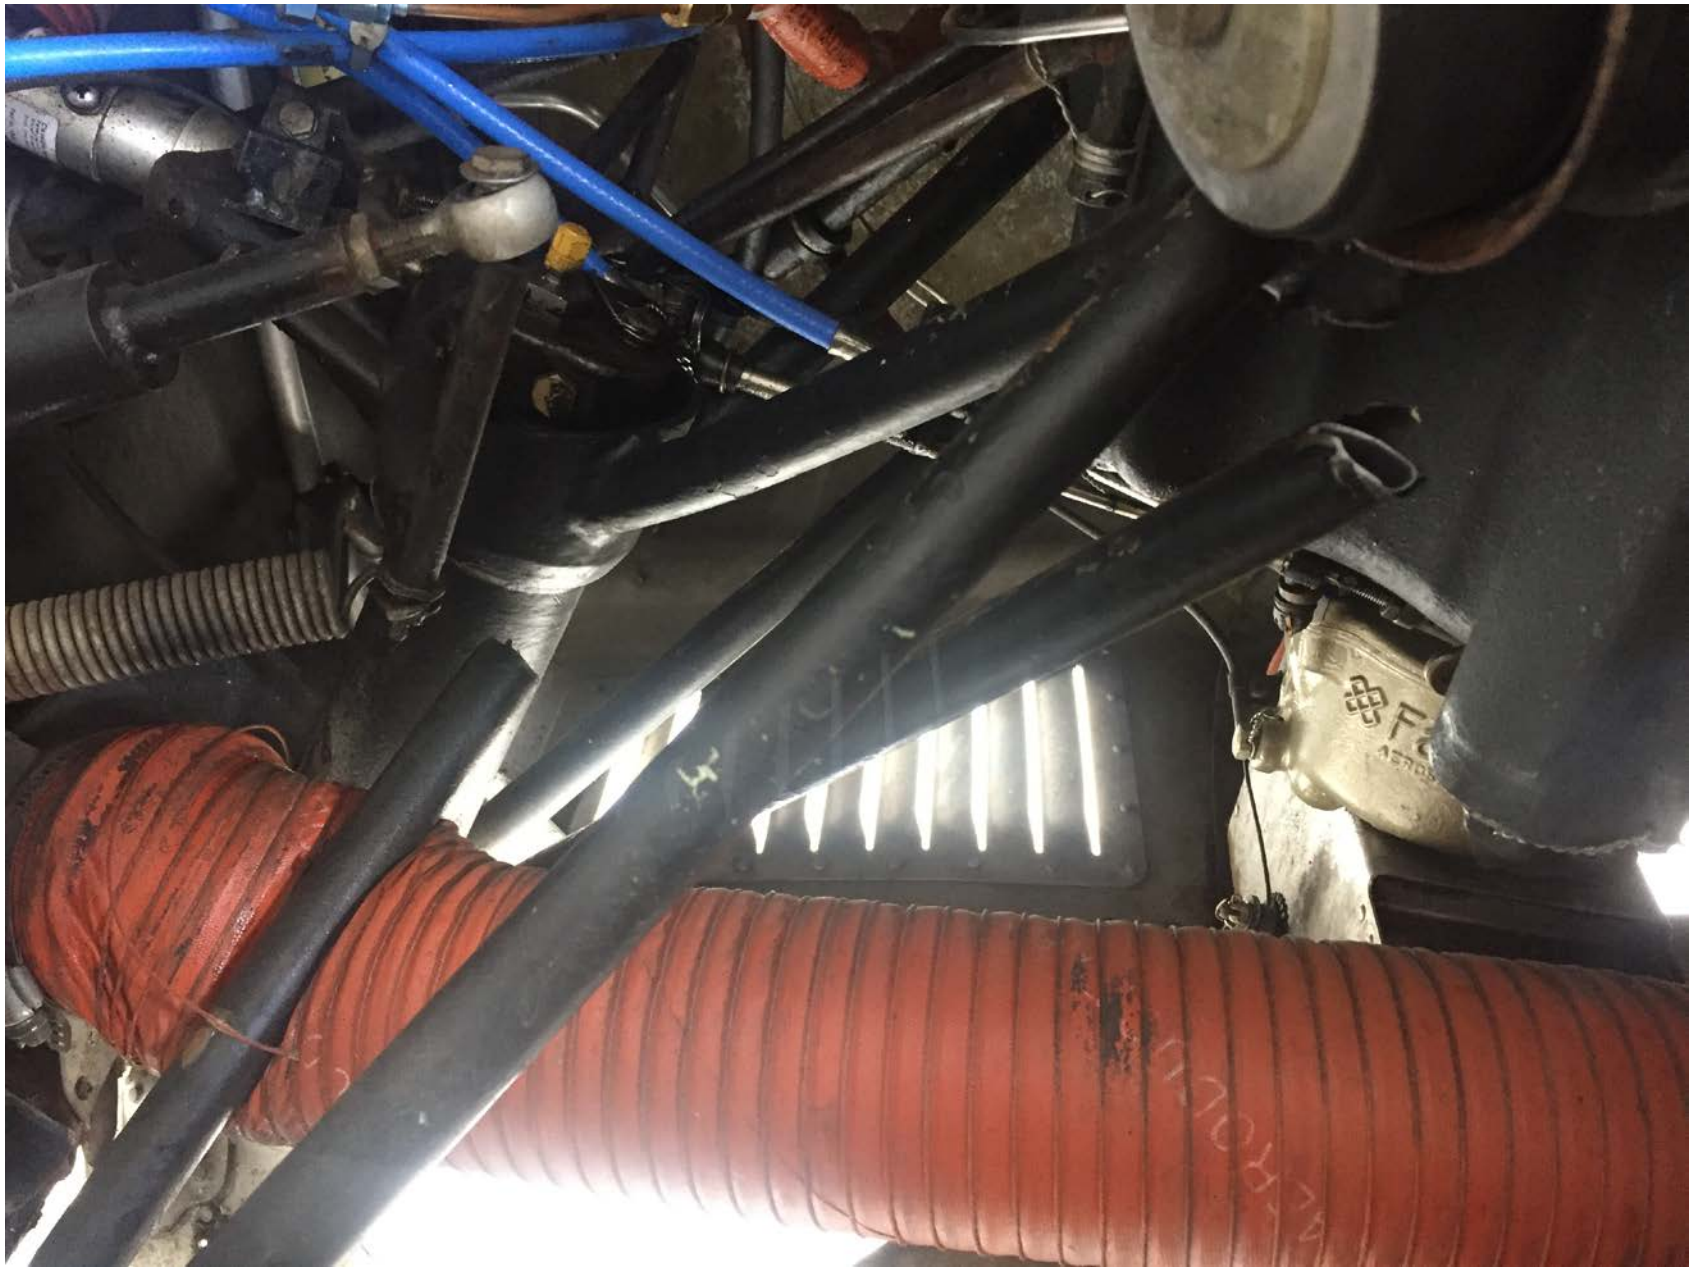
**Photo 1 – View of damage to engine mounts (Courtesy of Operator)**
