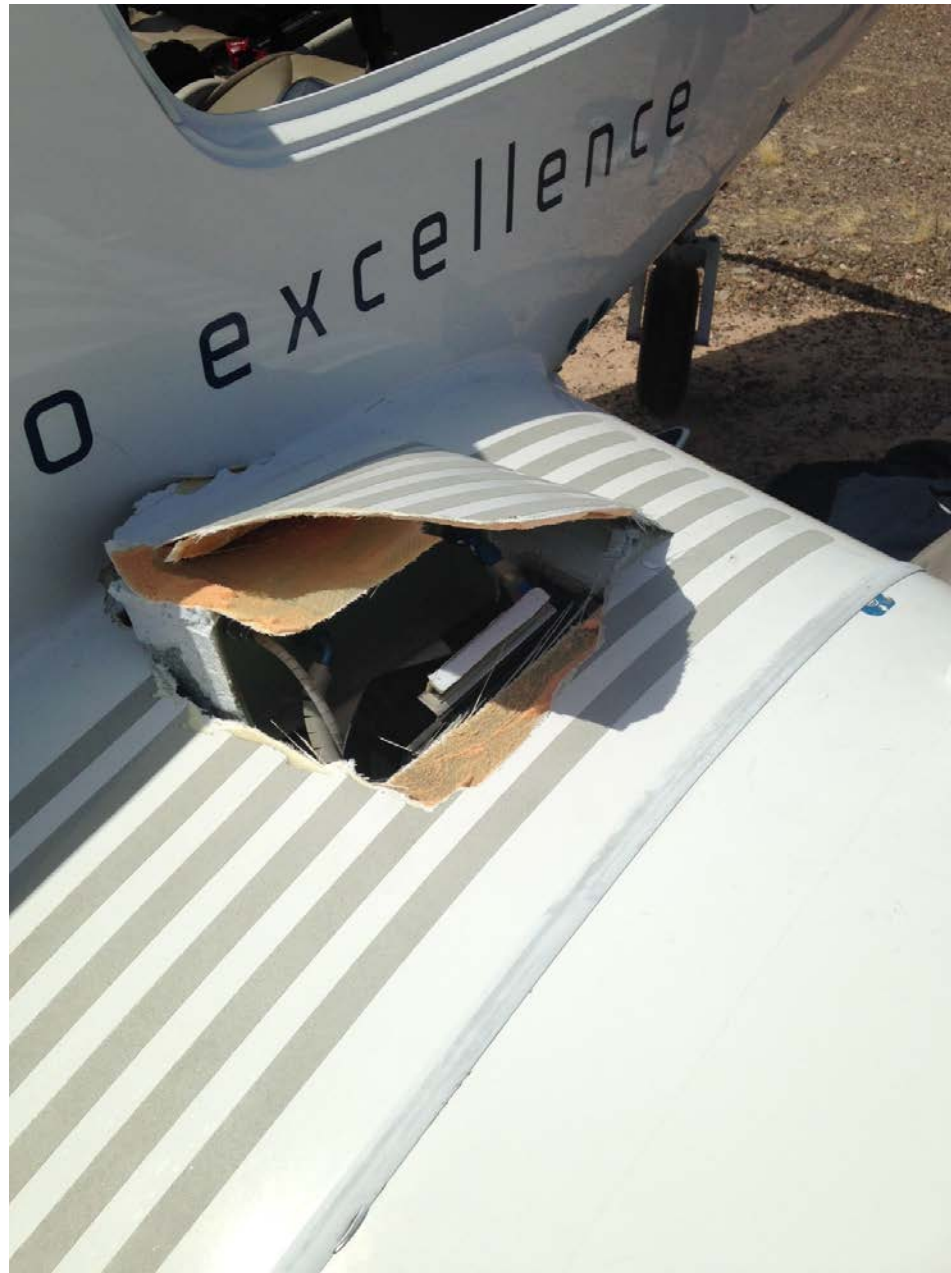
**Photo 1 – View of damaged right wing (photo courtesy unknown)**

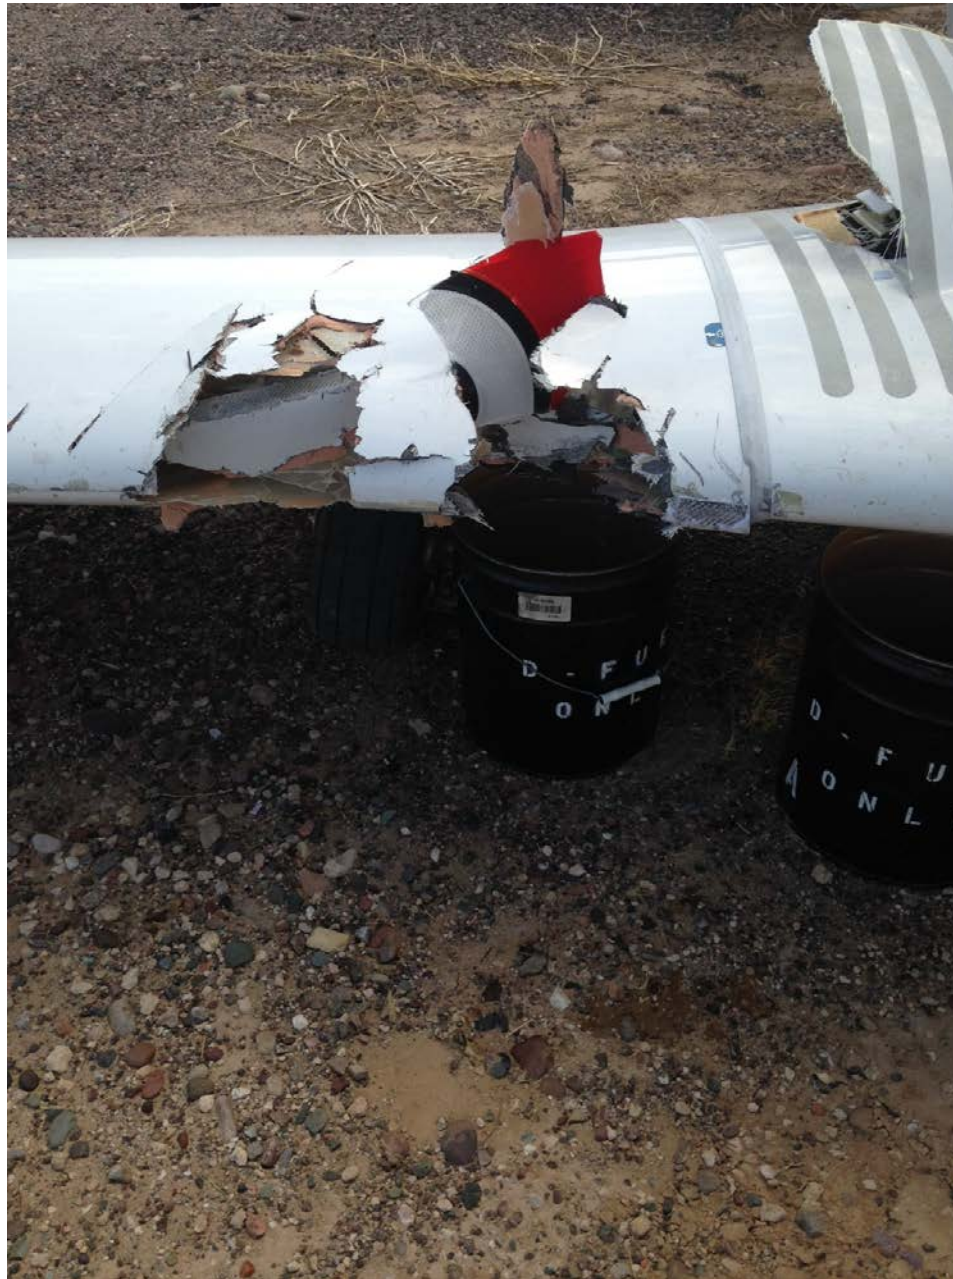
**Photo 2 – View of damaged right wing leading edge with taxiway sign (photo courtesy unknown)**
