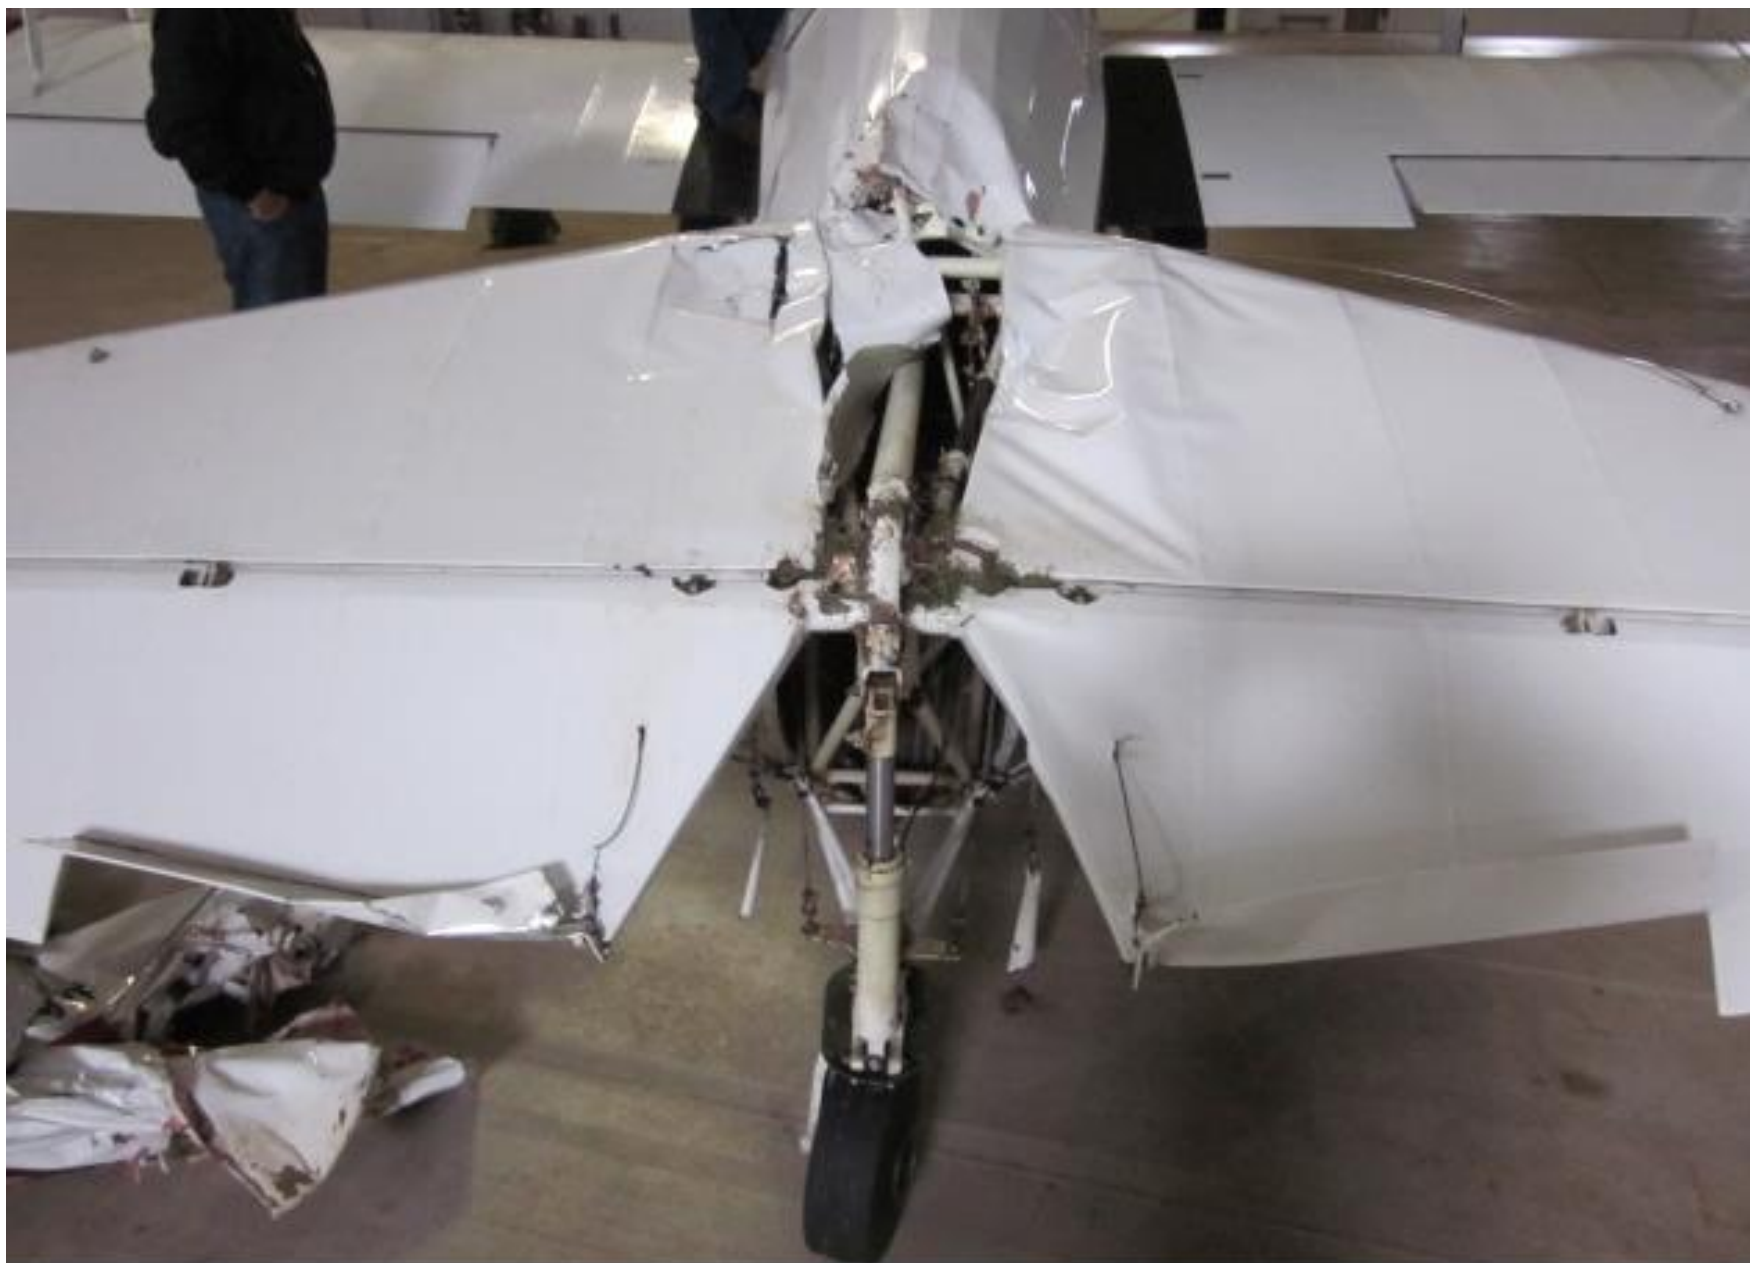
**Photo 1 – View of damage to empennage and airframe (Photo courtesy of the FAA)**
