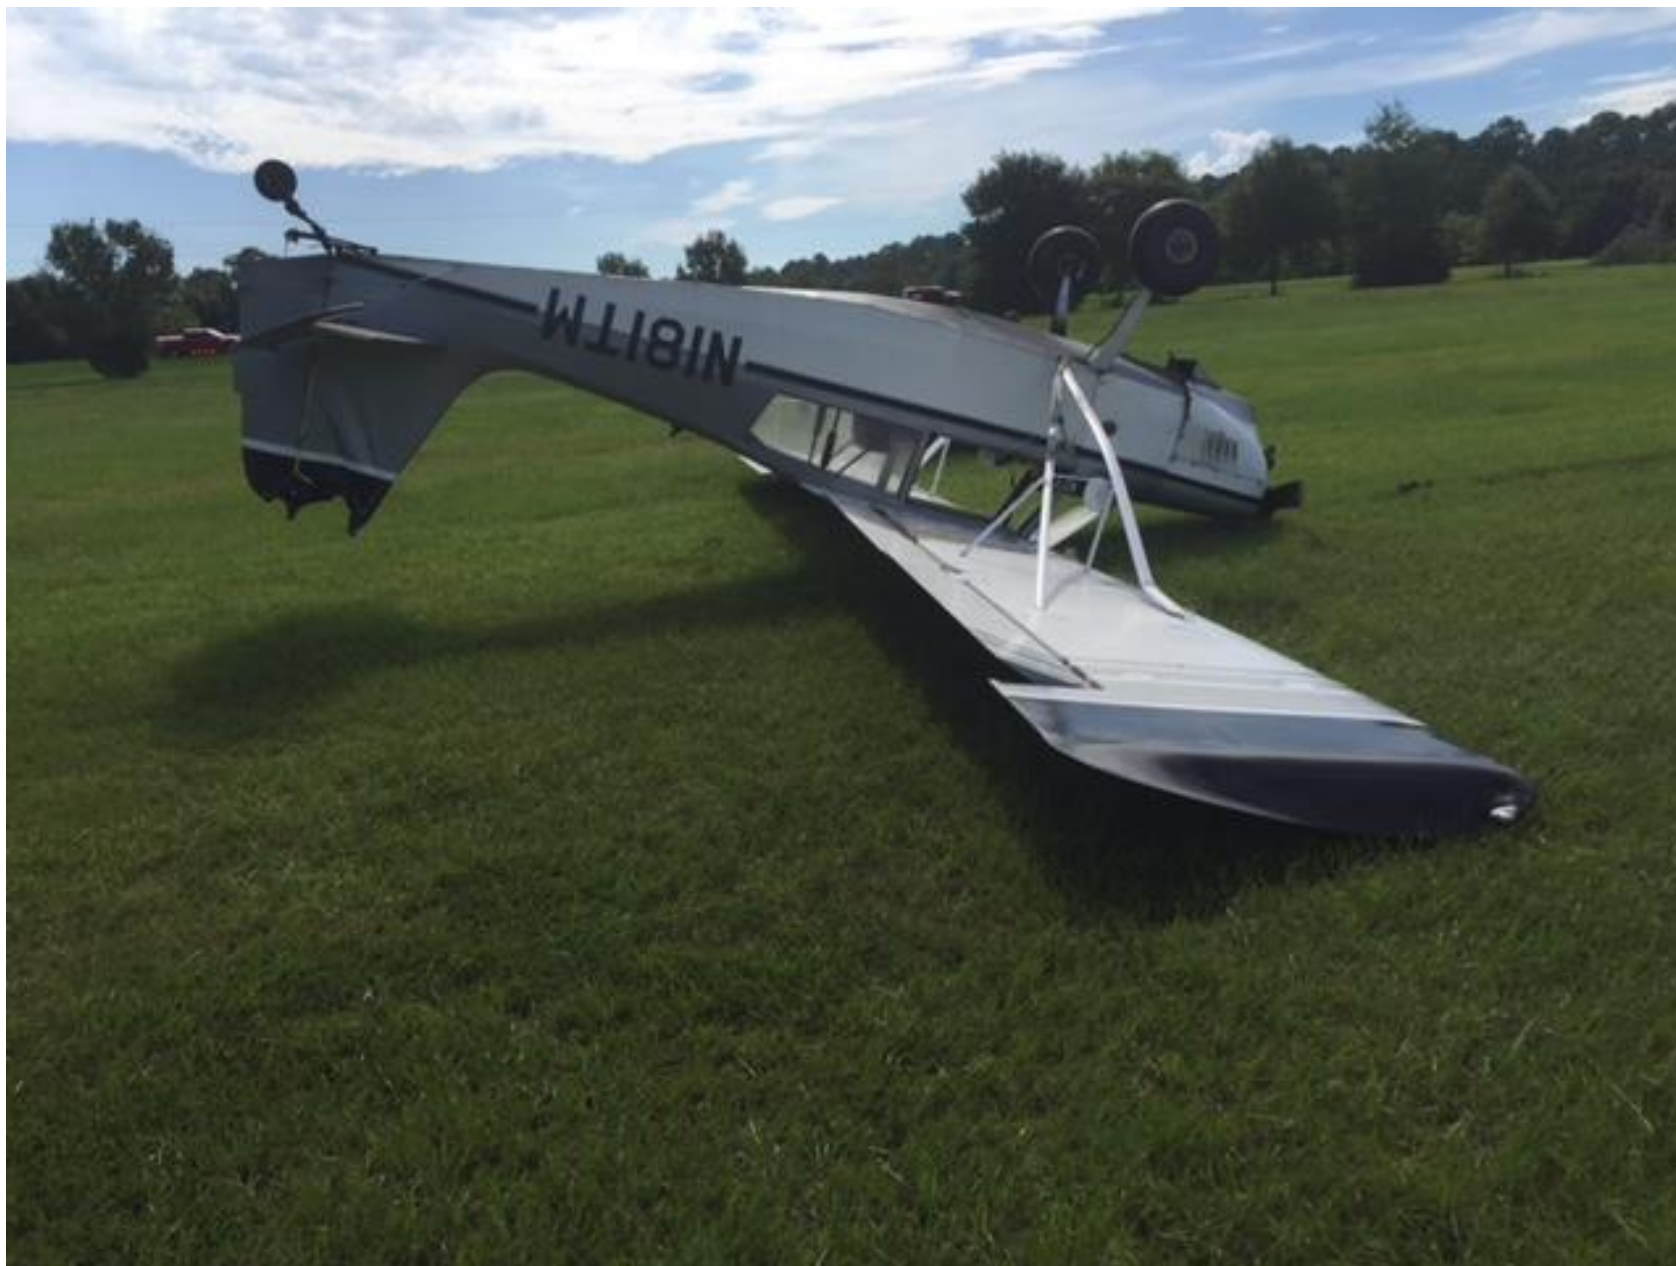
**Photo 1 – View of empennage damage (photo courtesy of the FAA)**

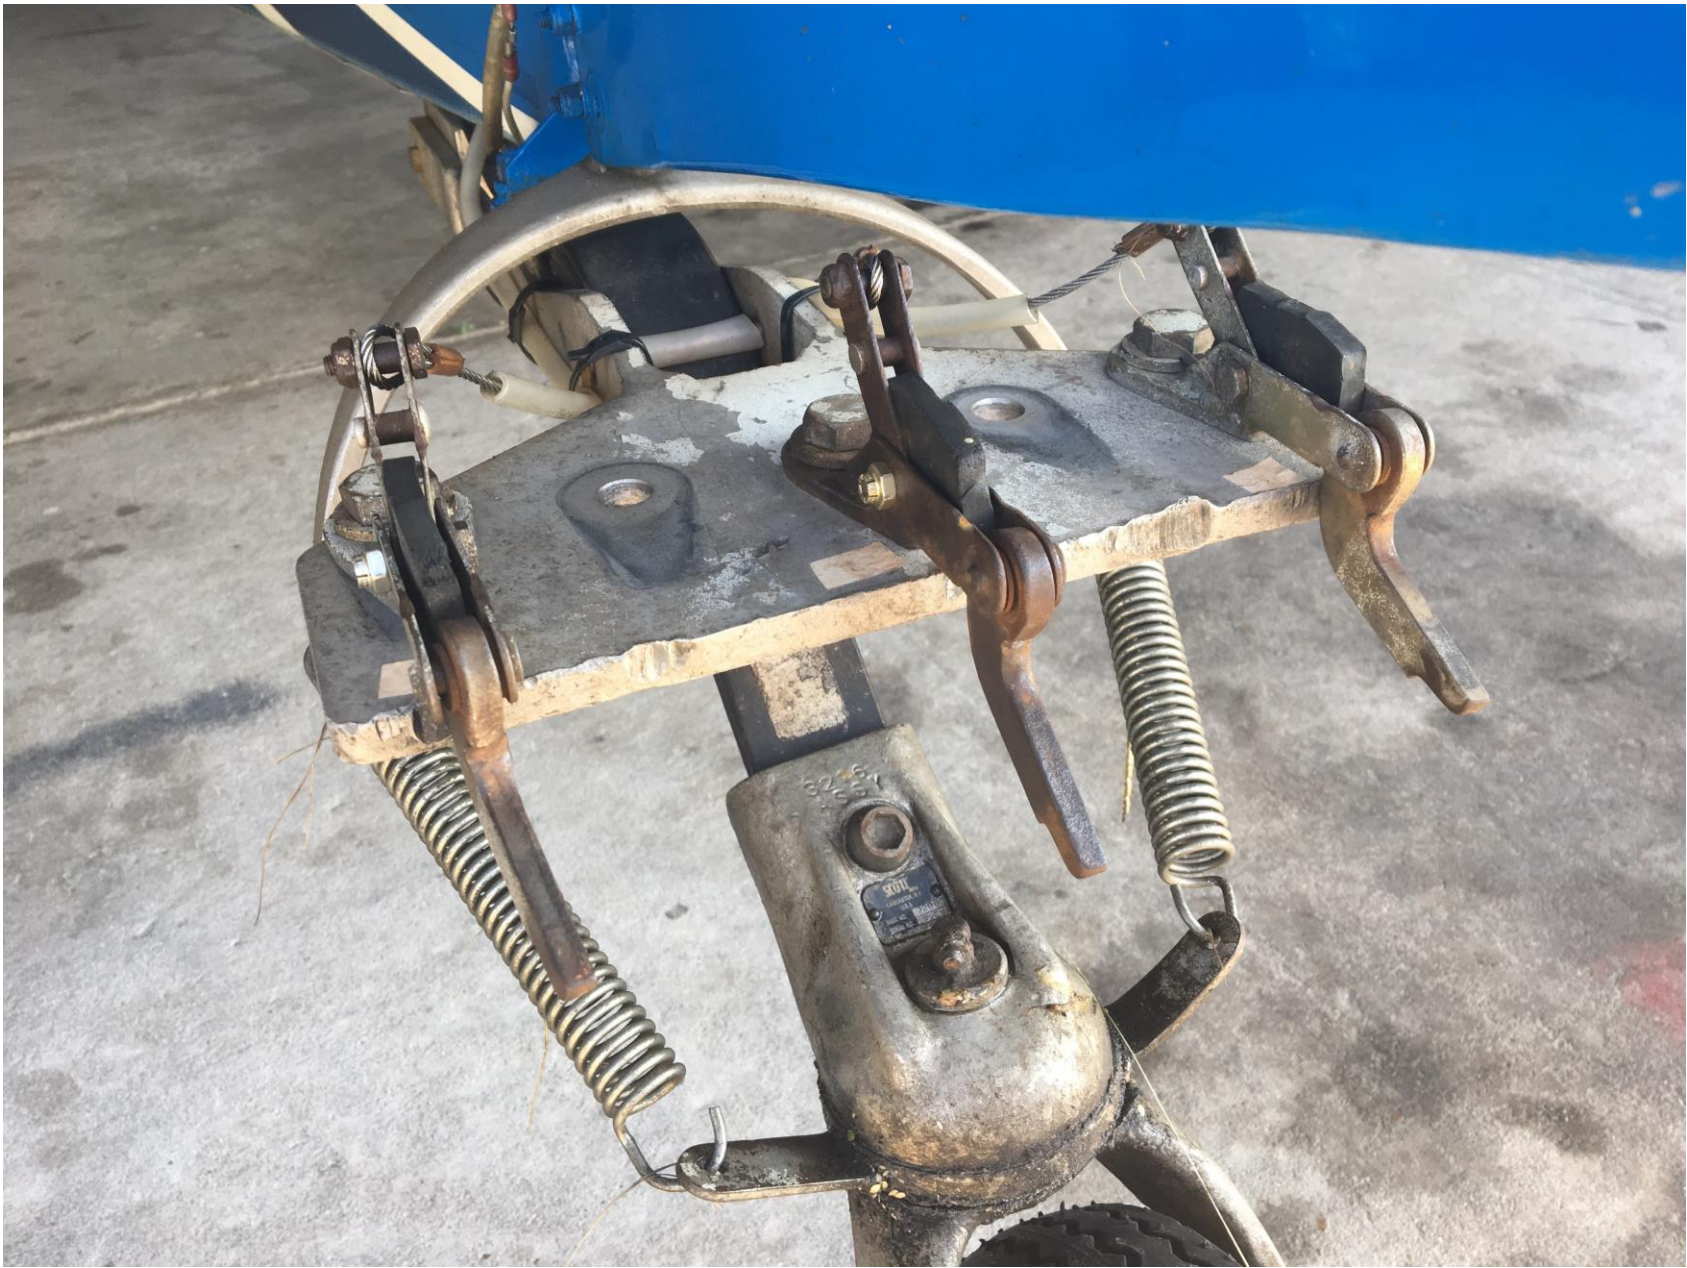
**Photo 2 - View of the three-hook banner release mechanism (photo courtesy of the Operator)**
