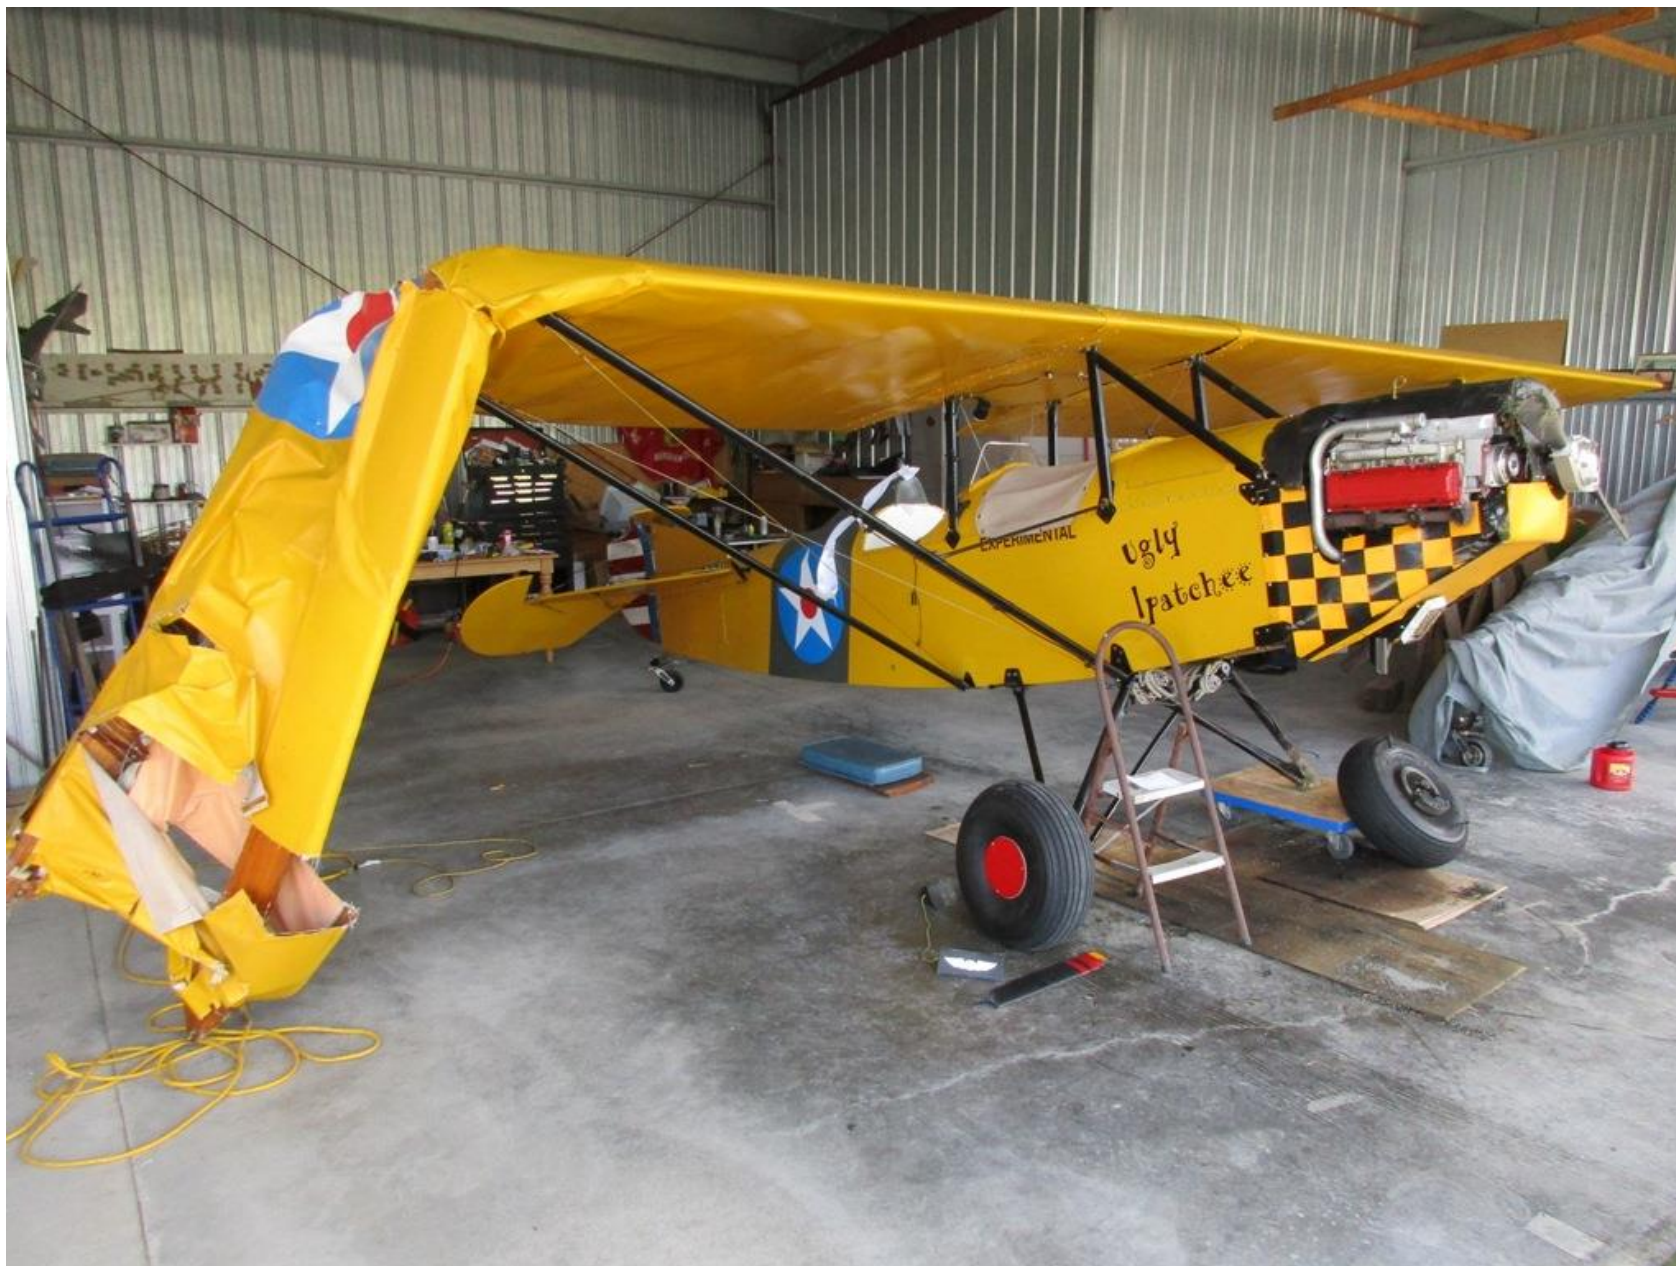
**Photo 1 – View of right wing damage (photo courtesy of the pilot)**

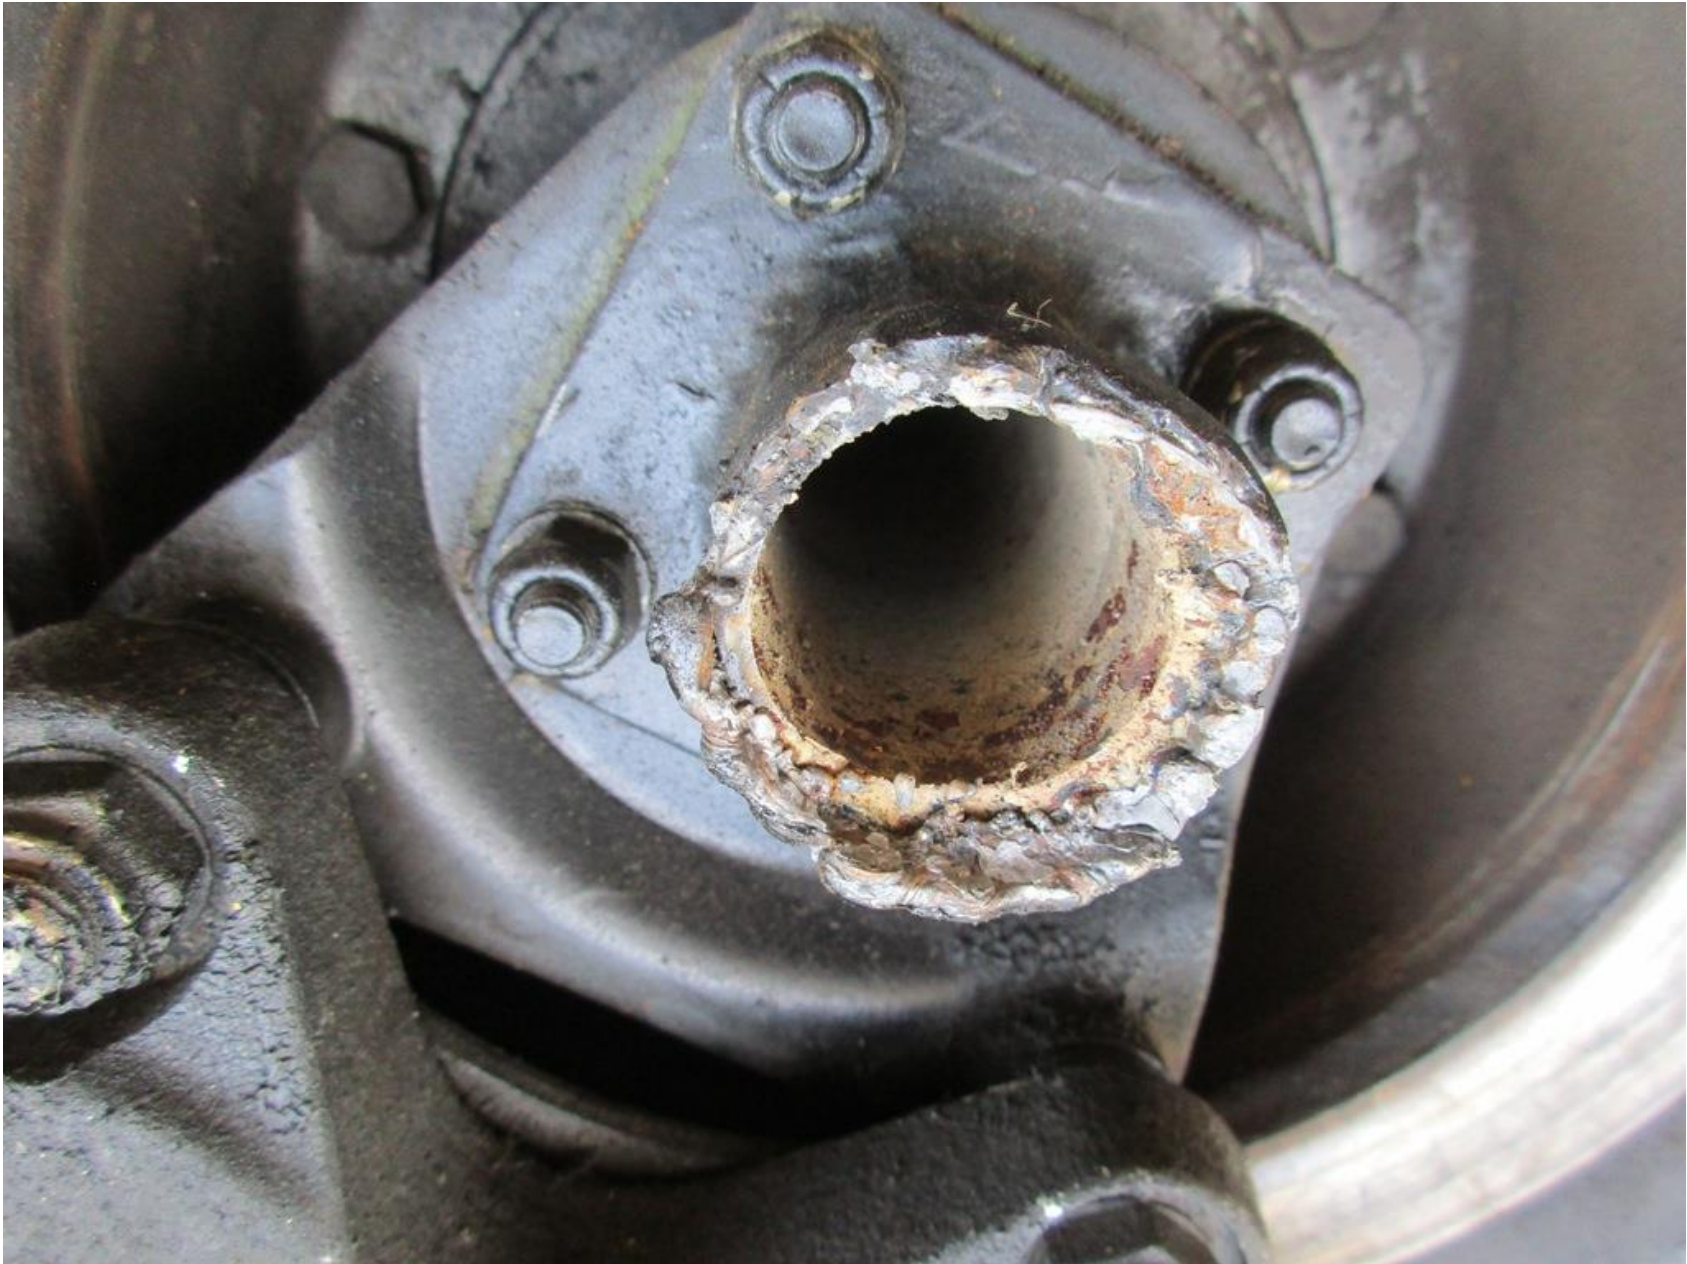
**Photo 2 - View of broken weld on left main landing gear axle (photo courtesy of the pilot)**
