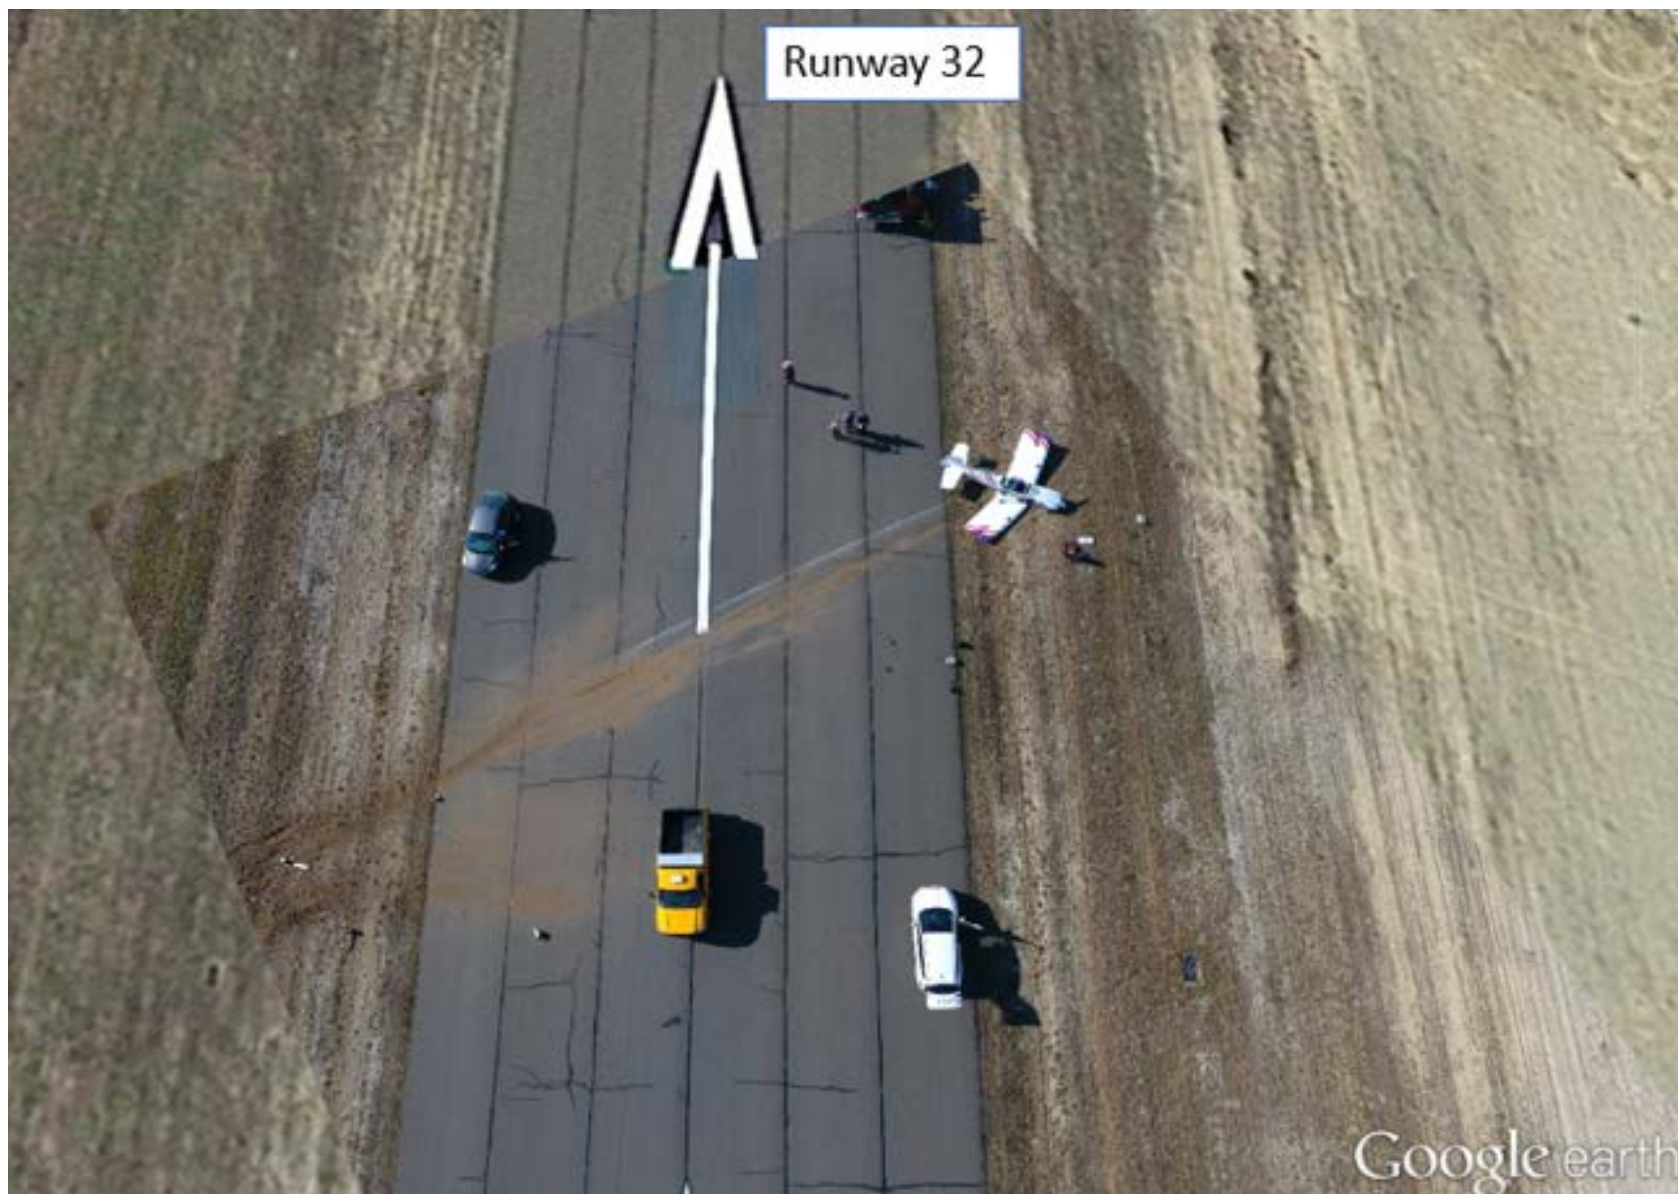
**Photo 1 – Overview of Accident Site (Photo Courtesy of Massachusetts Department of Transportation, Aeronautics Division)**

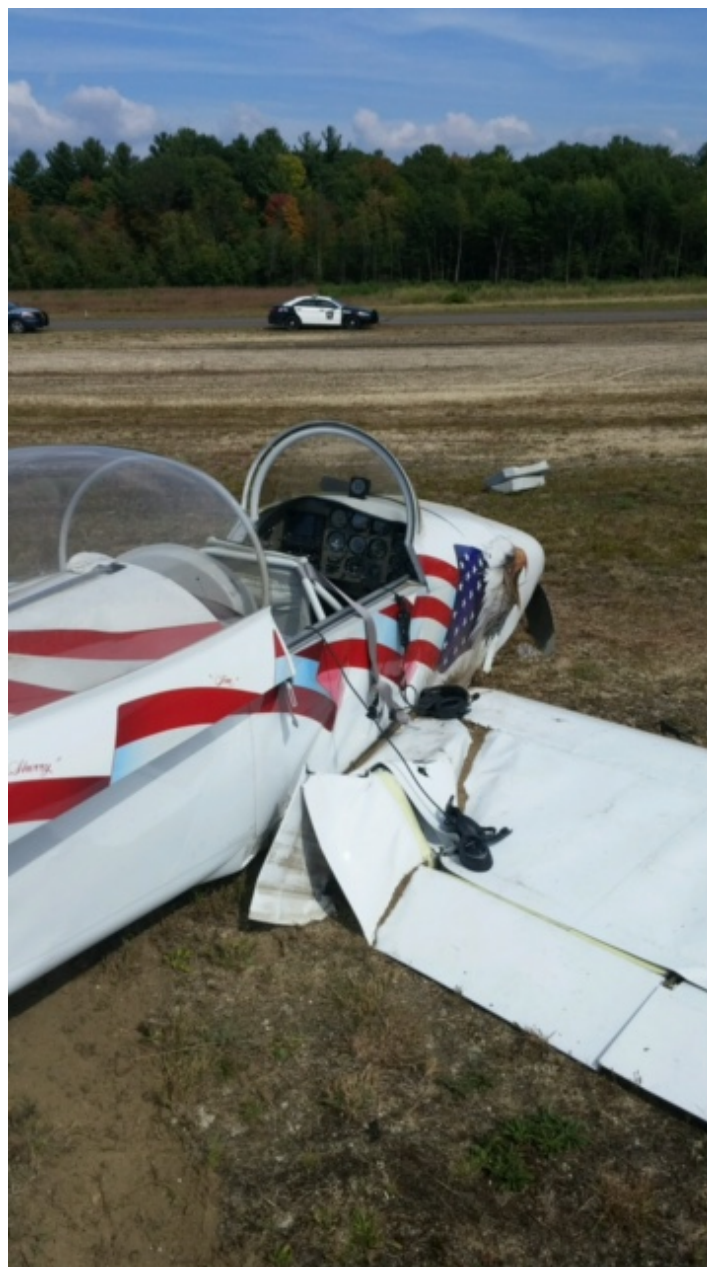
**Photo 2 - Substantially Damaged Right Wing (Photo Courtesy of FAA)**

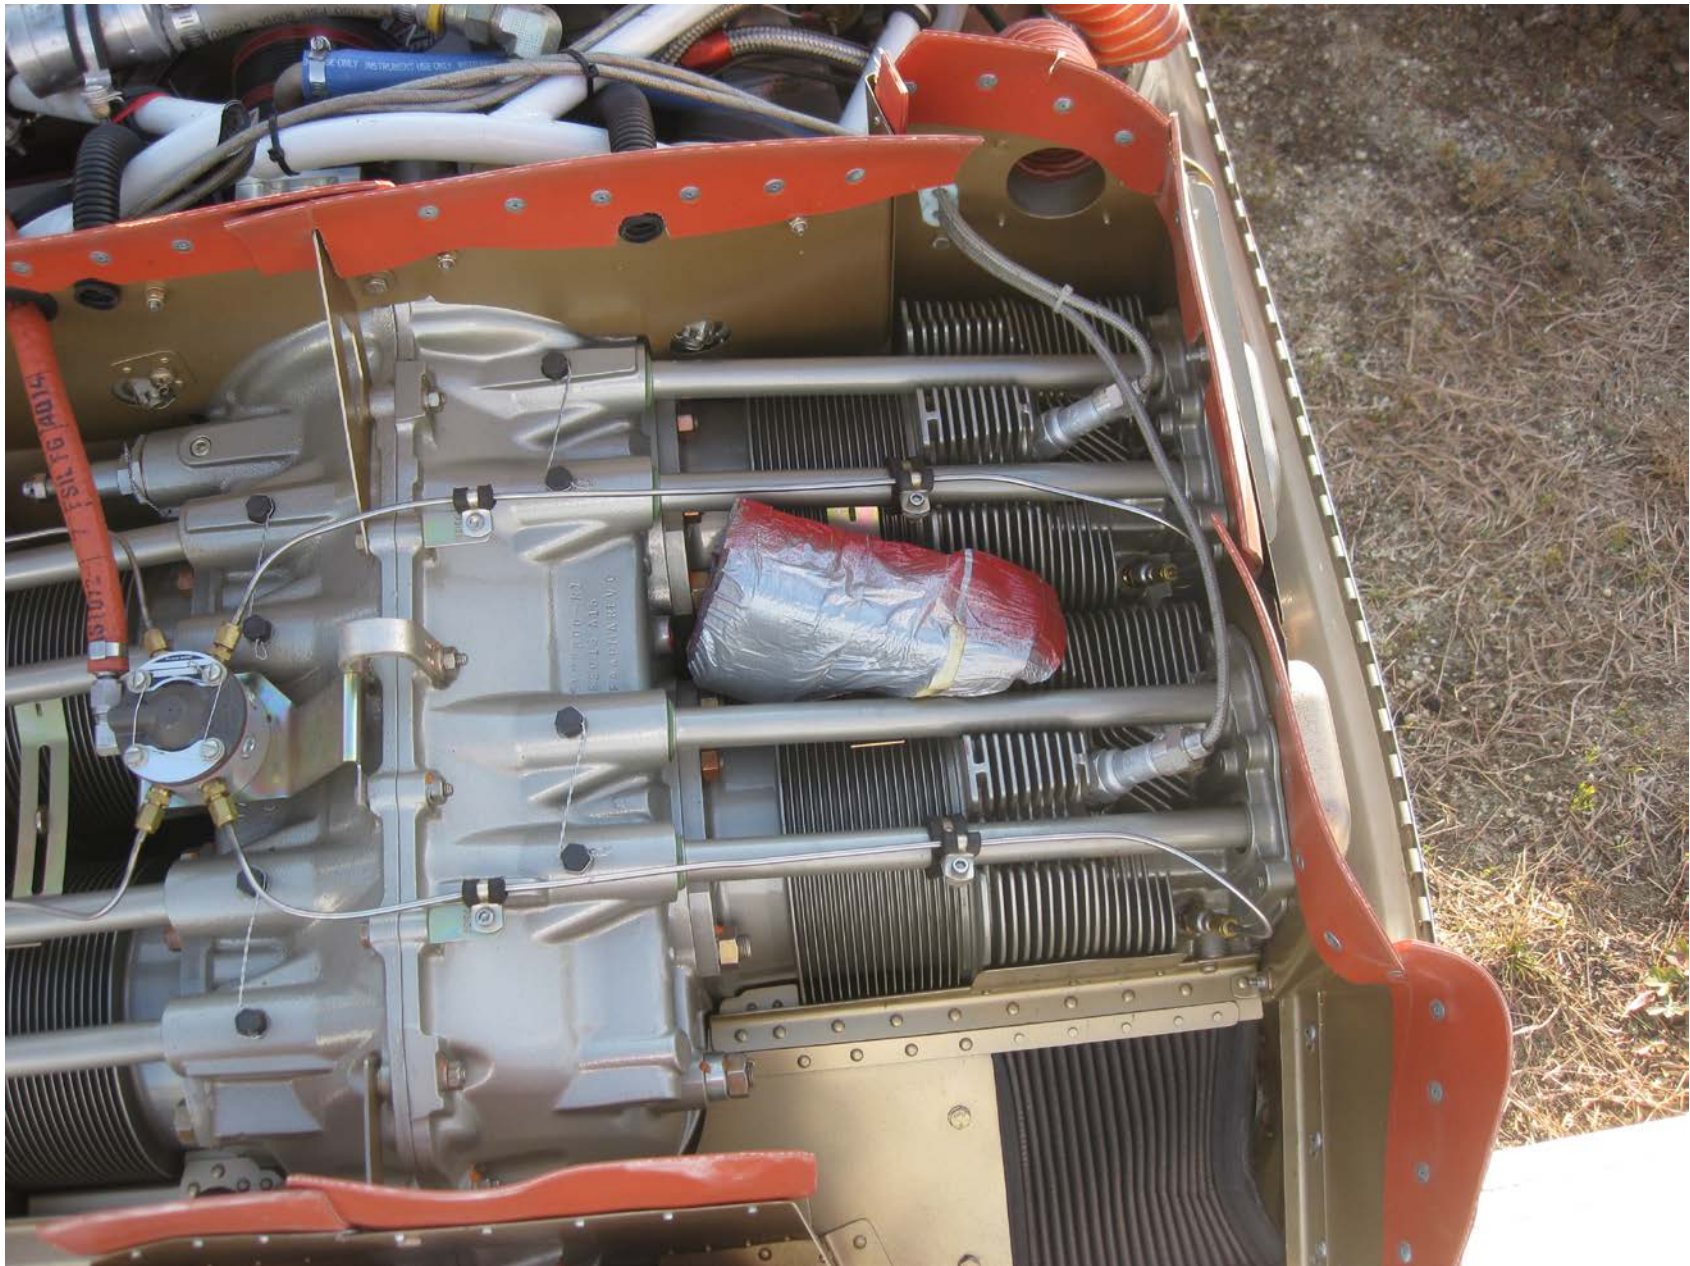
**Photo 3 – Engine Cowl Plug as Found After Accident (Photo Courtesy of FAA)**

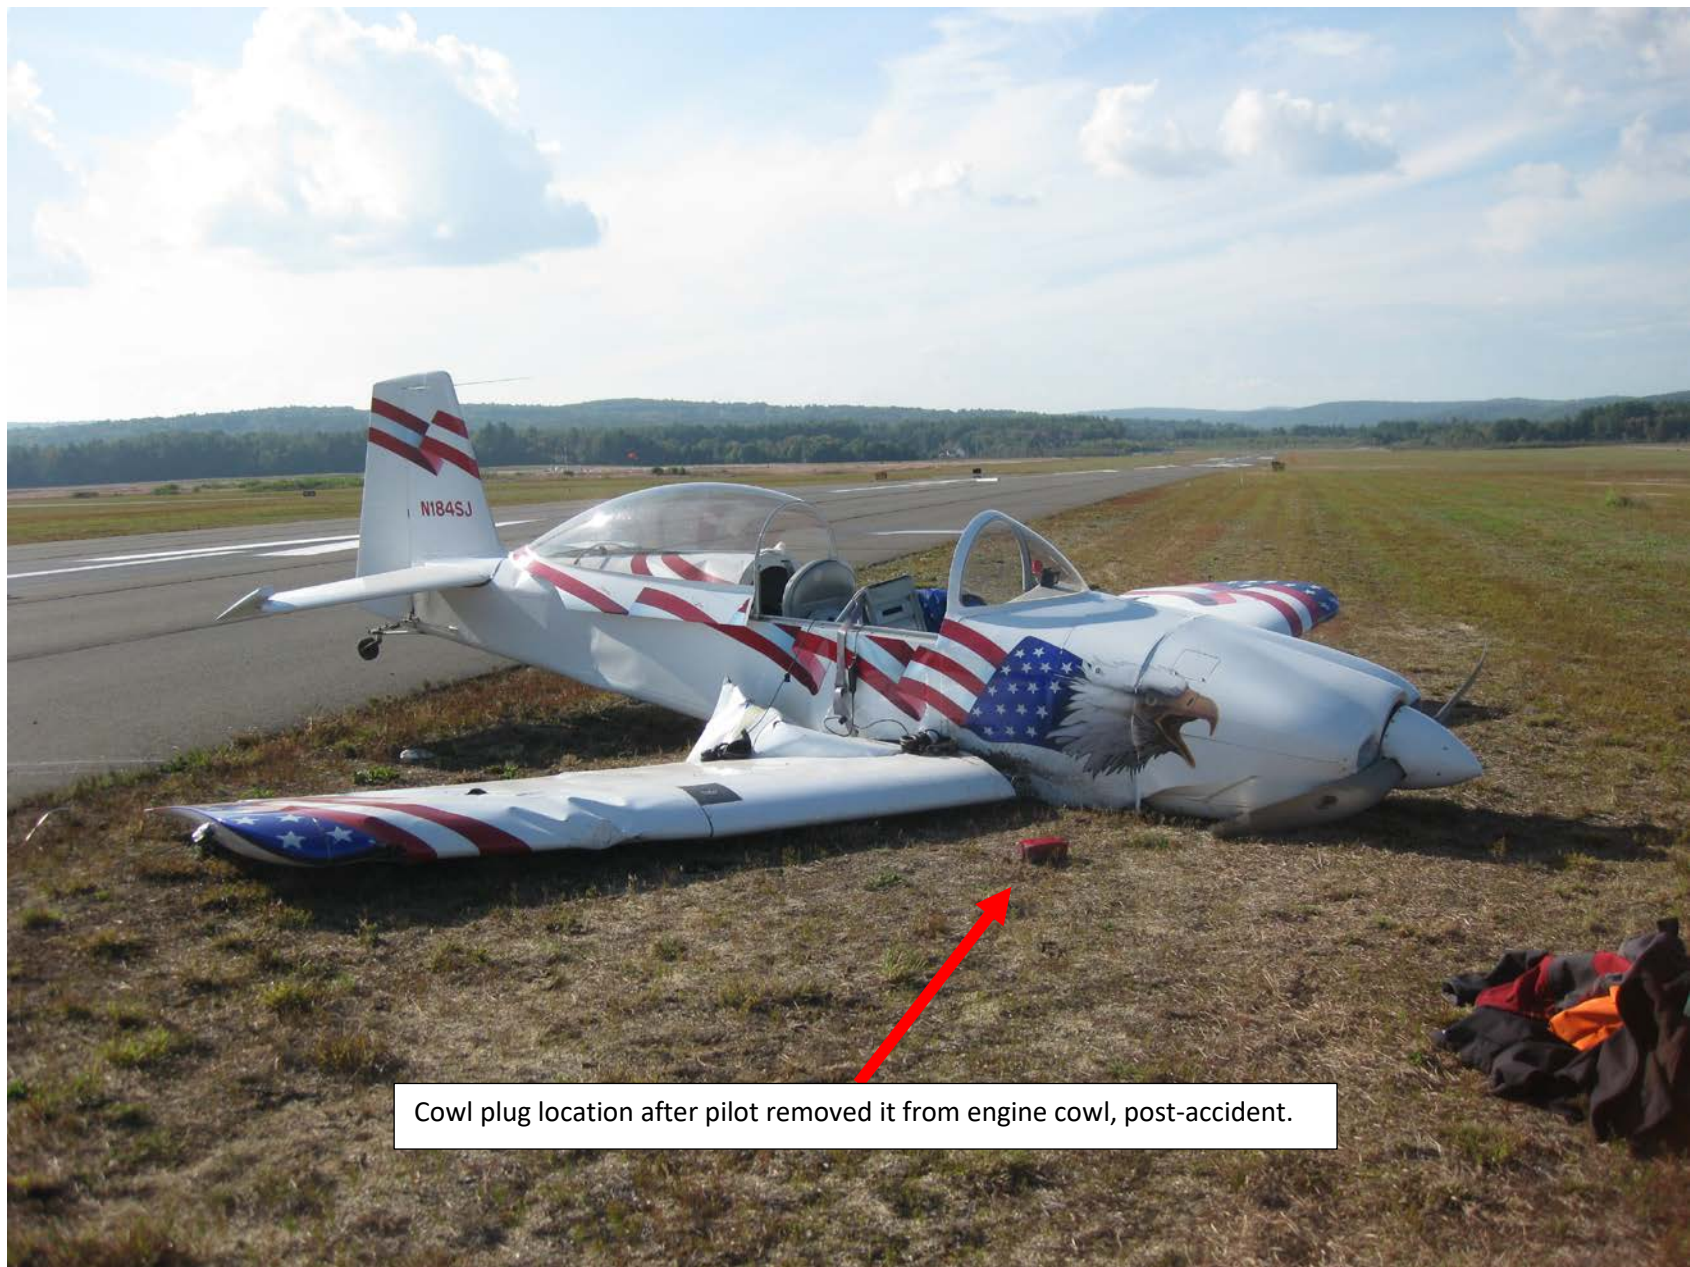
Cowl plug location after pilot removed it from engine cowl, post-accident.

**Photo 4 – Overview of Accident Airplane and Cowl Plug (Photo Courtesy of FAA)**
