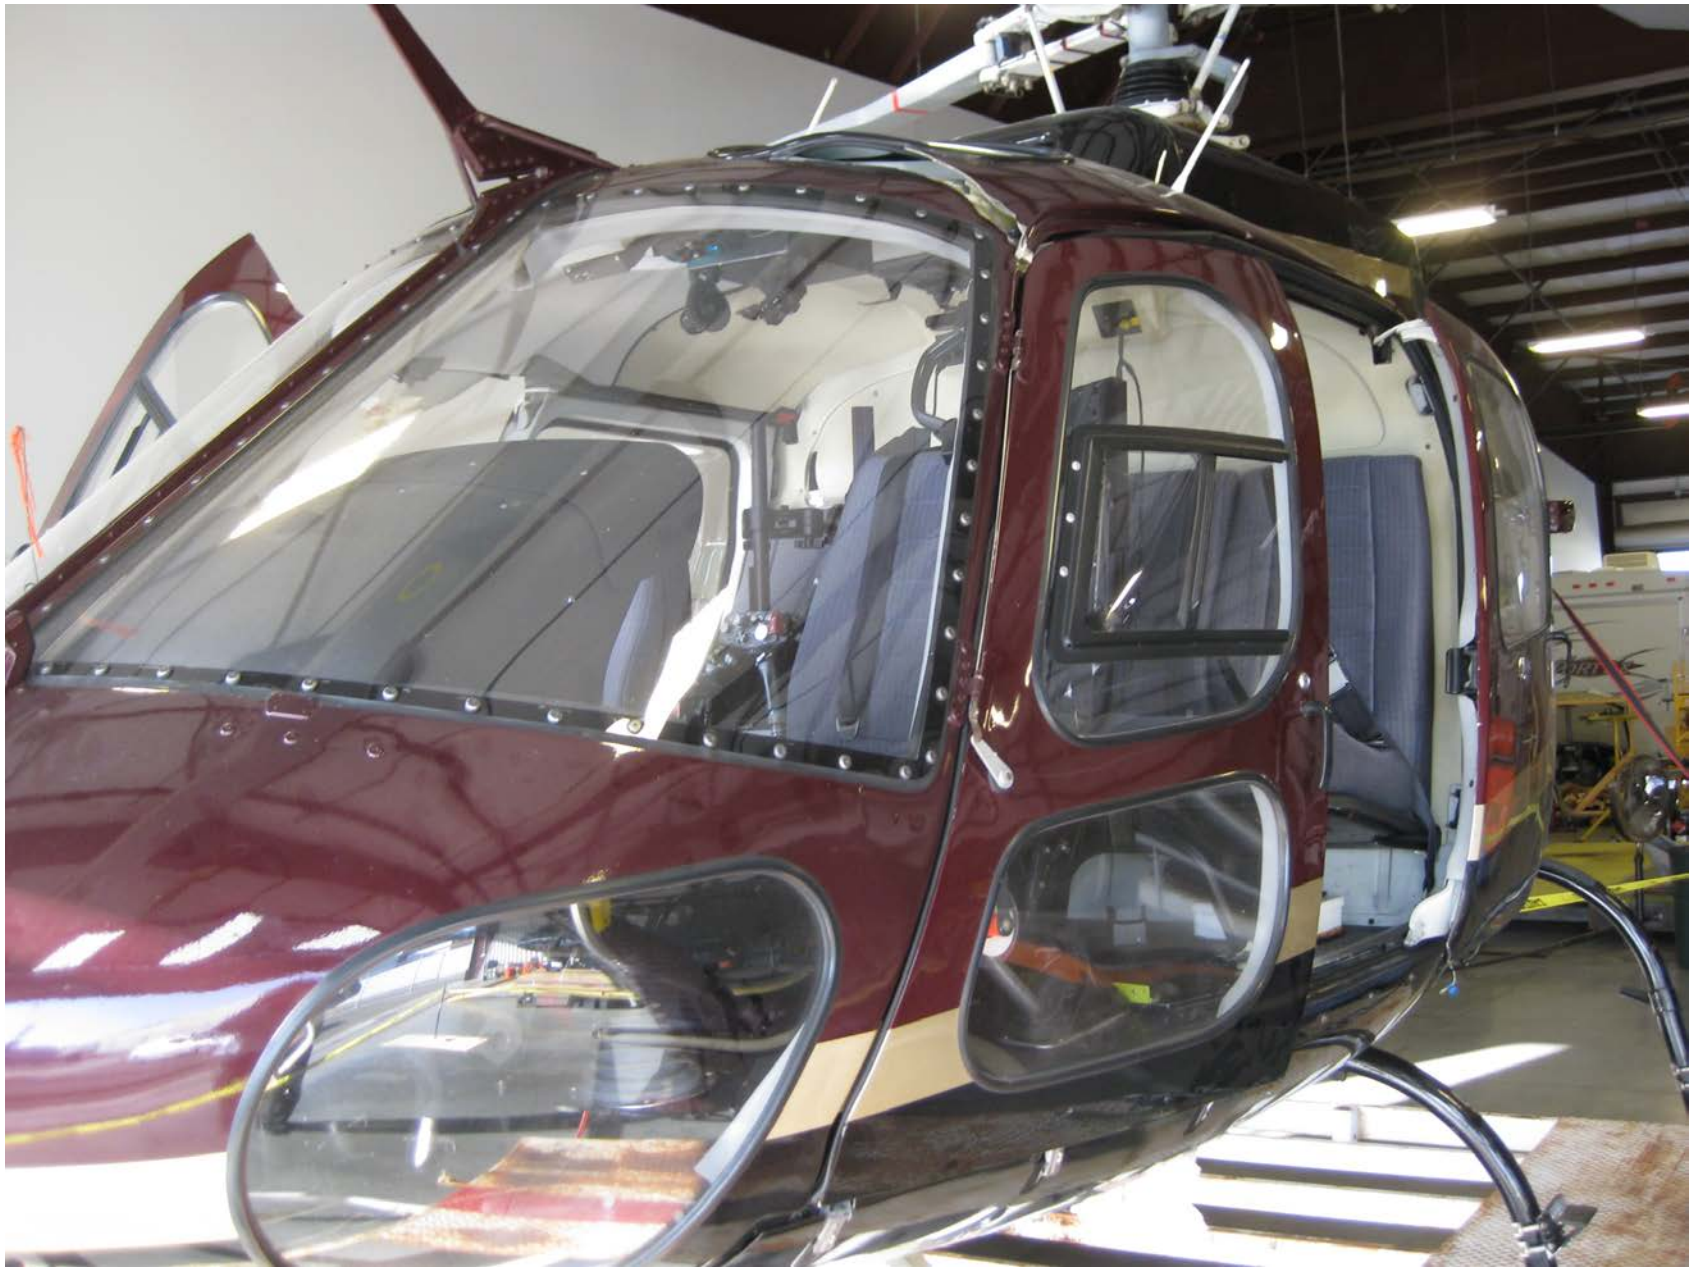
**Photo 1 – View of damage to the upper cabin (Courtesy of Operator)**

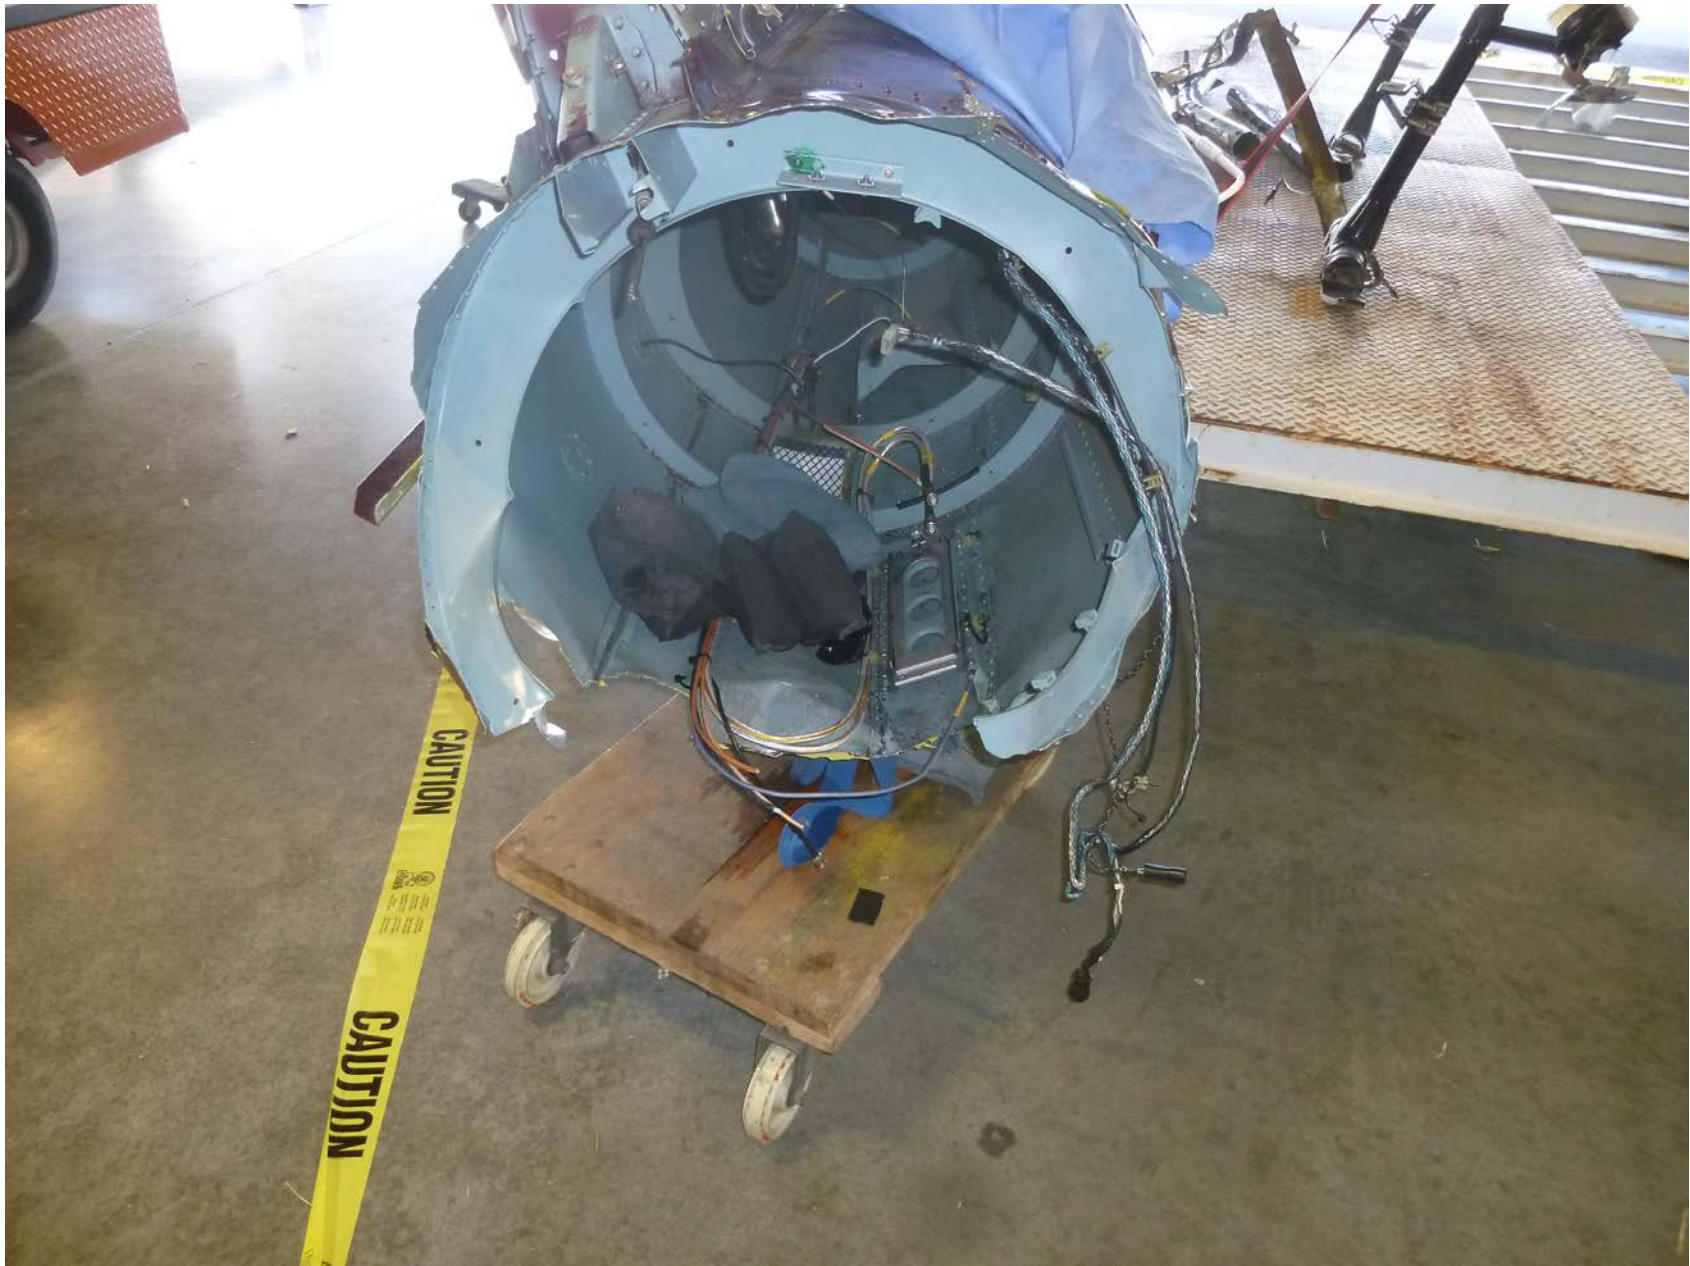
**Photo 2 – View of damage to the tailboom (Courtesy of Operator)**
