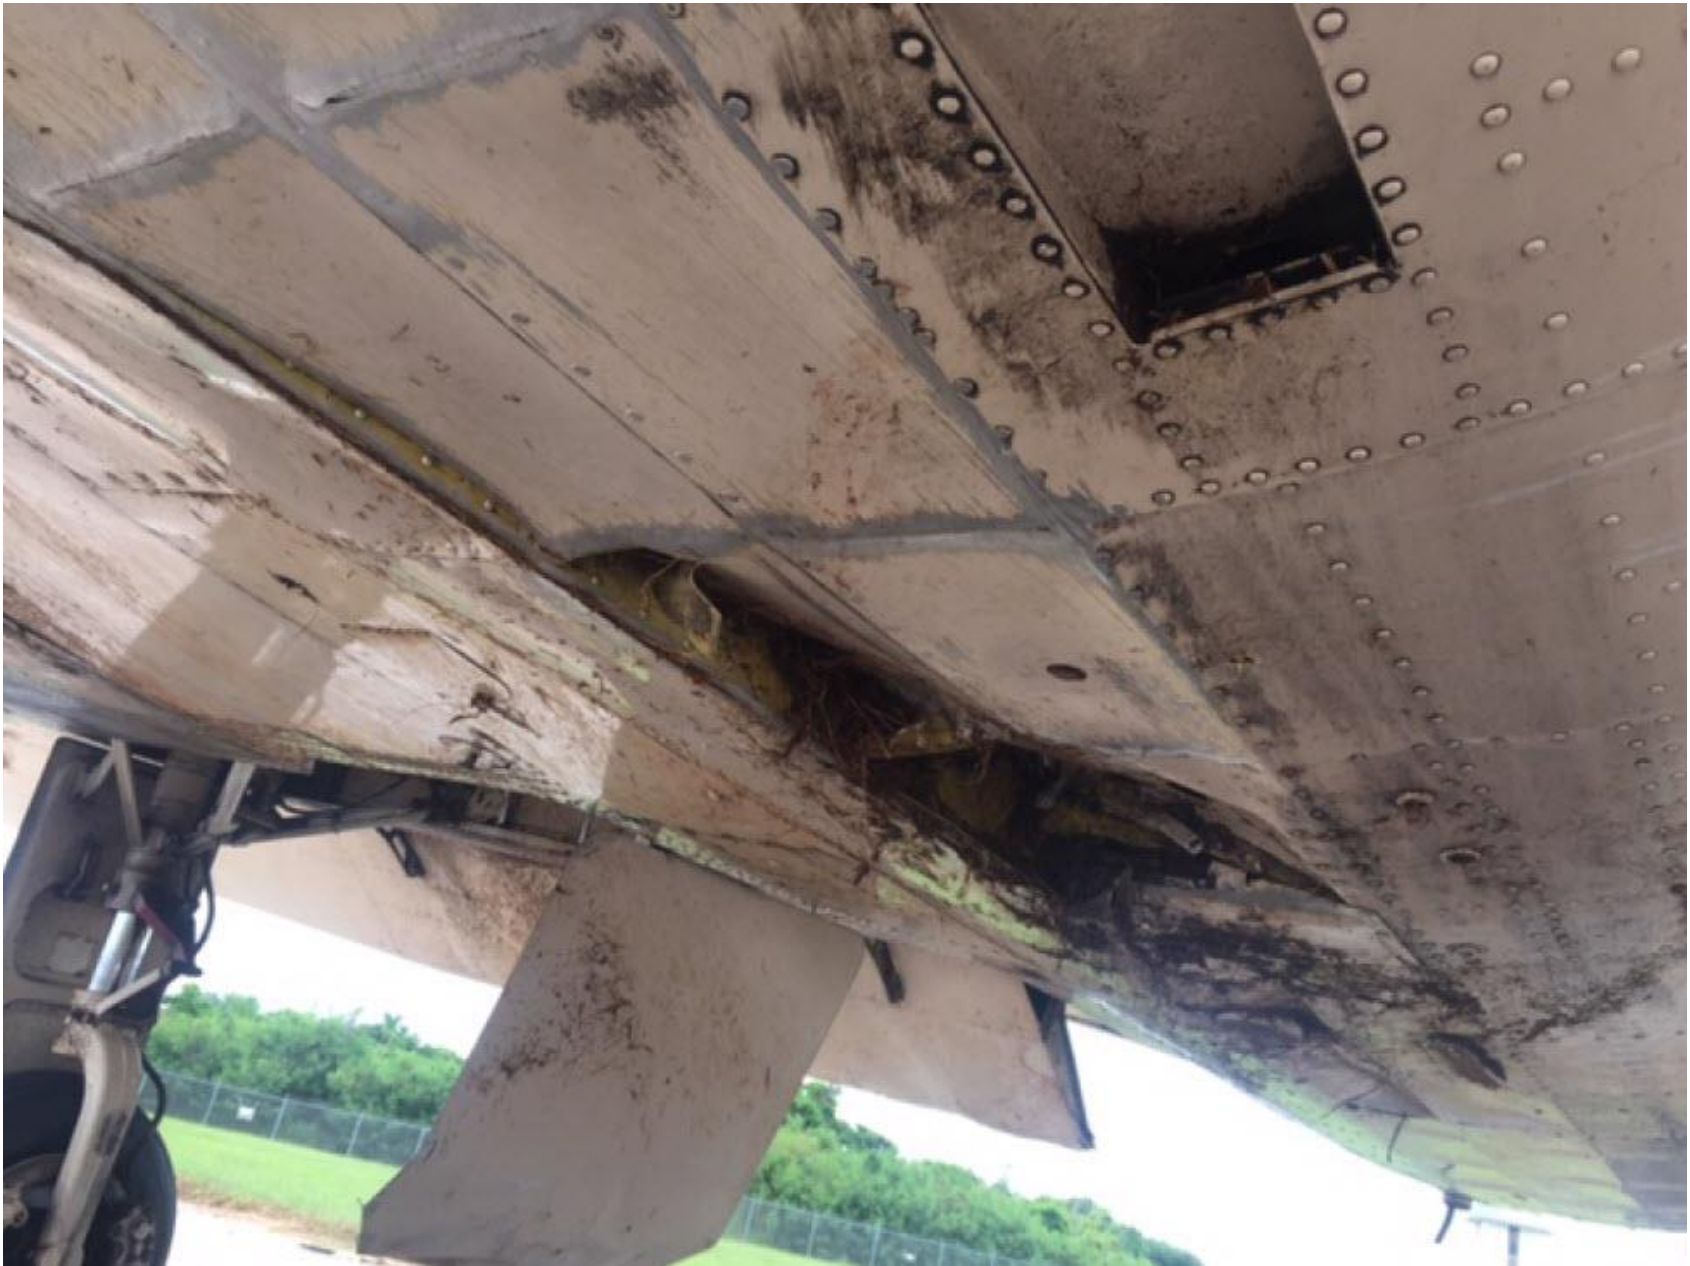
**Photo 1 – View of fuselage damage (photo courtesy of the FAA)**

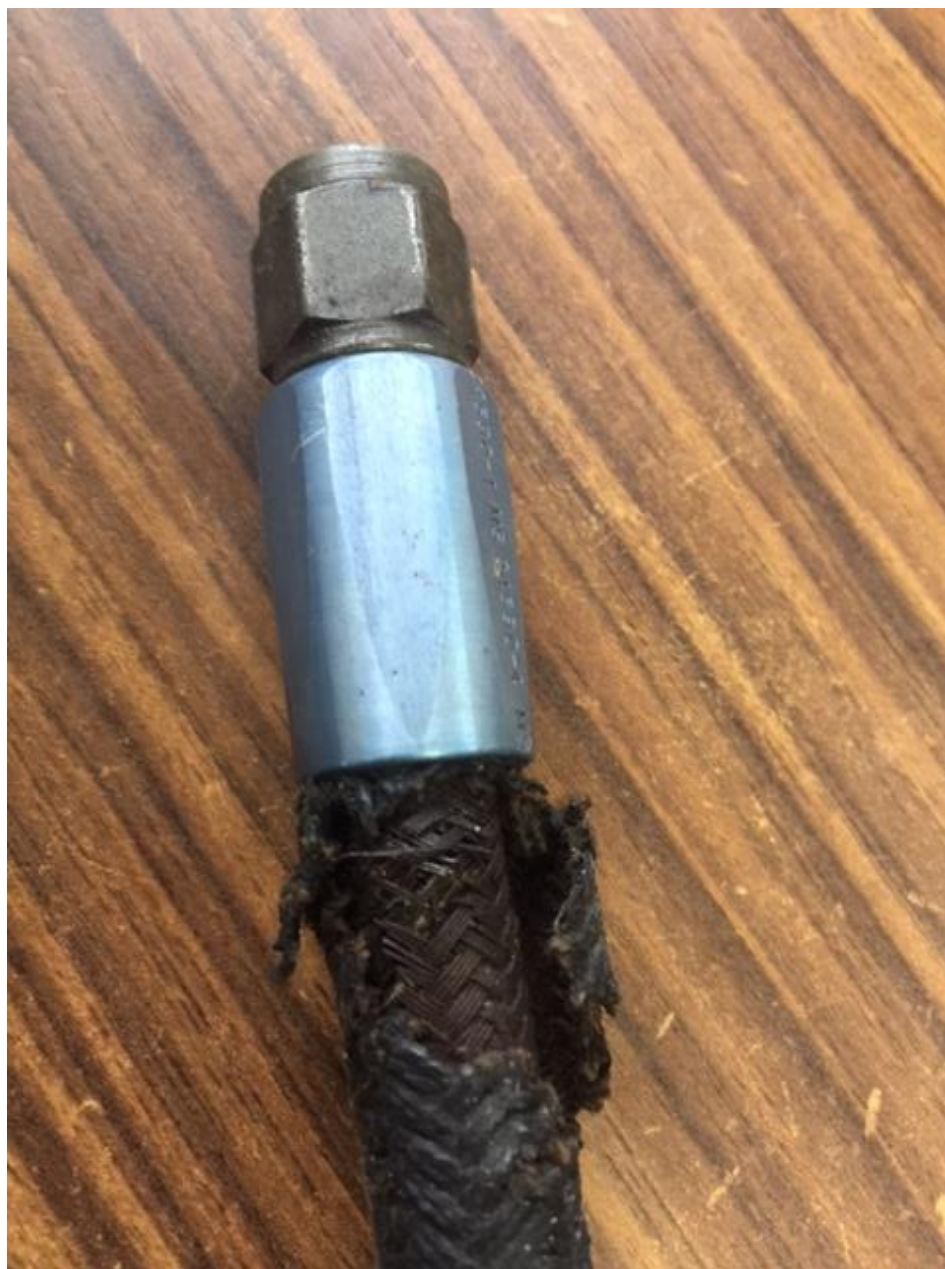
**Photo 2 - View of right inboard main landing gear door actuator hose (photo courtesy of the Operator)**
