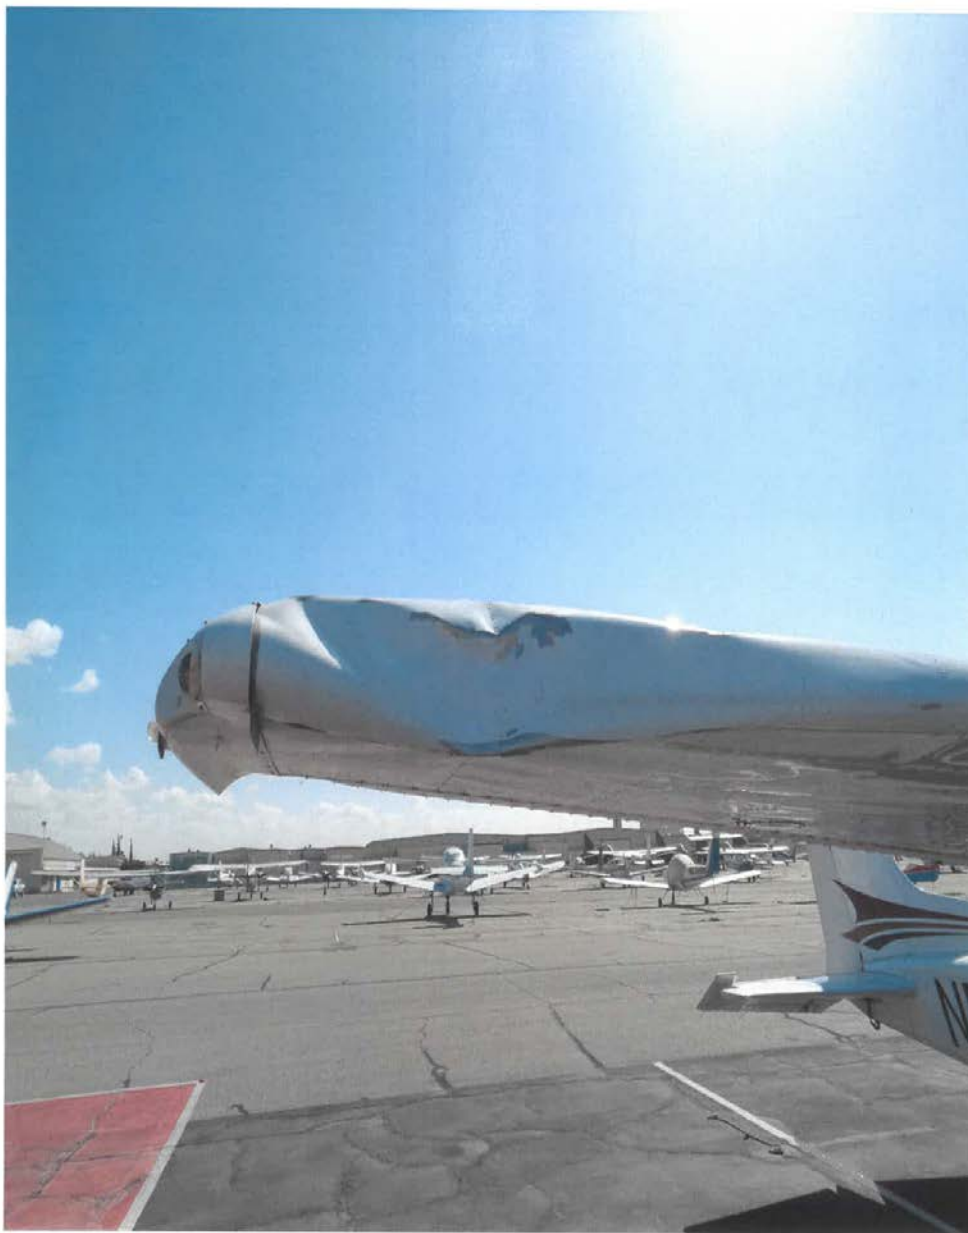
**Photo 1 – View of damaged right wing leading edge (photo courtesy of airport maintenance)**
