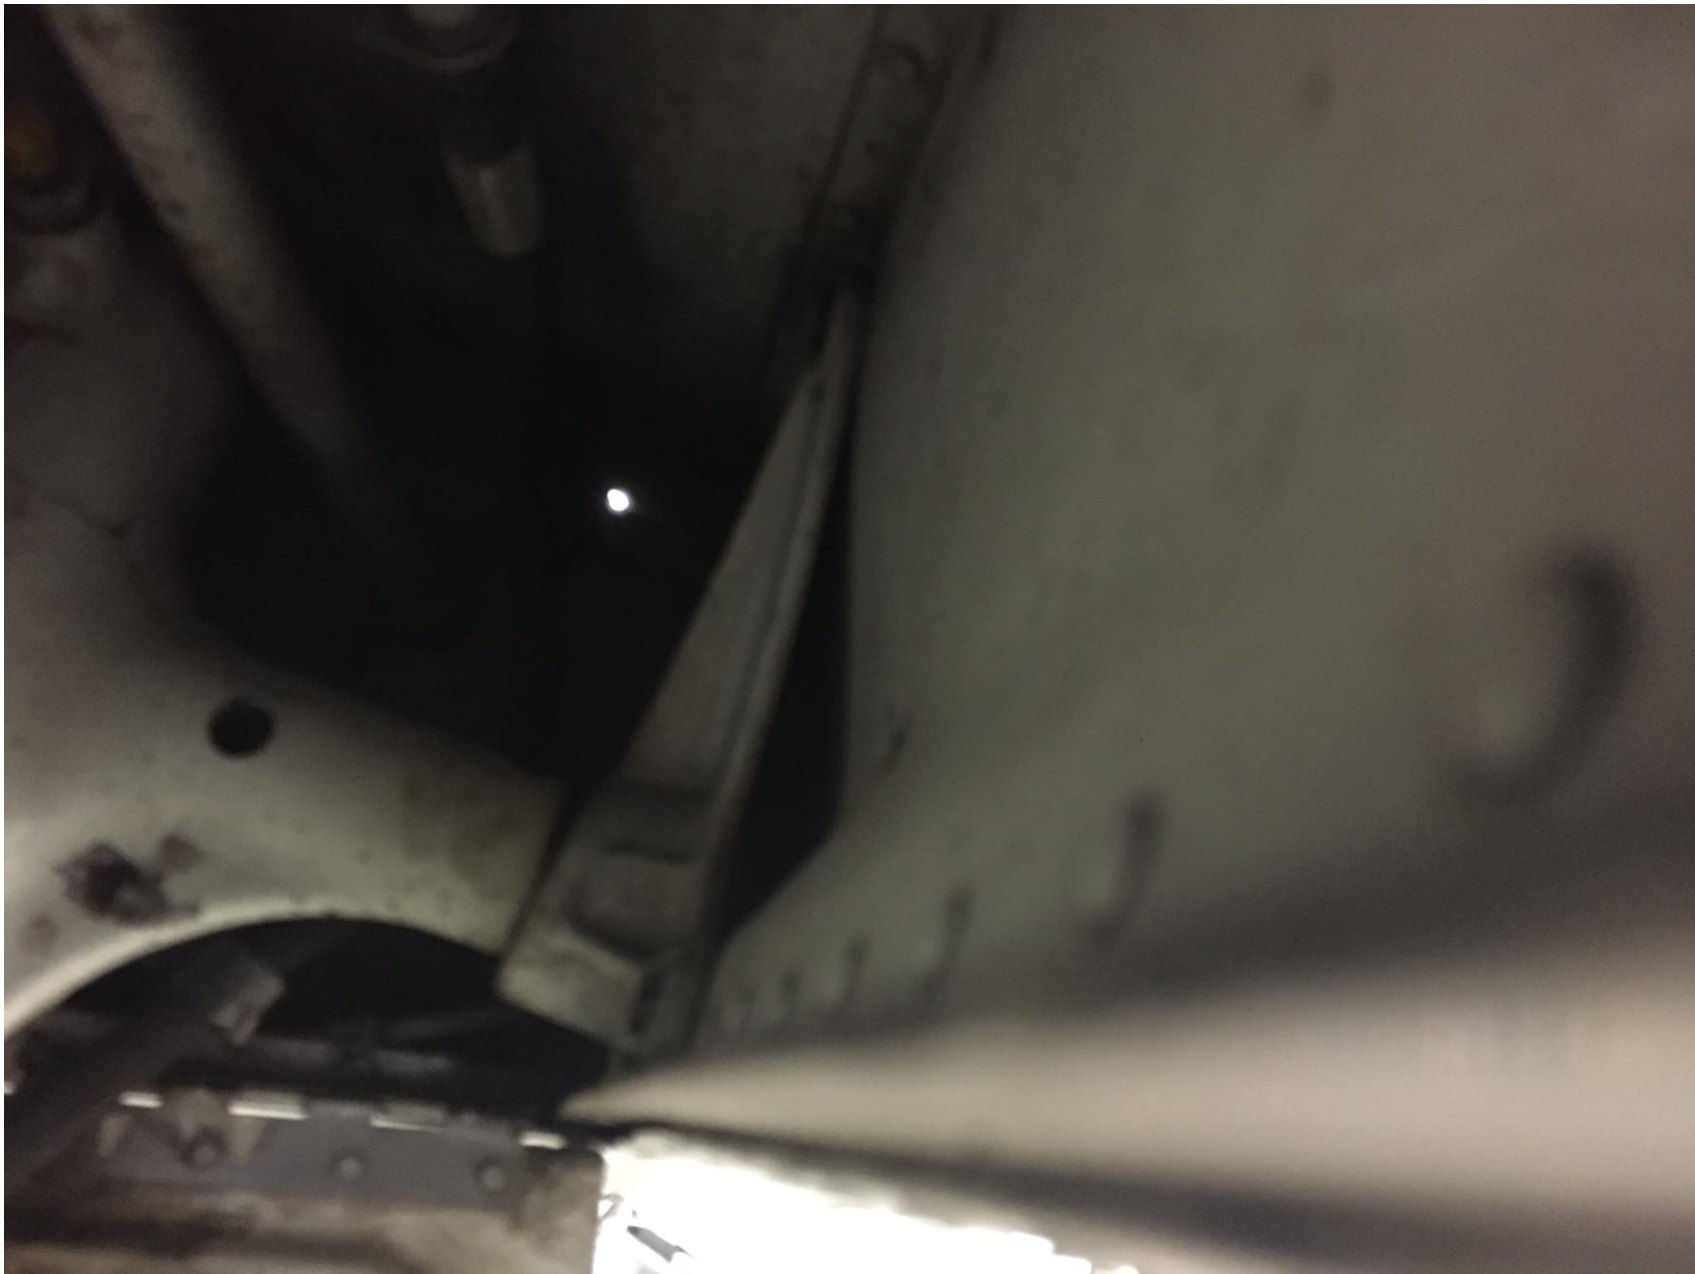
**Photo 1 – View of right wing spar damage looking up from right landing gear well (photo courtesy of FAA)**
