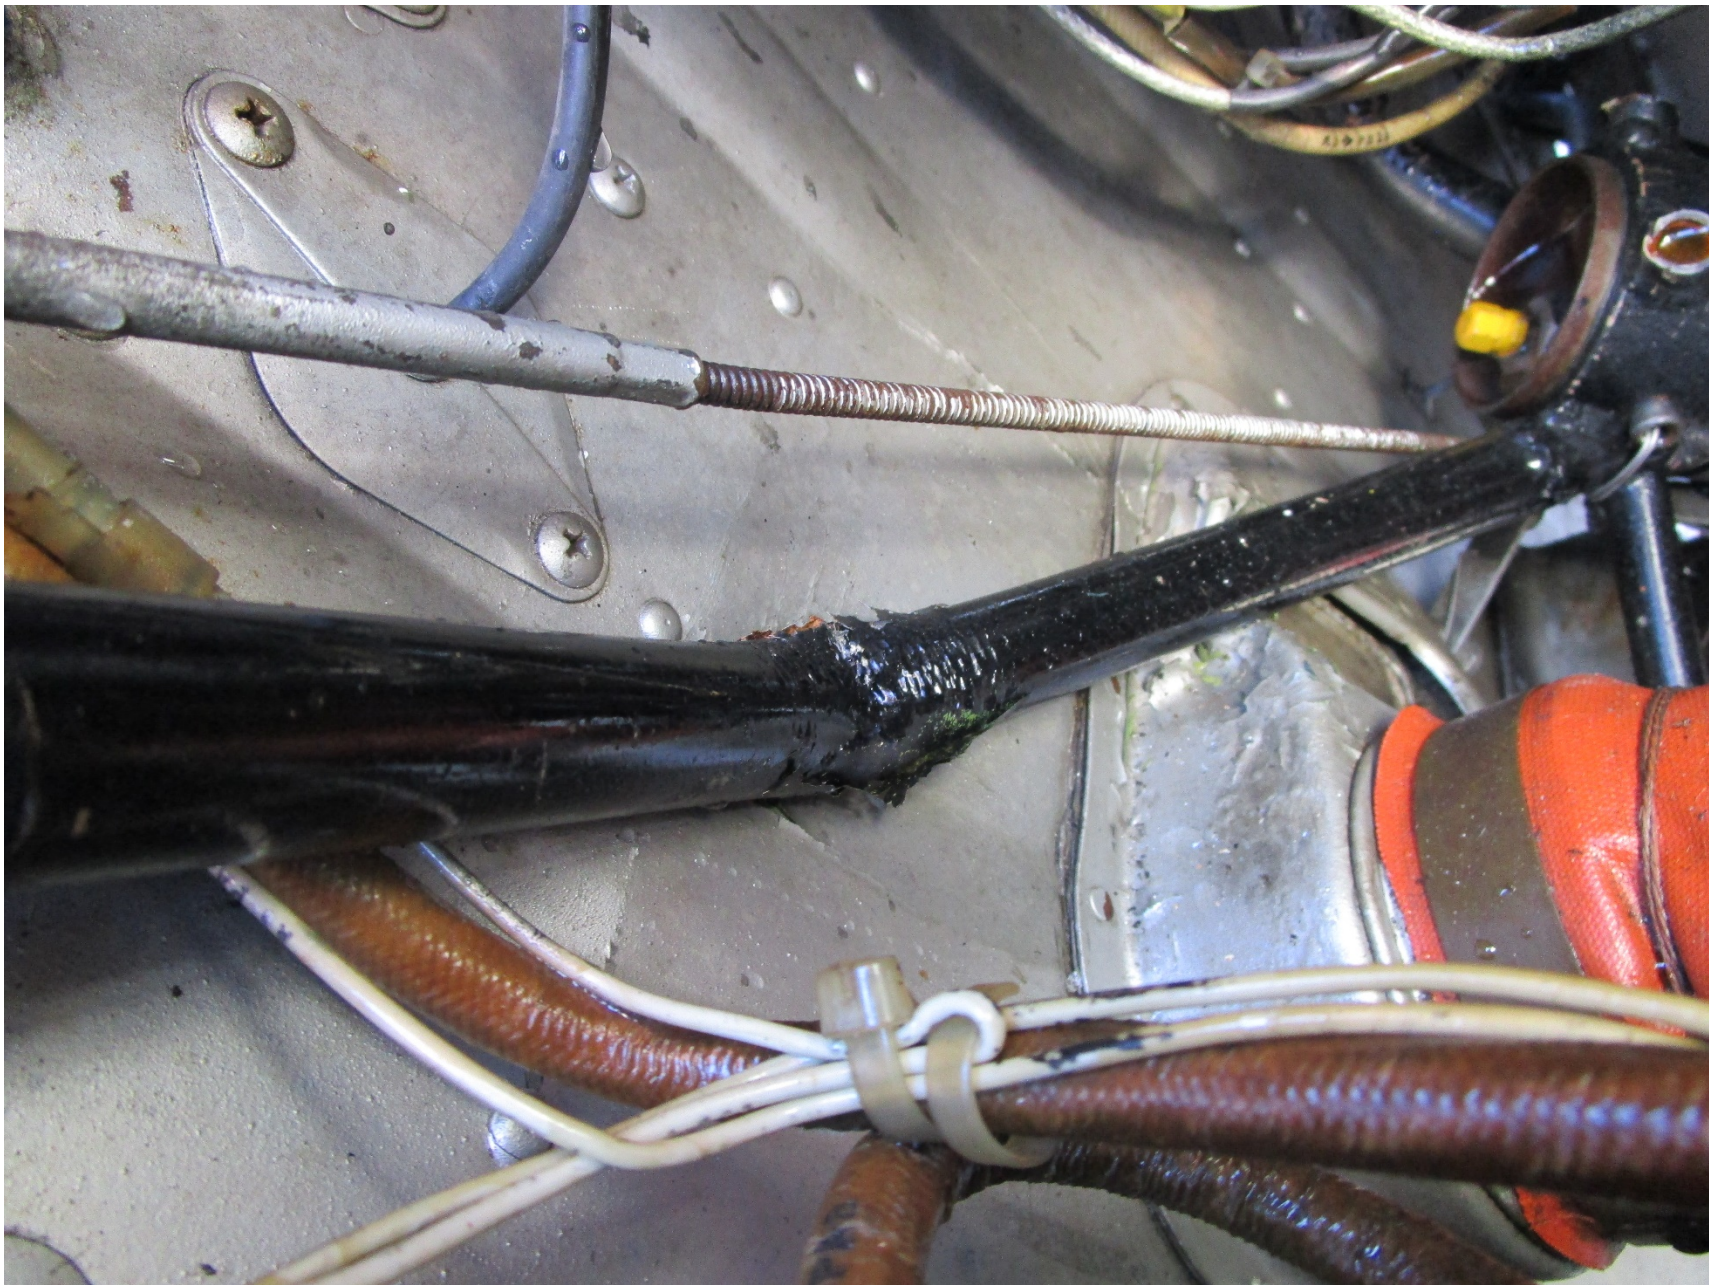
**Photo 1 – View of damaged engine mount (photo courtesy of the FAA)**
