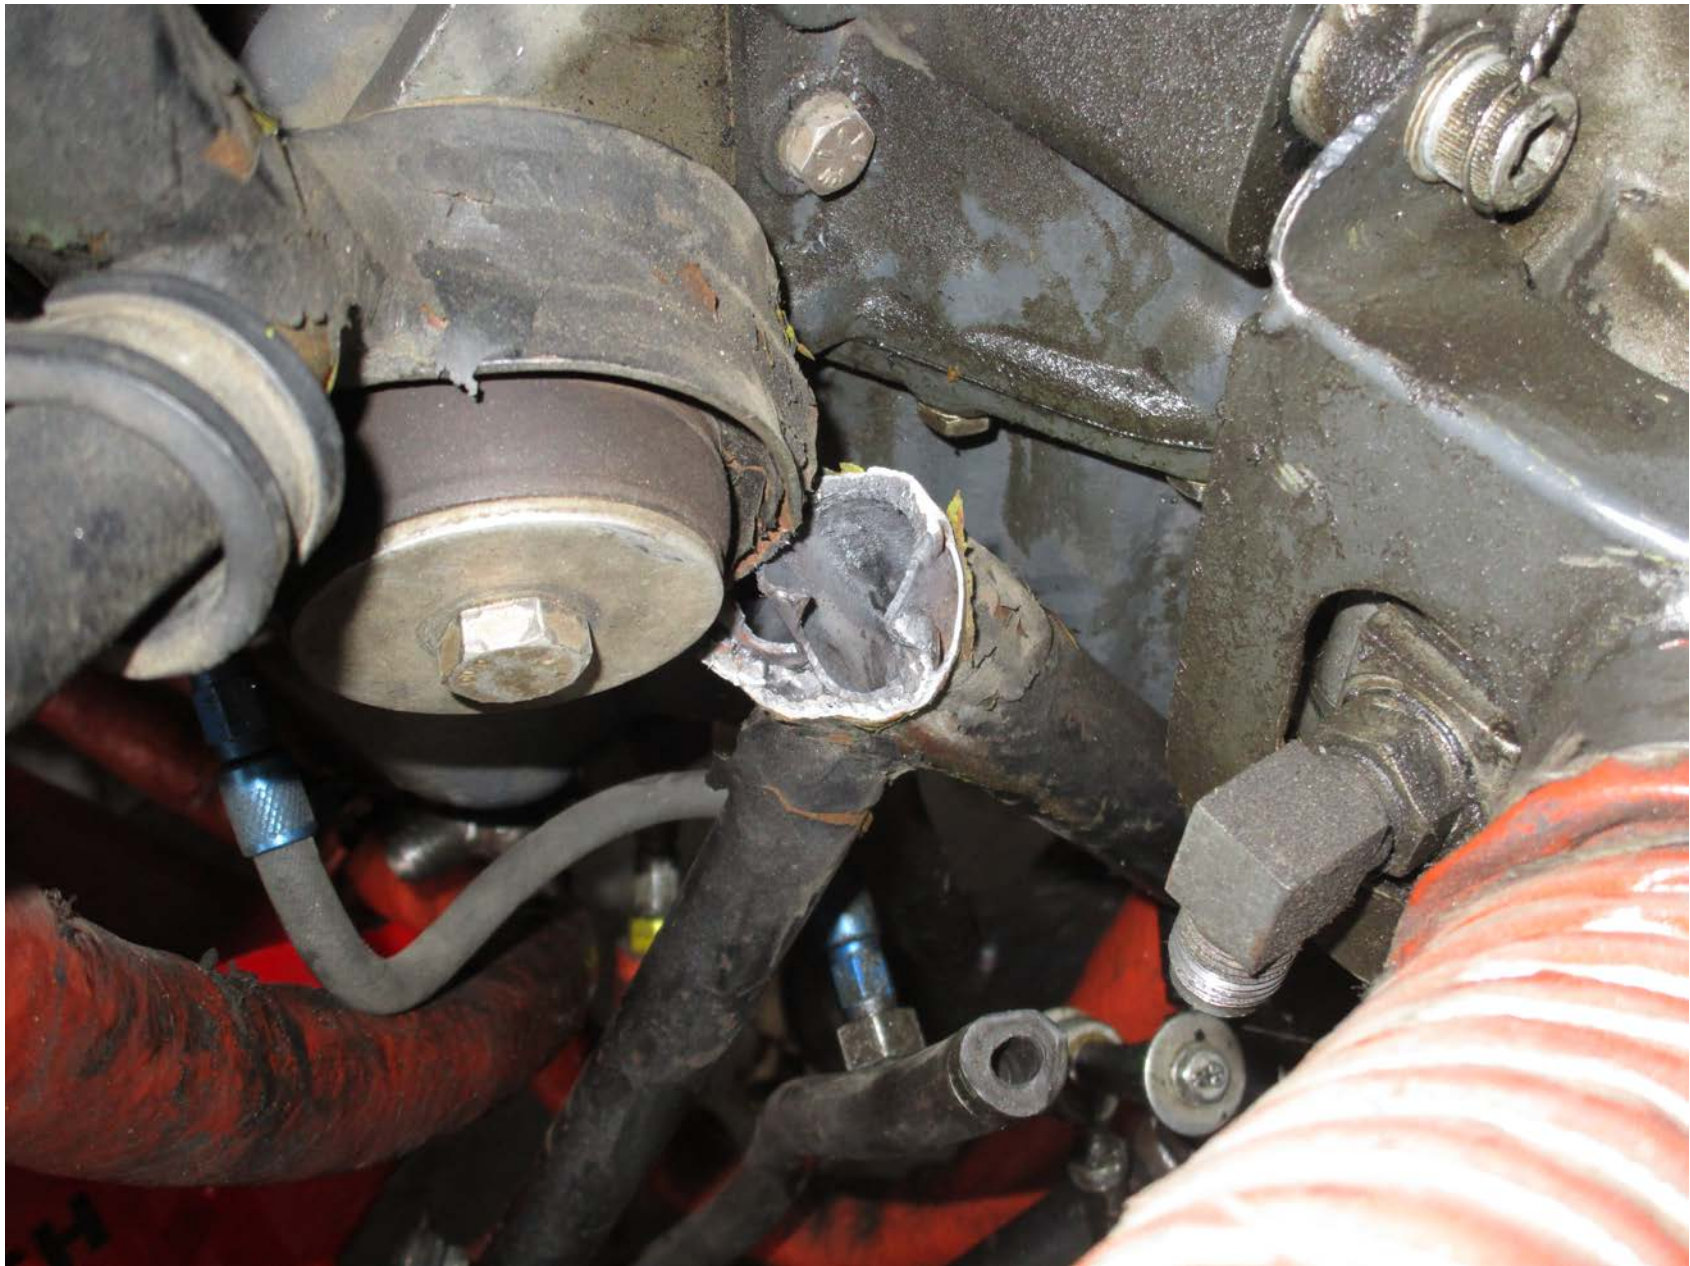
**Photo 1 – View of damage to the engine mount (Courtesy of FAA)**
