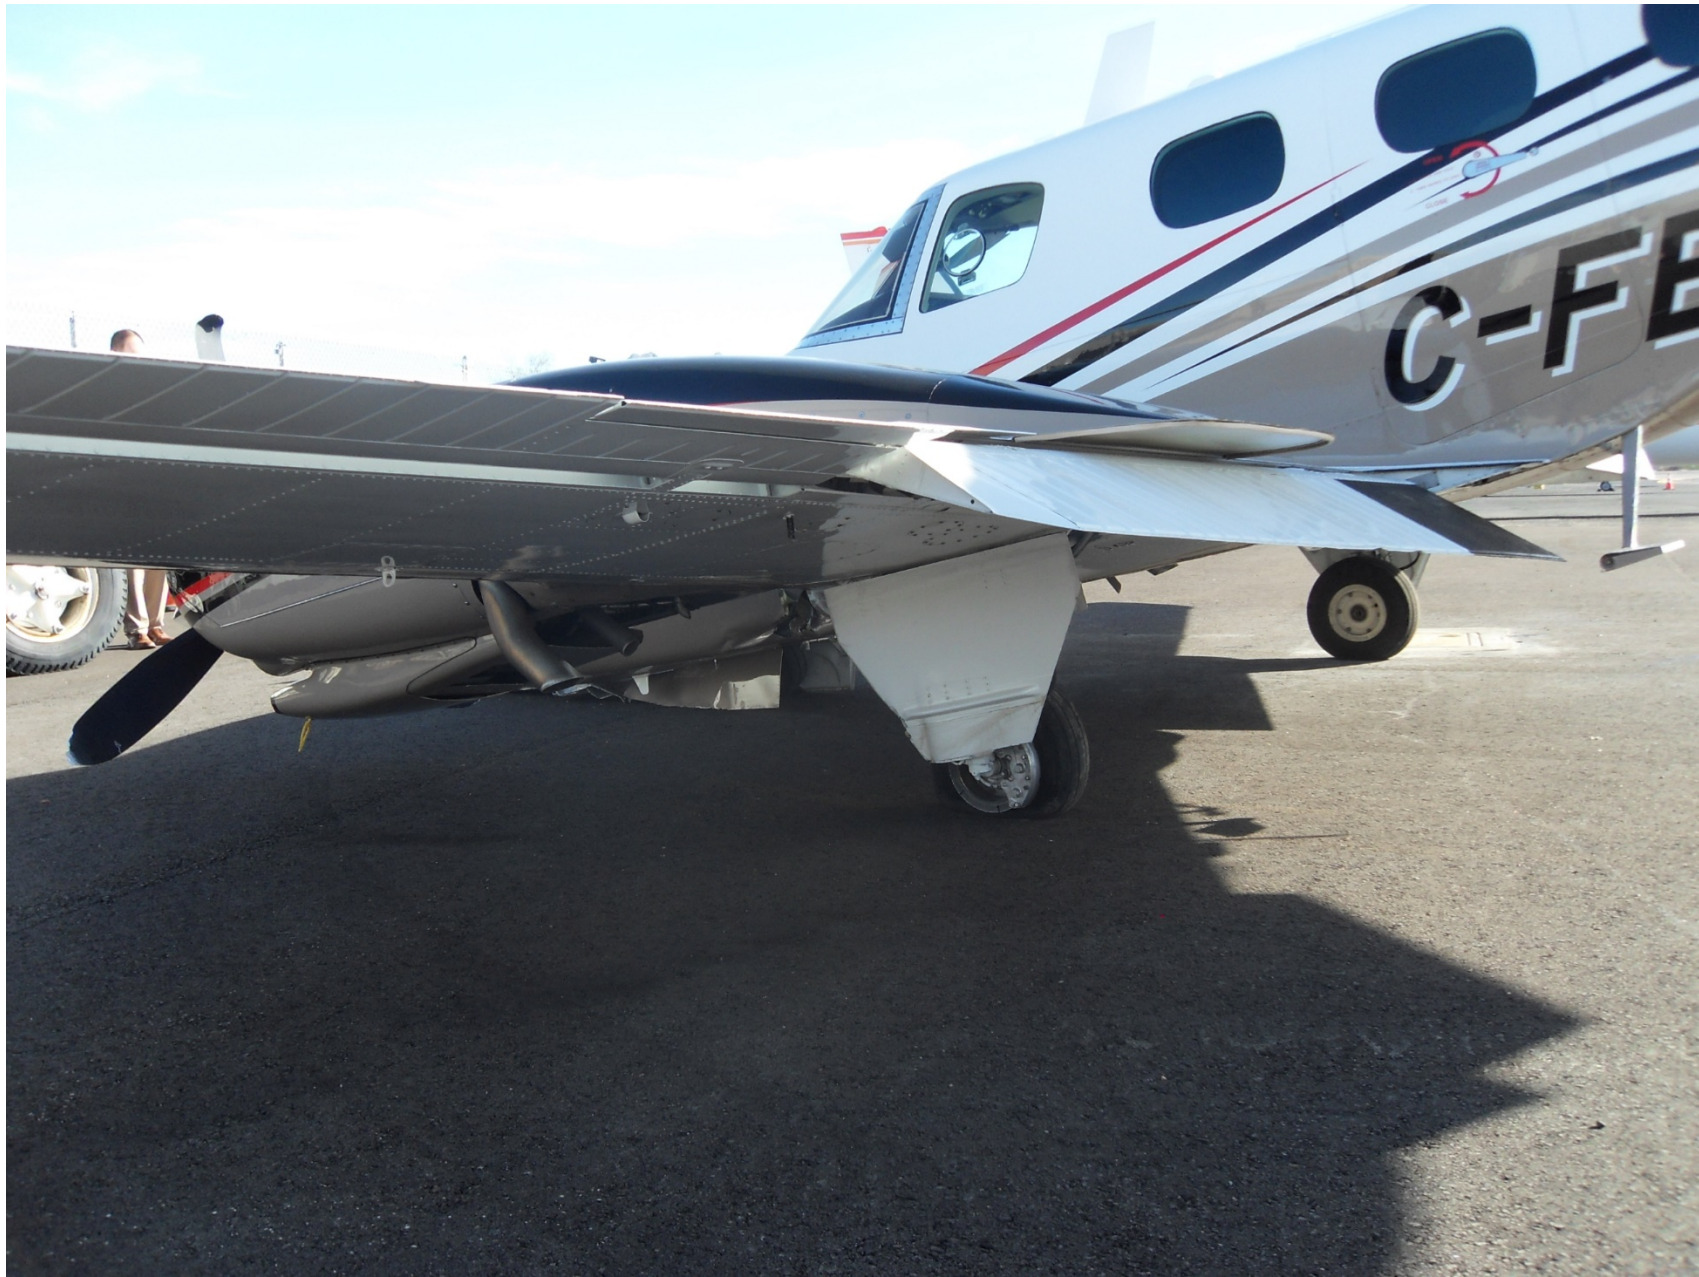
**Photo 1 – View of the damaged pressure vessel (Photo courtesy of the FAA)**

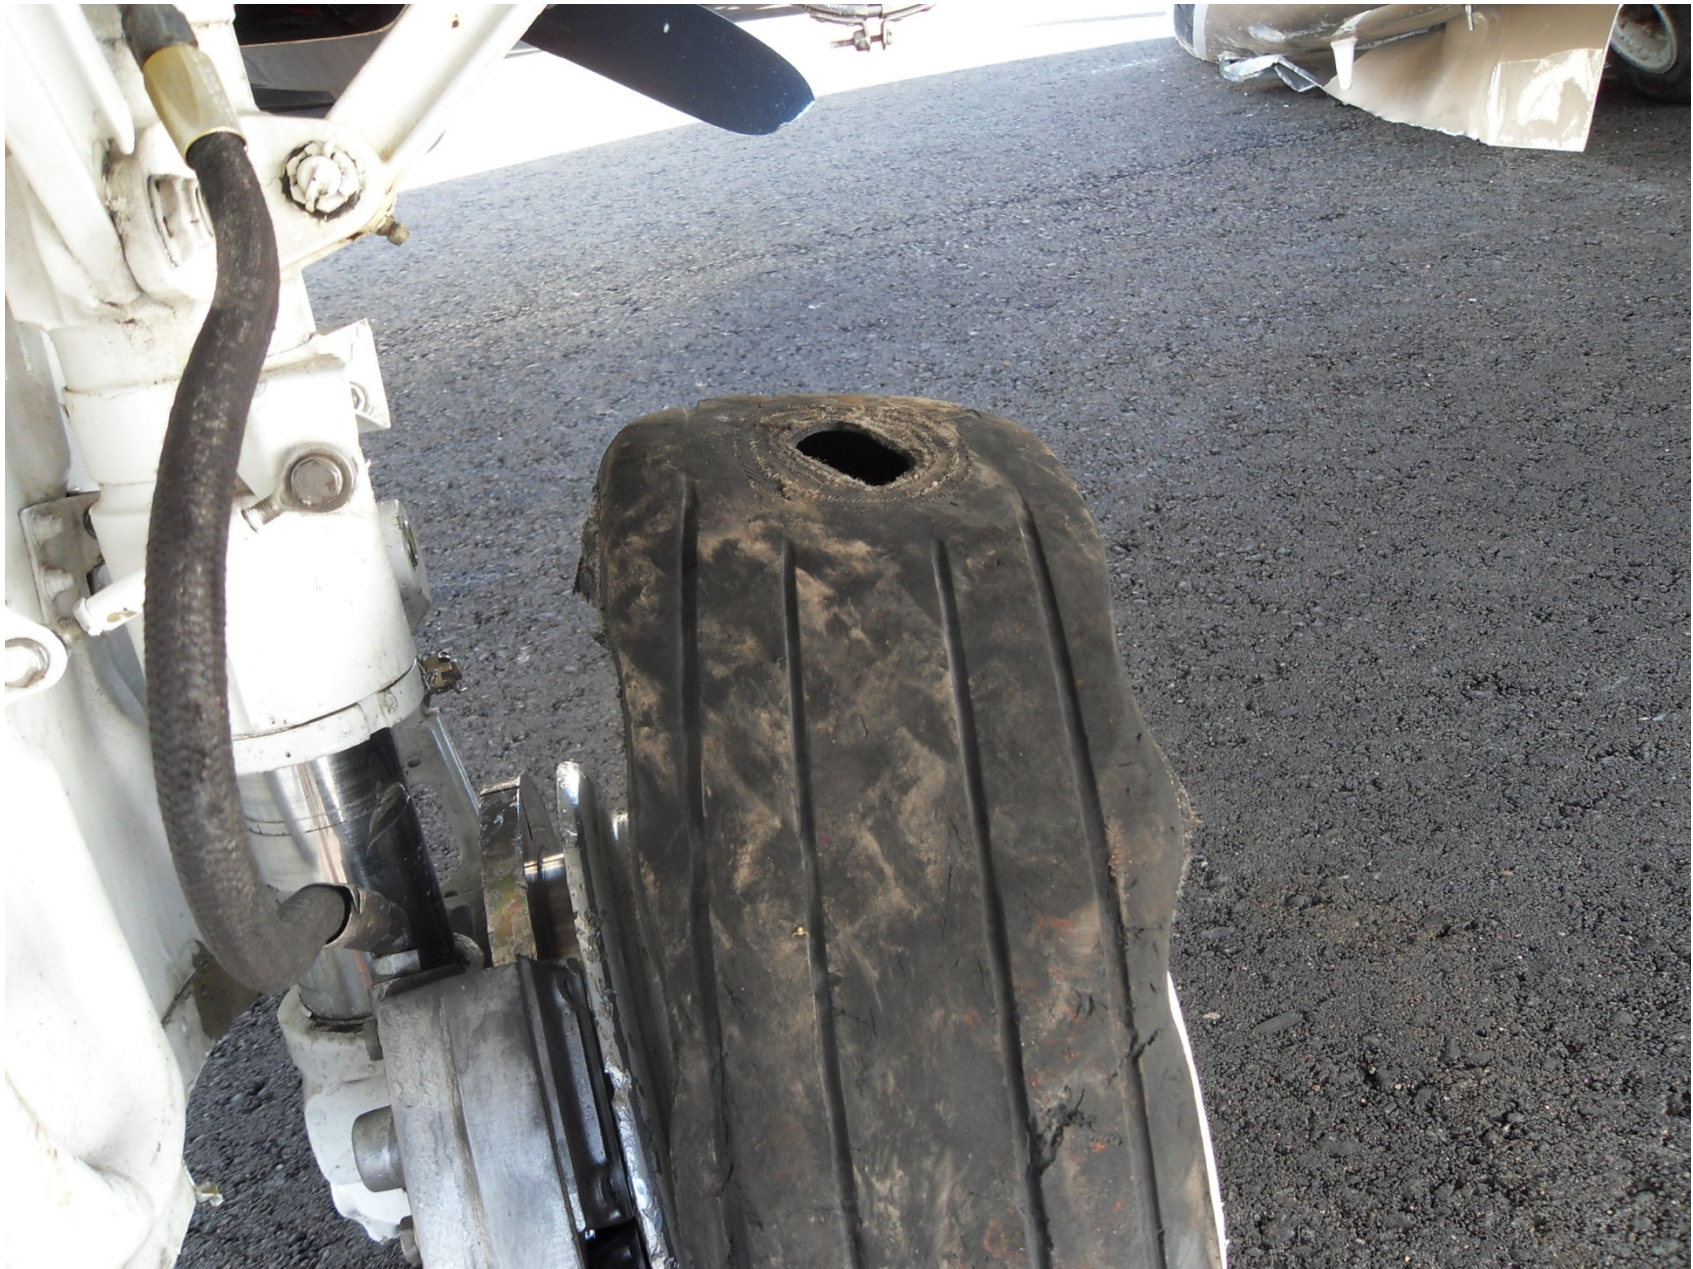
**Photo 2 – View of hole in left main landing gear tire (Photo courtesy of the FAA)**
