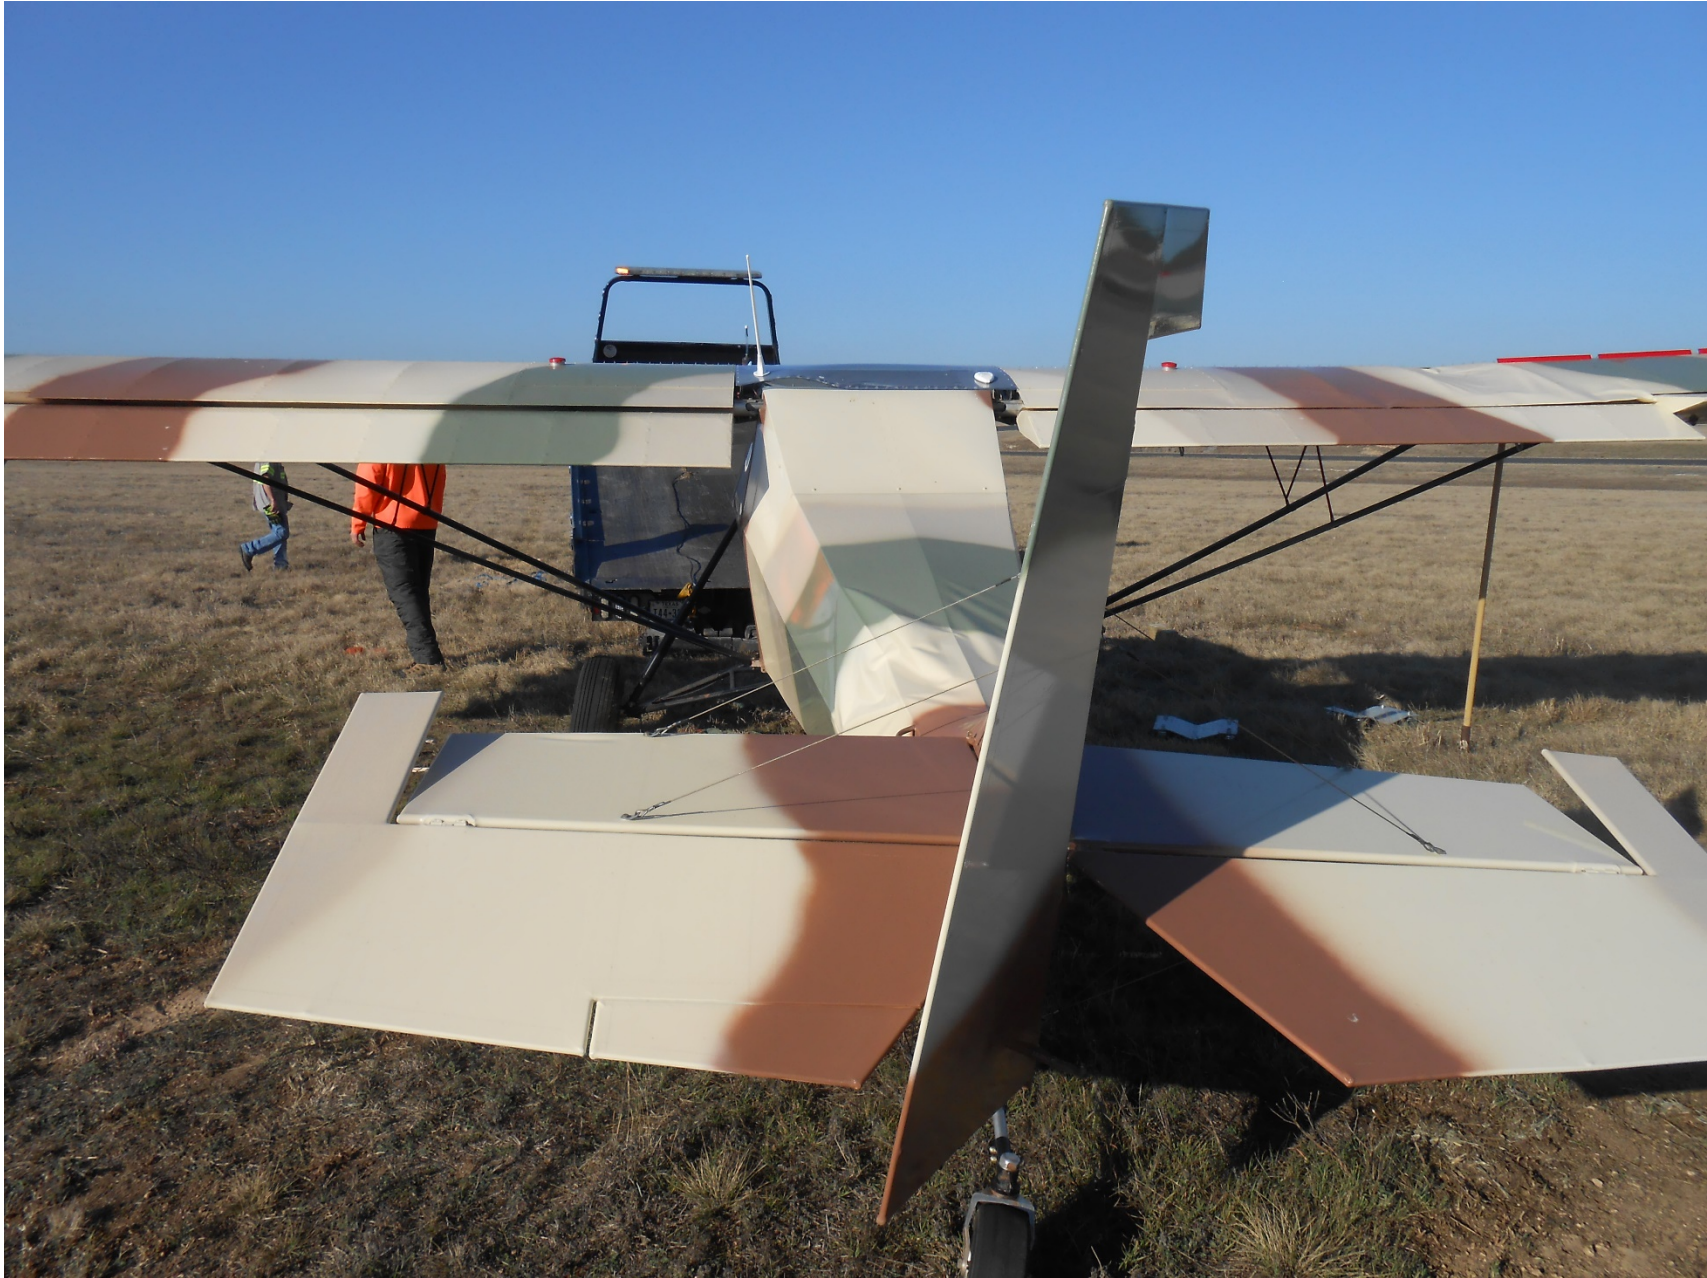
**Photo 1 – View of damaged empennage from rear of airplane (Photo courtesy of the FAA)**

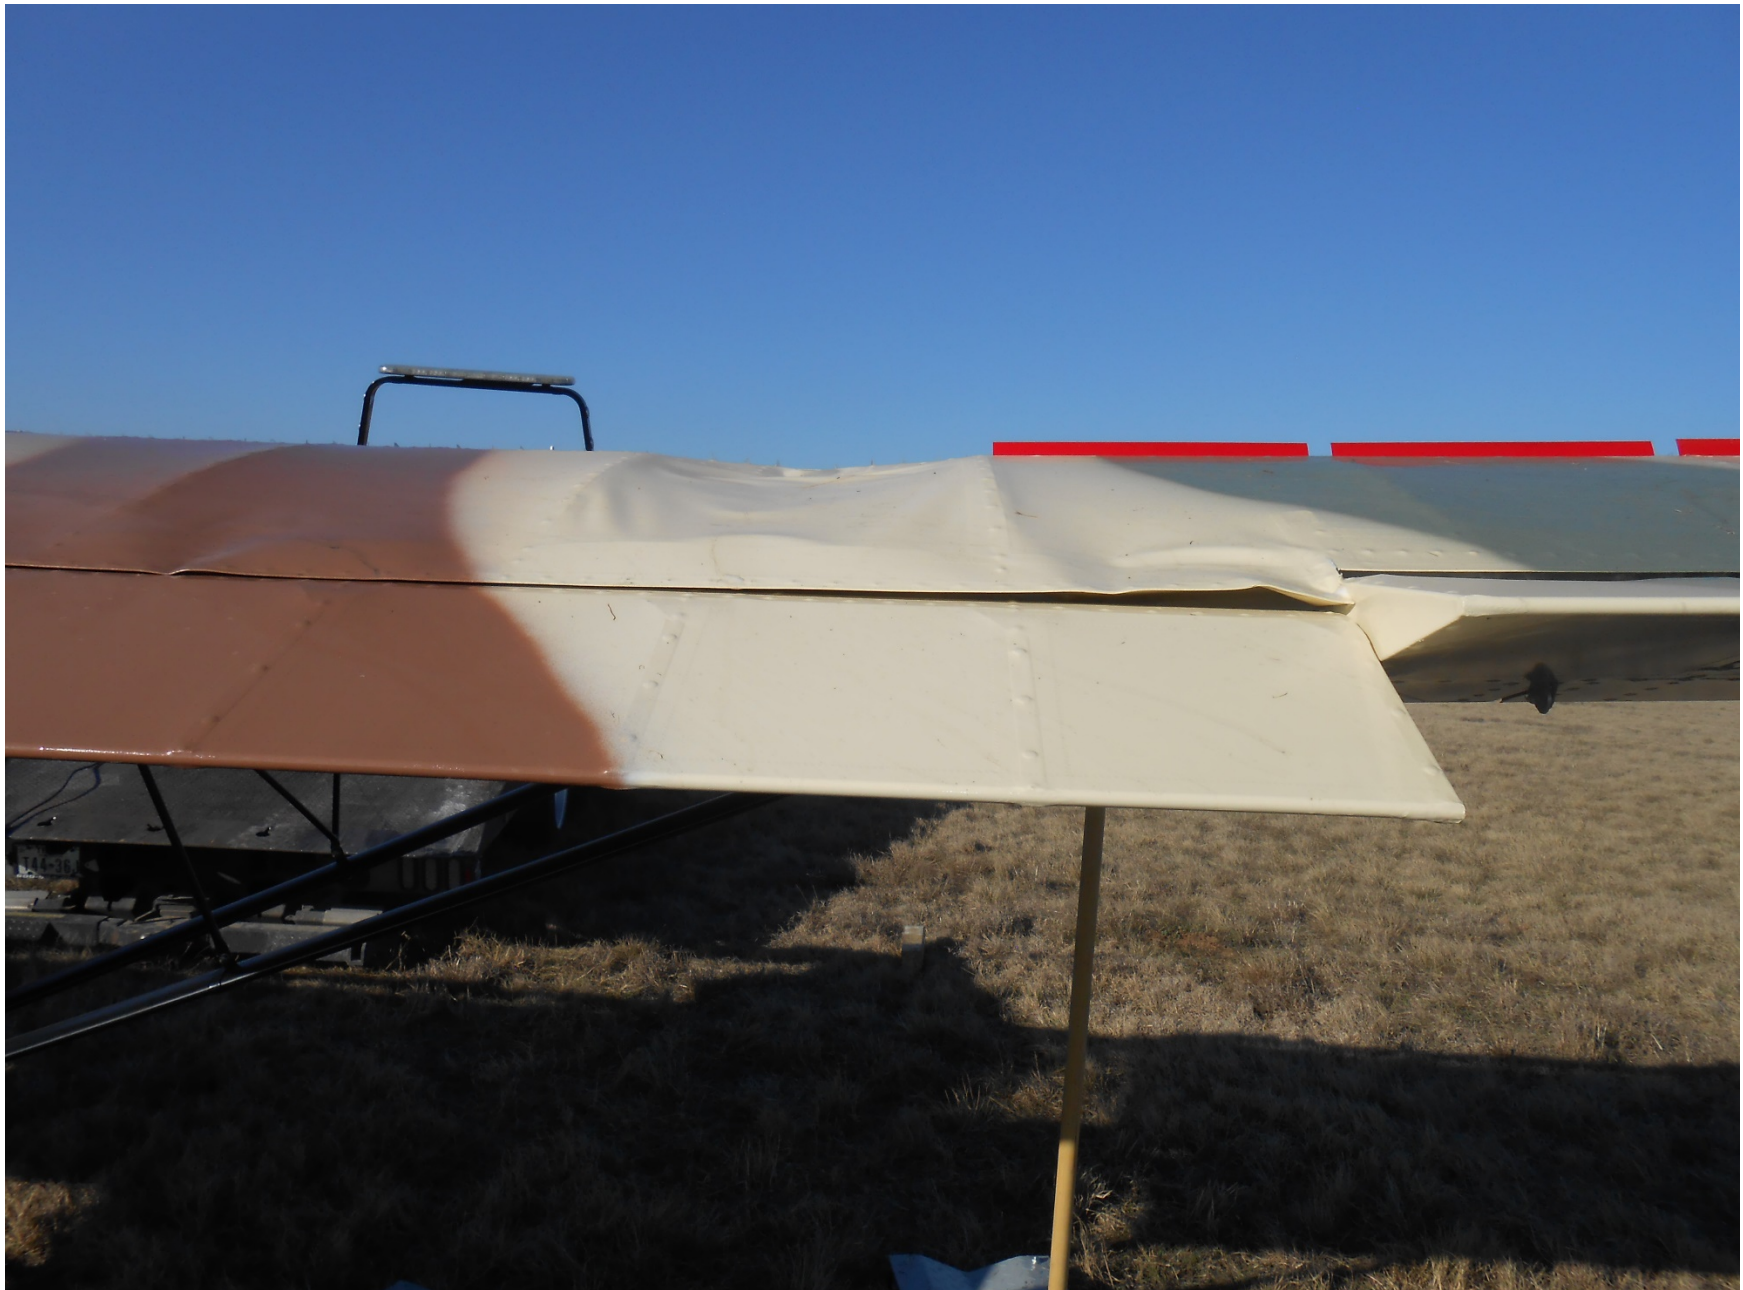
**Photo 2 – View of damaged right wing (Photo courtesy of the FAA)**
