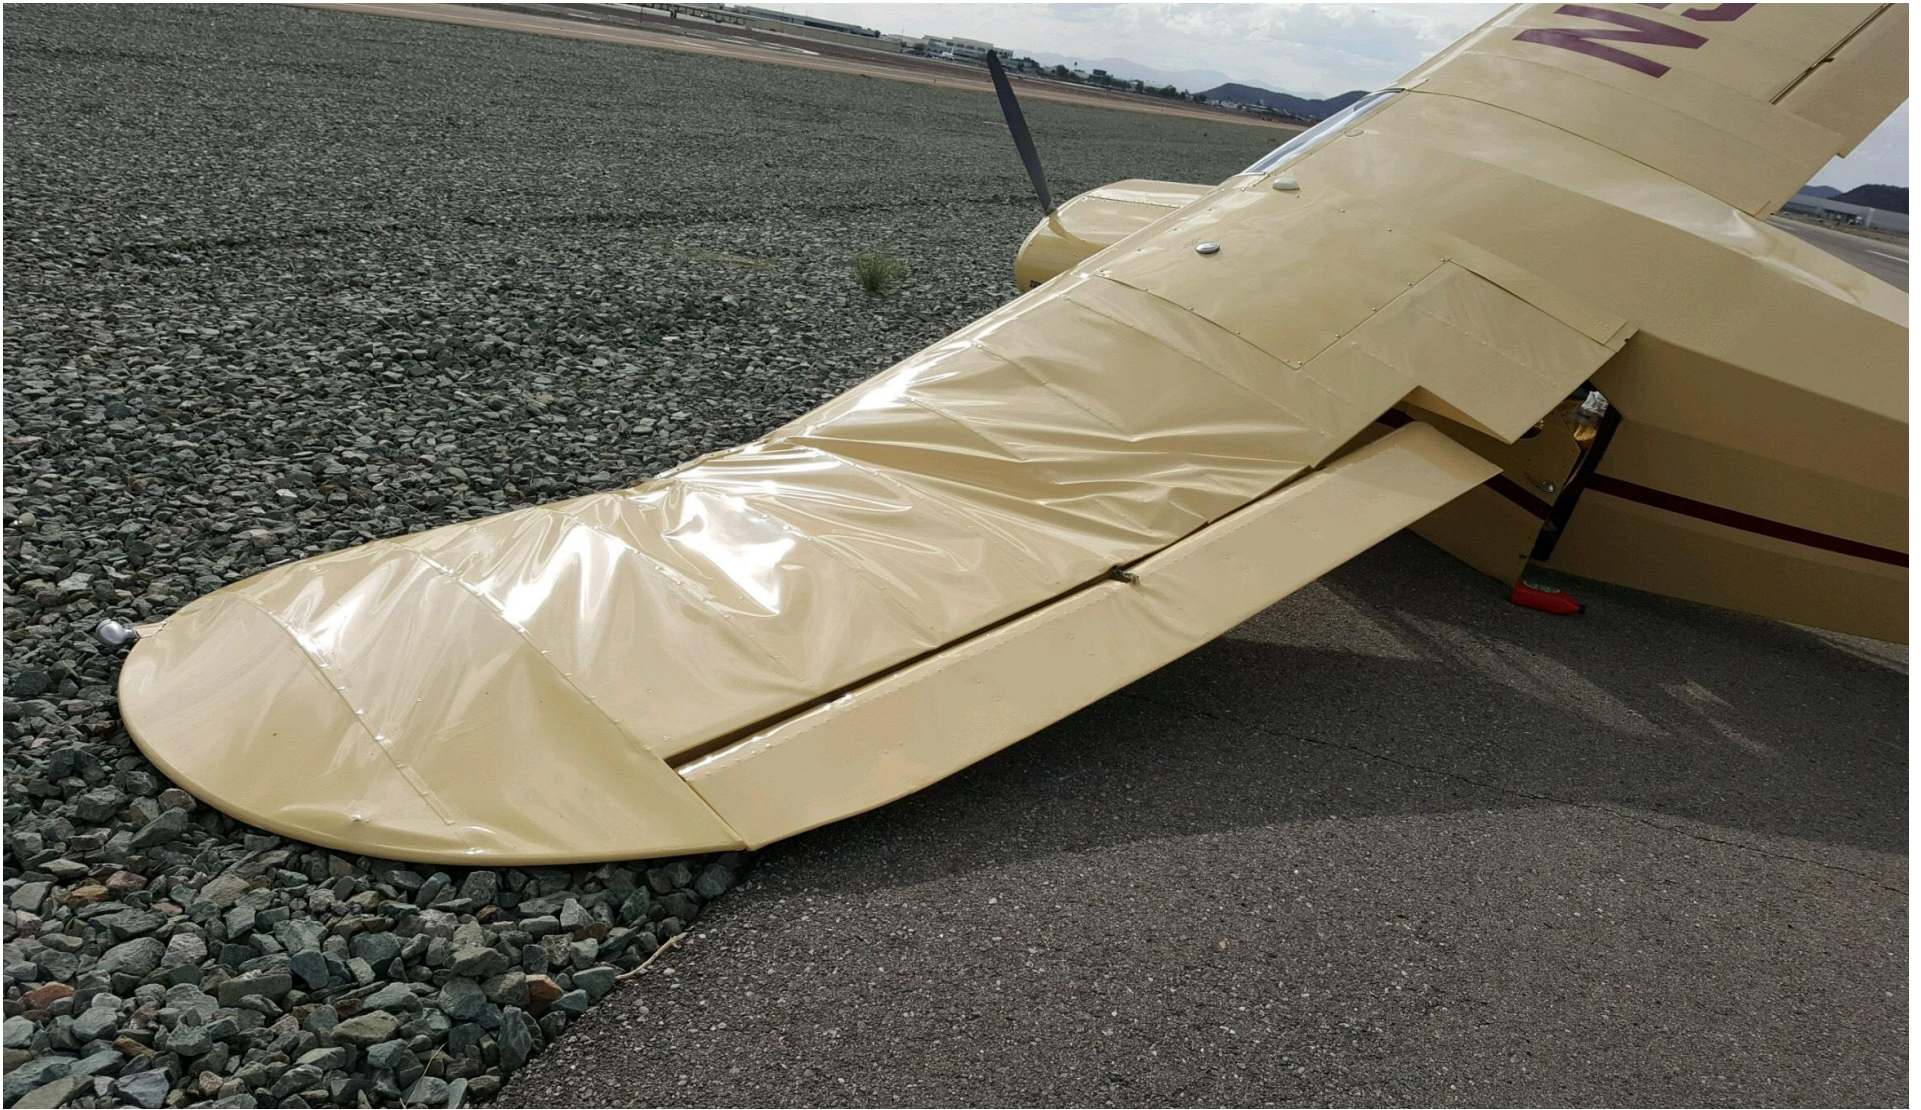
**Photo 1 – View of damaged left wing (Photo courtesy of the owner)**
