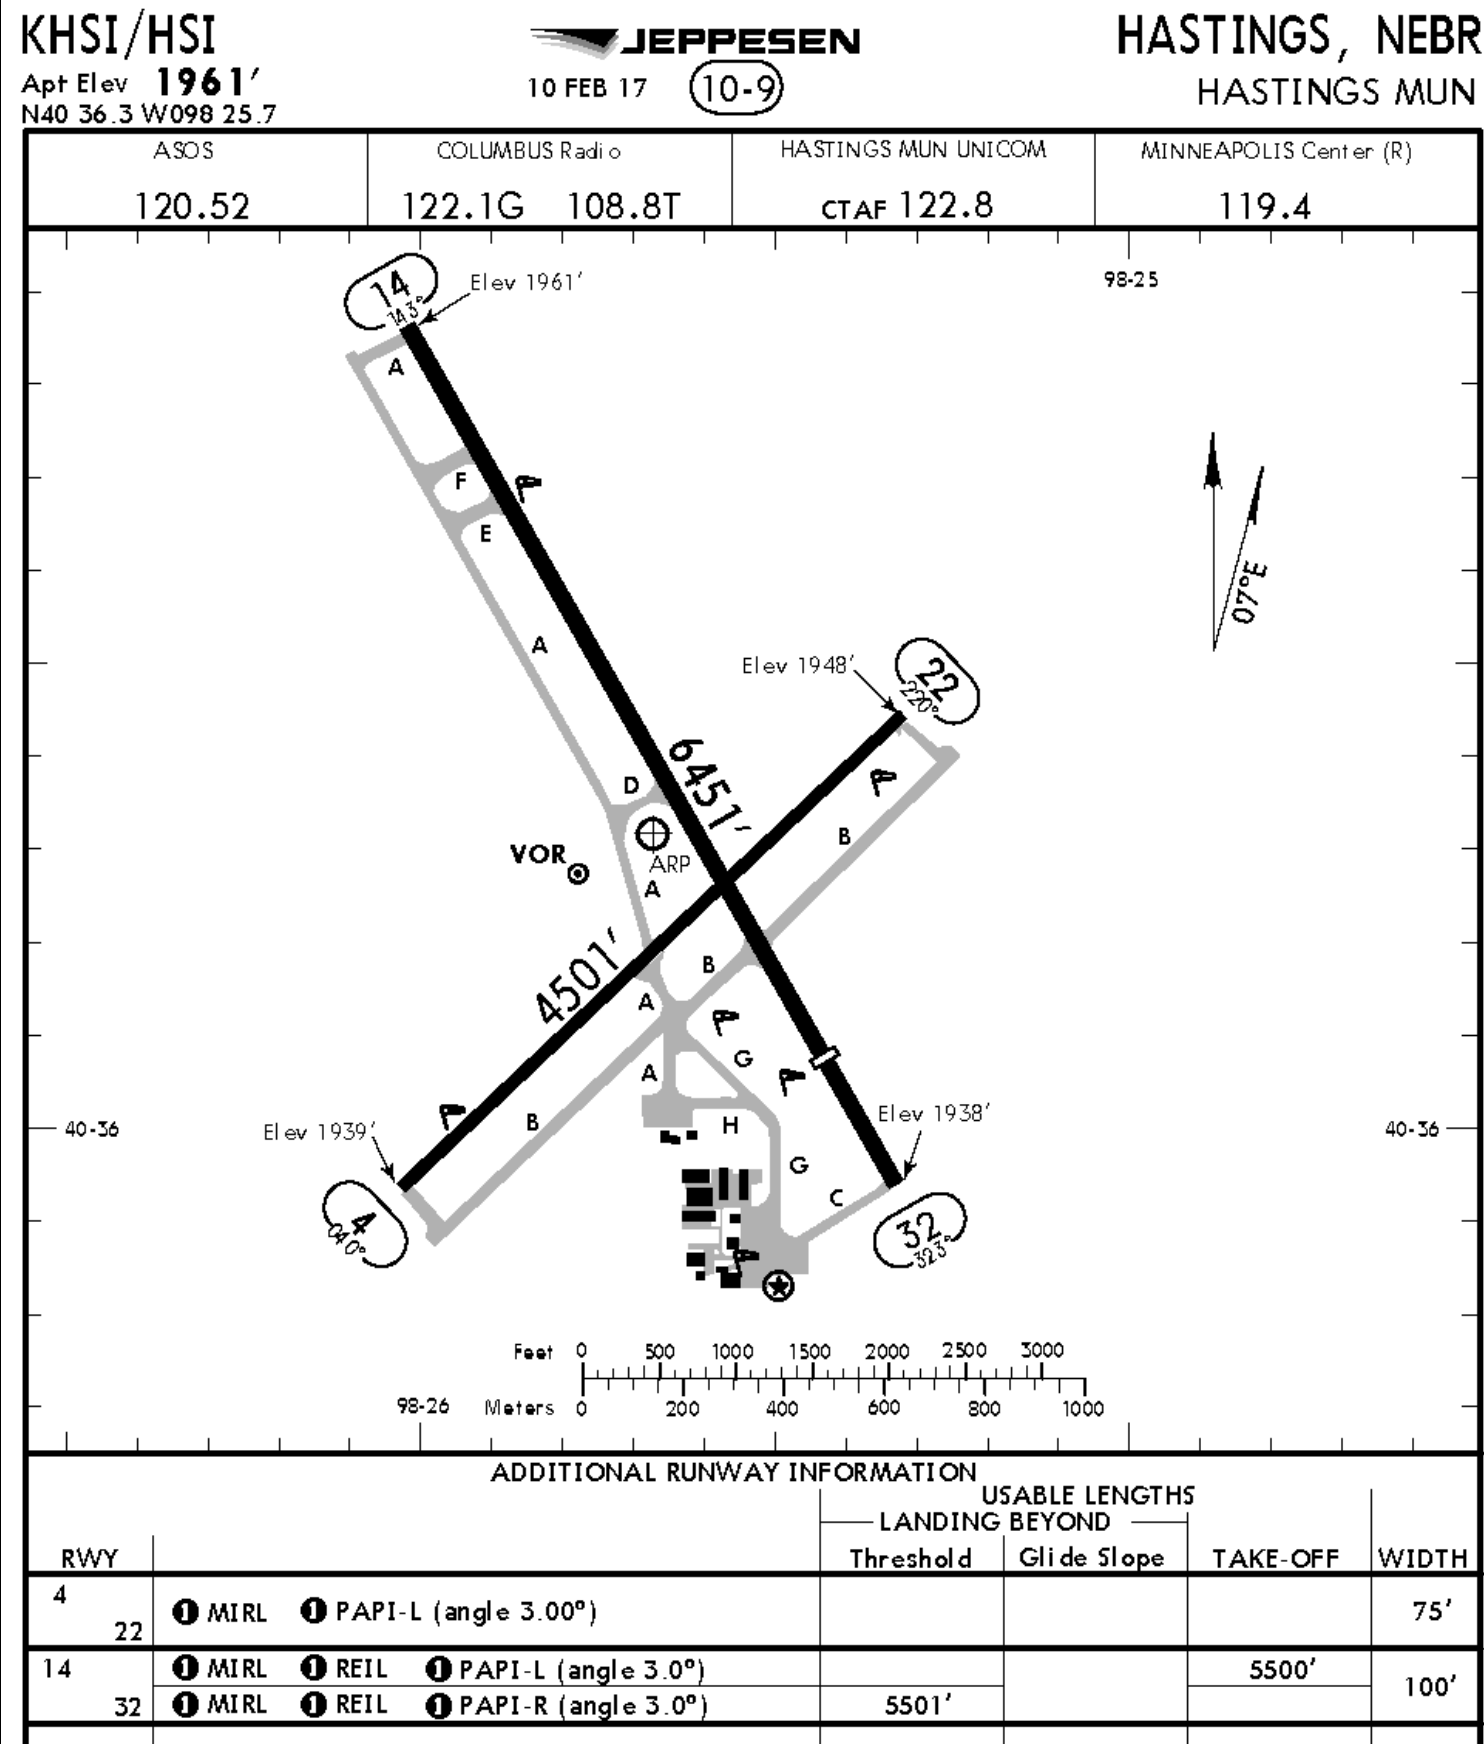
6. The aircraft continued northbound and departed the runway 14/32 pavement approximately 500 ft. northwest of the runway intersection, narrowly passing north of the third runway edge light from that intersection. After traversing an additional estimated 50 ft. of grassway, the aircraft came to rest in the grass on the east side of runway 14/32 (~40.605700N, 98.426878W). The nose gear had separated during the event and was found in the grass east of runway 14/32, south-southeast of the aircraft.

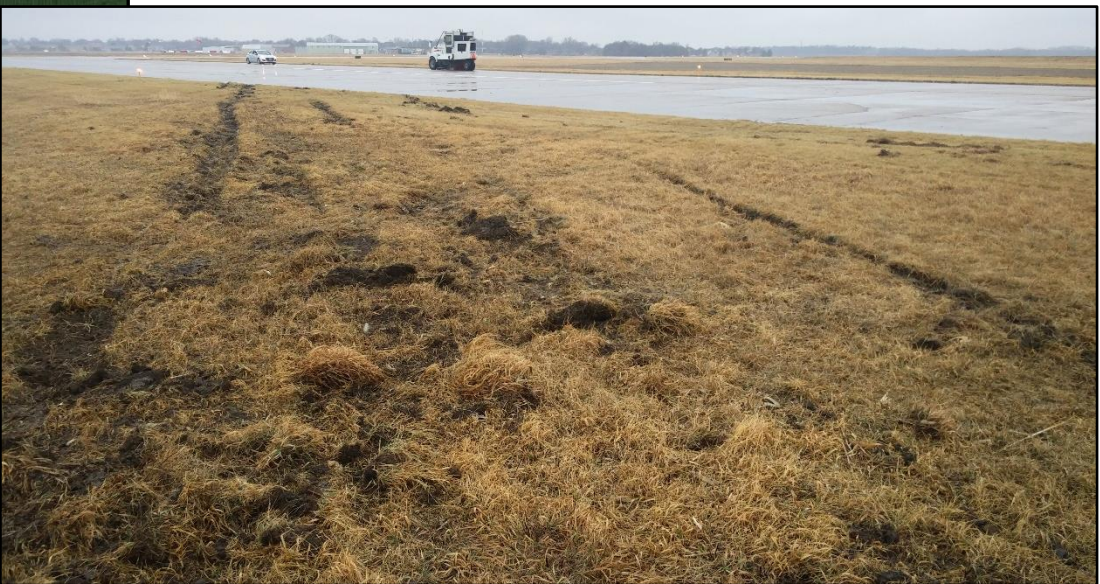
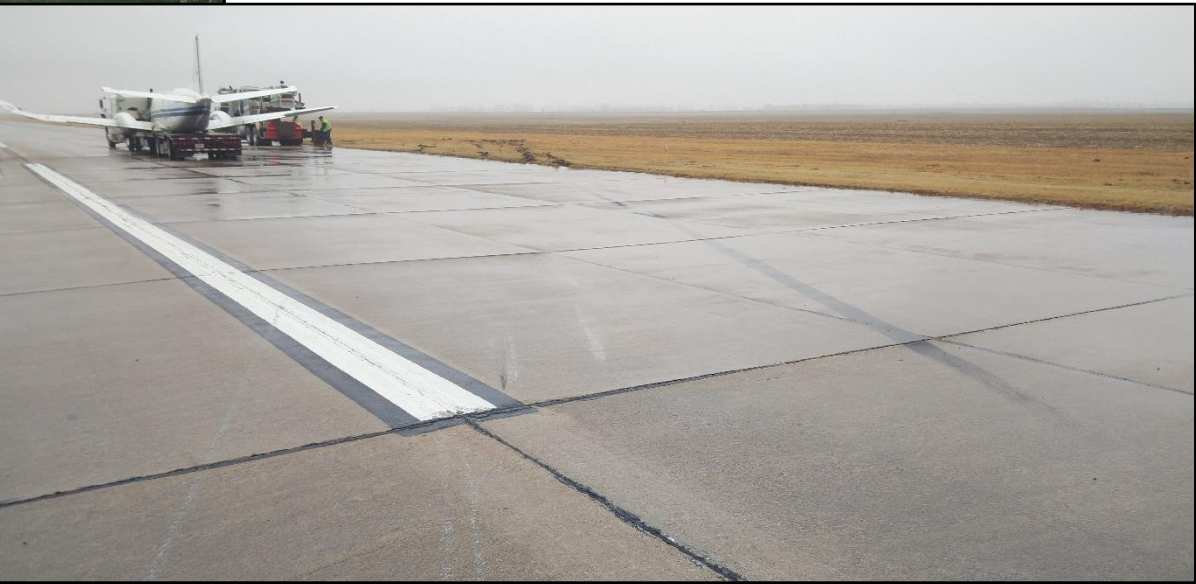
5. Now moving on a northerly magnetic track, the aircraft crossed the southern tip of the 3<sup>rd</sup> runway 14/32 centerline marking approximately 400 ft. northwest of the runway intersection (40.605342N, 98.426897W). Heavy tire skid marks became evident at this point.

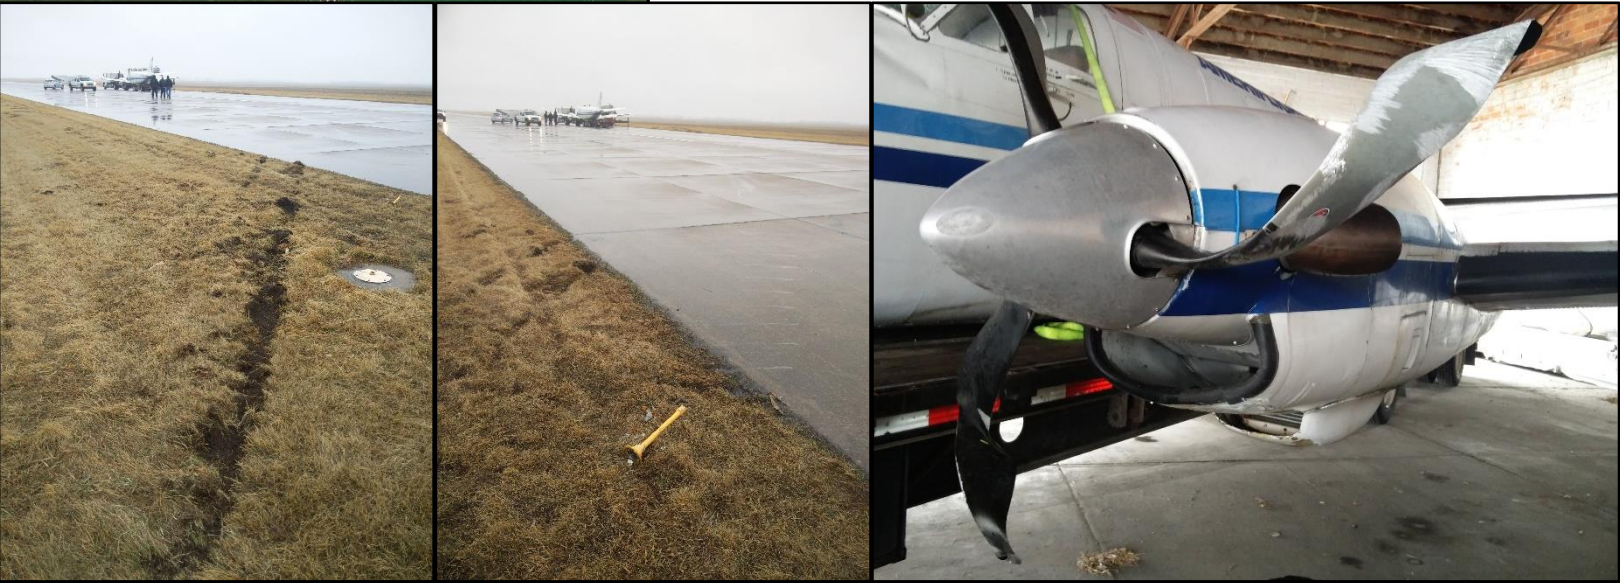
4. The aircraft destroyed the second runway light approximately 300 ft. northwest of the intersection of the crossing runways (40.605019N, 98.426905W) as it entered the west side of runway 14/32. Propeller scrapes became evident as the aircraft encountered the runway 14/32 pavement. S-bending on both propellers indicates that the engines were producing power through some or all of the accident sequence.

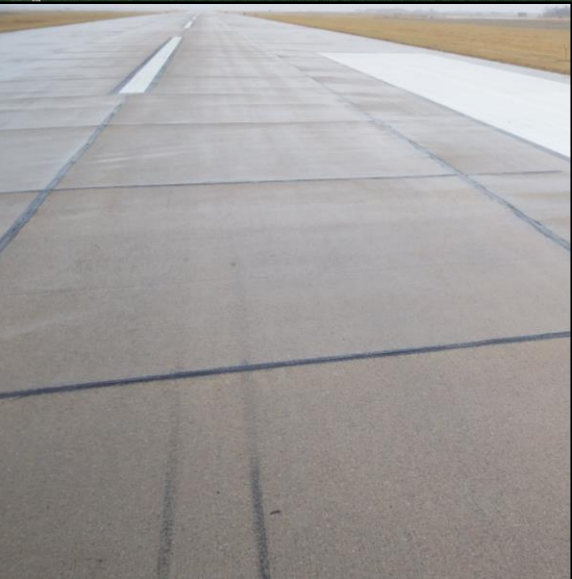
1. Skid marks roughly corresponding to the wheel spacing of a BE-99 were found between the aiming point markers, approximately 1000 ft. from the approach end of runway 4, suggesting a possible (though not confirmed) first point of touchdown. (~40.600901N, 98.431032W)

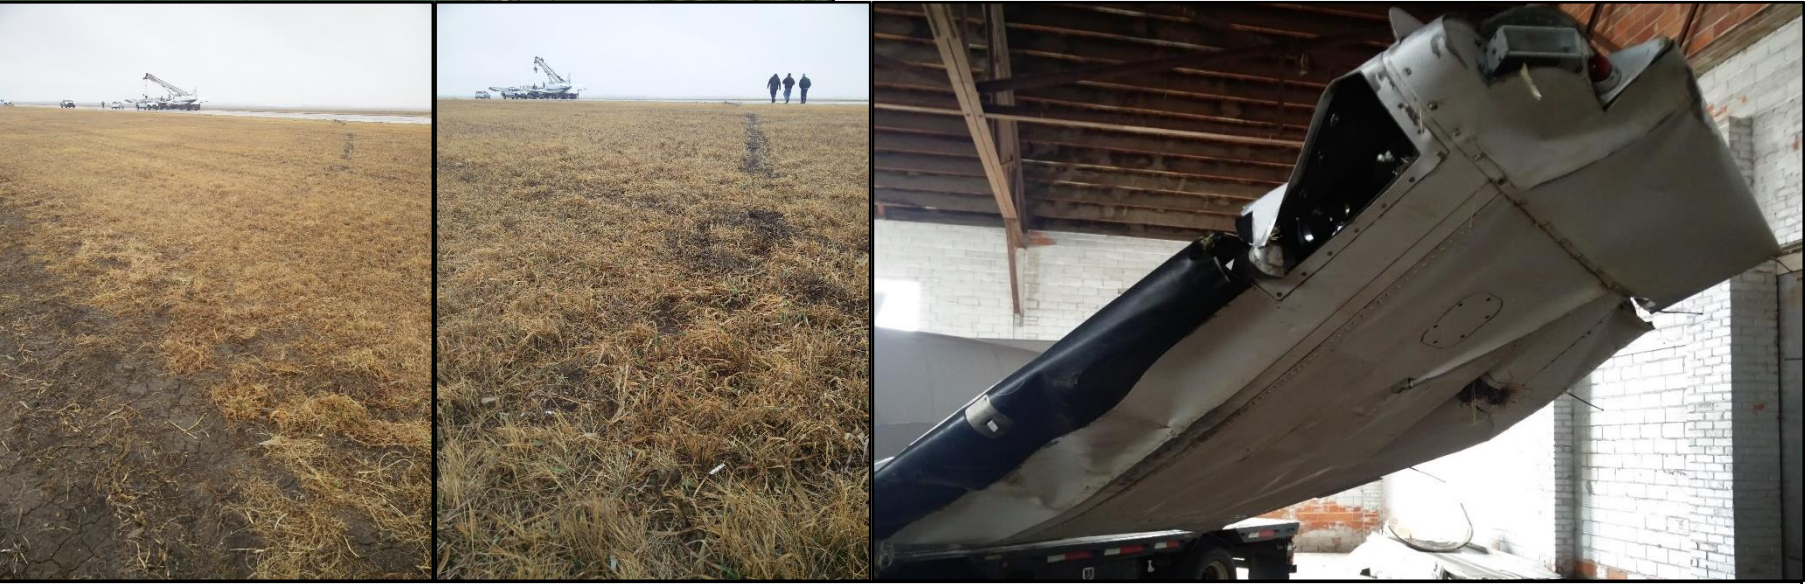
3. The next evidence of ground contact was in the grassway west of runway 14/32 (~ 40.604730N, 98.426958W). Mud and grass on the damaged left wing tip, combined with paint chips and plastic lens fragments found in this area suggest the left wing contacted first. The aircraft appears to have been airborne as it traversed most of the infield area, clearing relatively soft mud and a drainage culvert.

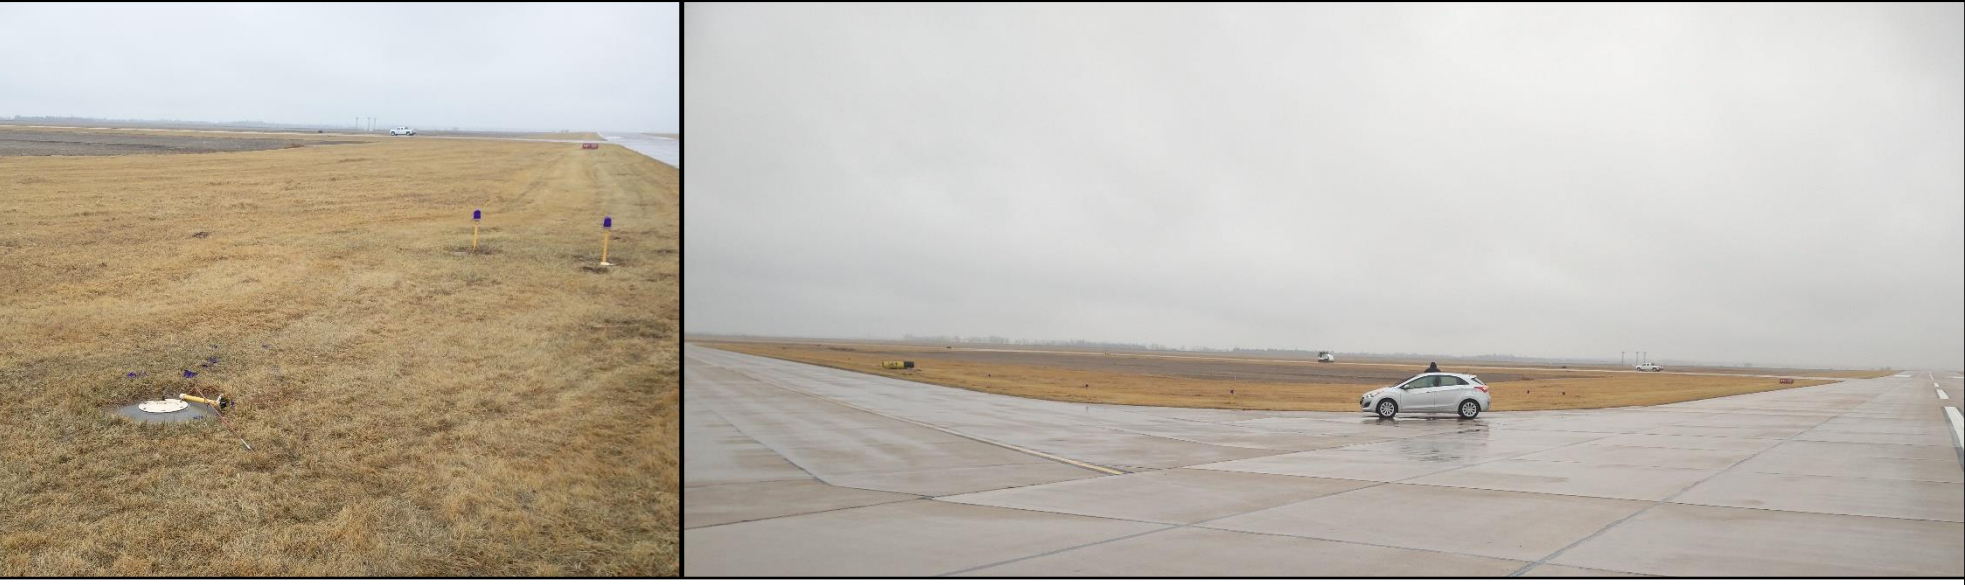
2. A destroyed taxi light immediately north-northeast of the intersection of Runway 4/22 and Taxiway A was the first evidence of runway excursion (40.603473N, 98.426878W). The aircraft would have been moving on a magnetic track of approximately 030 degrees.
