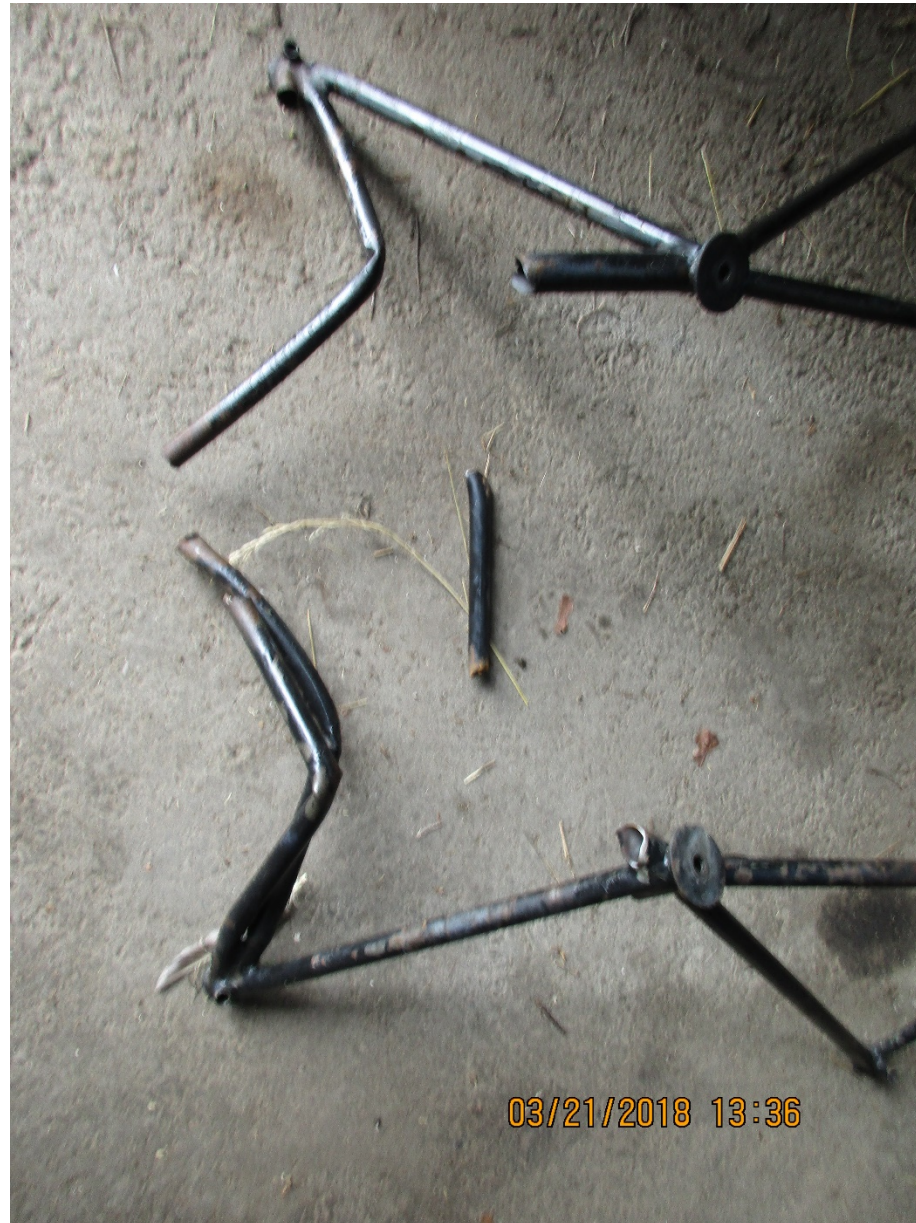
**Photo 1 – View of damaged engine mounts (Photo courtesy of the FAA)**
