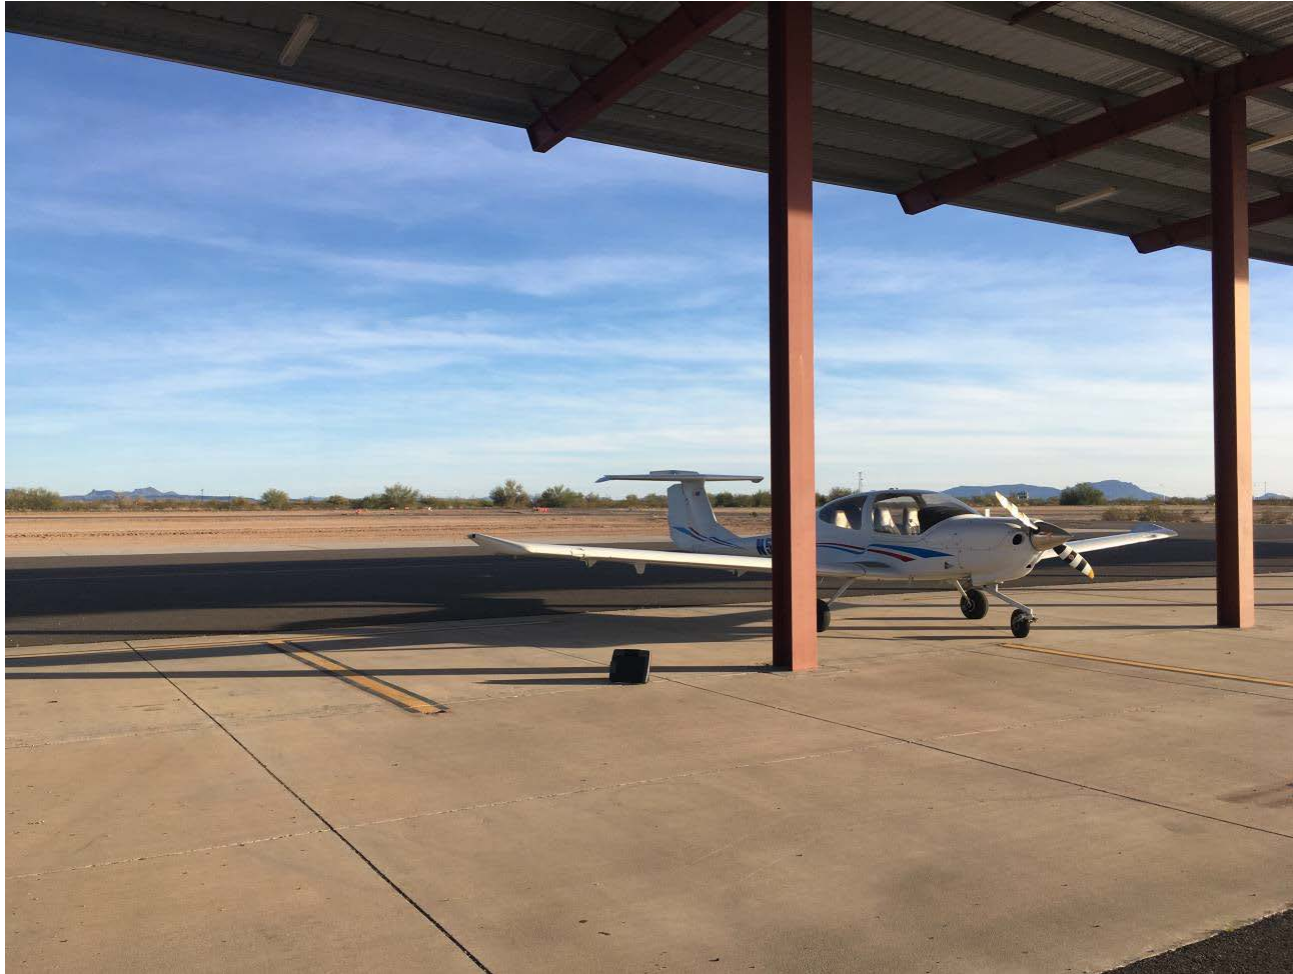
**Photo 1 – View of airplane after impacting pole (Photo courtesy of the flight school)**

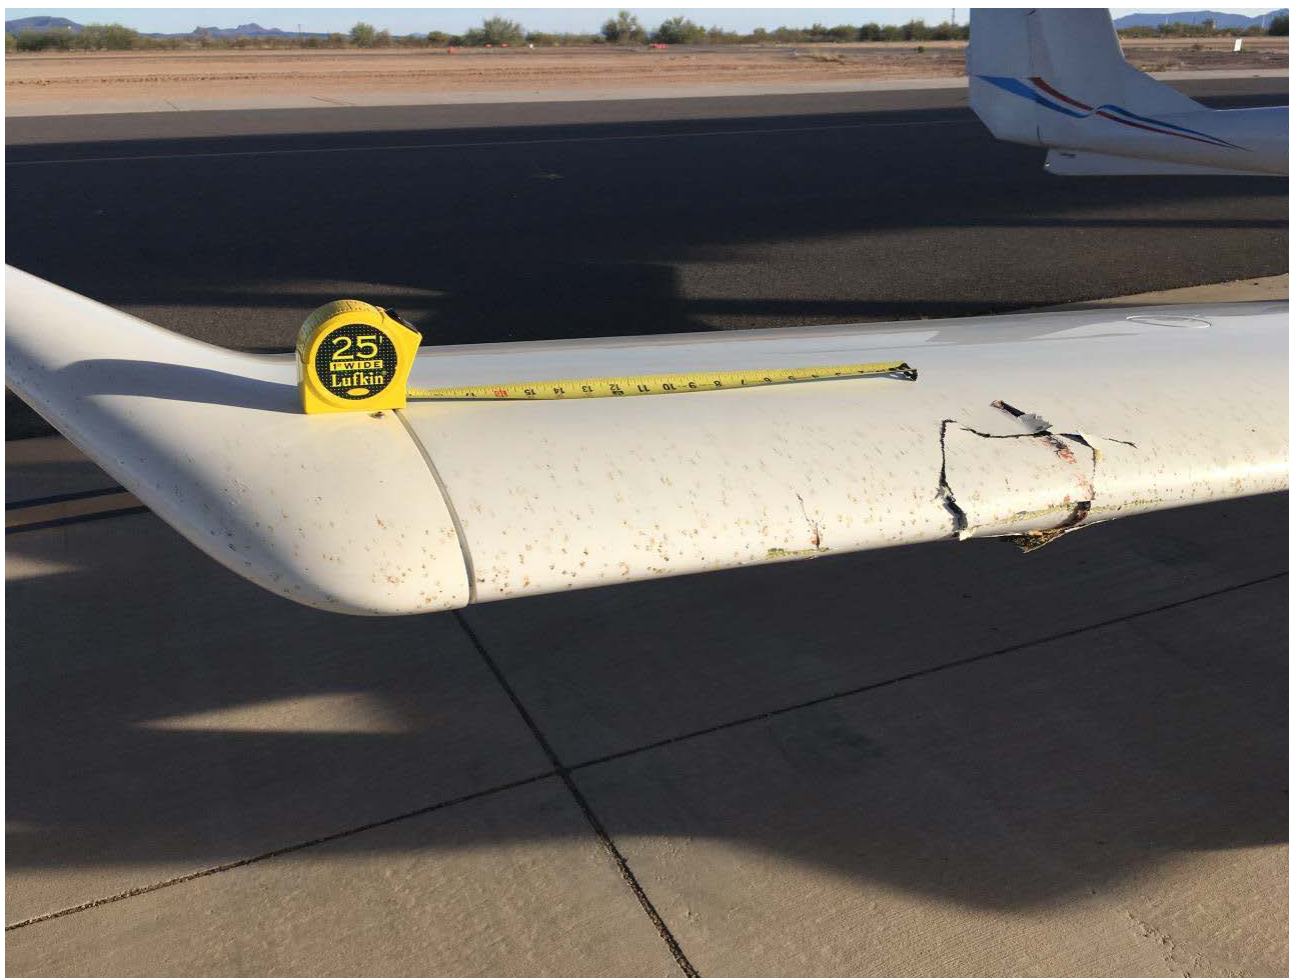
**Photo 2 – View of damaged right wing (Photo courtesy of the flight school)**
