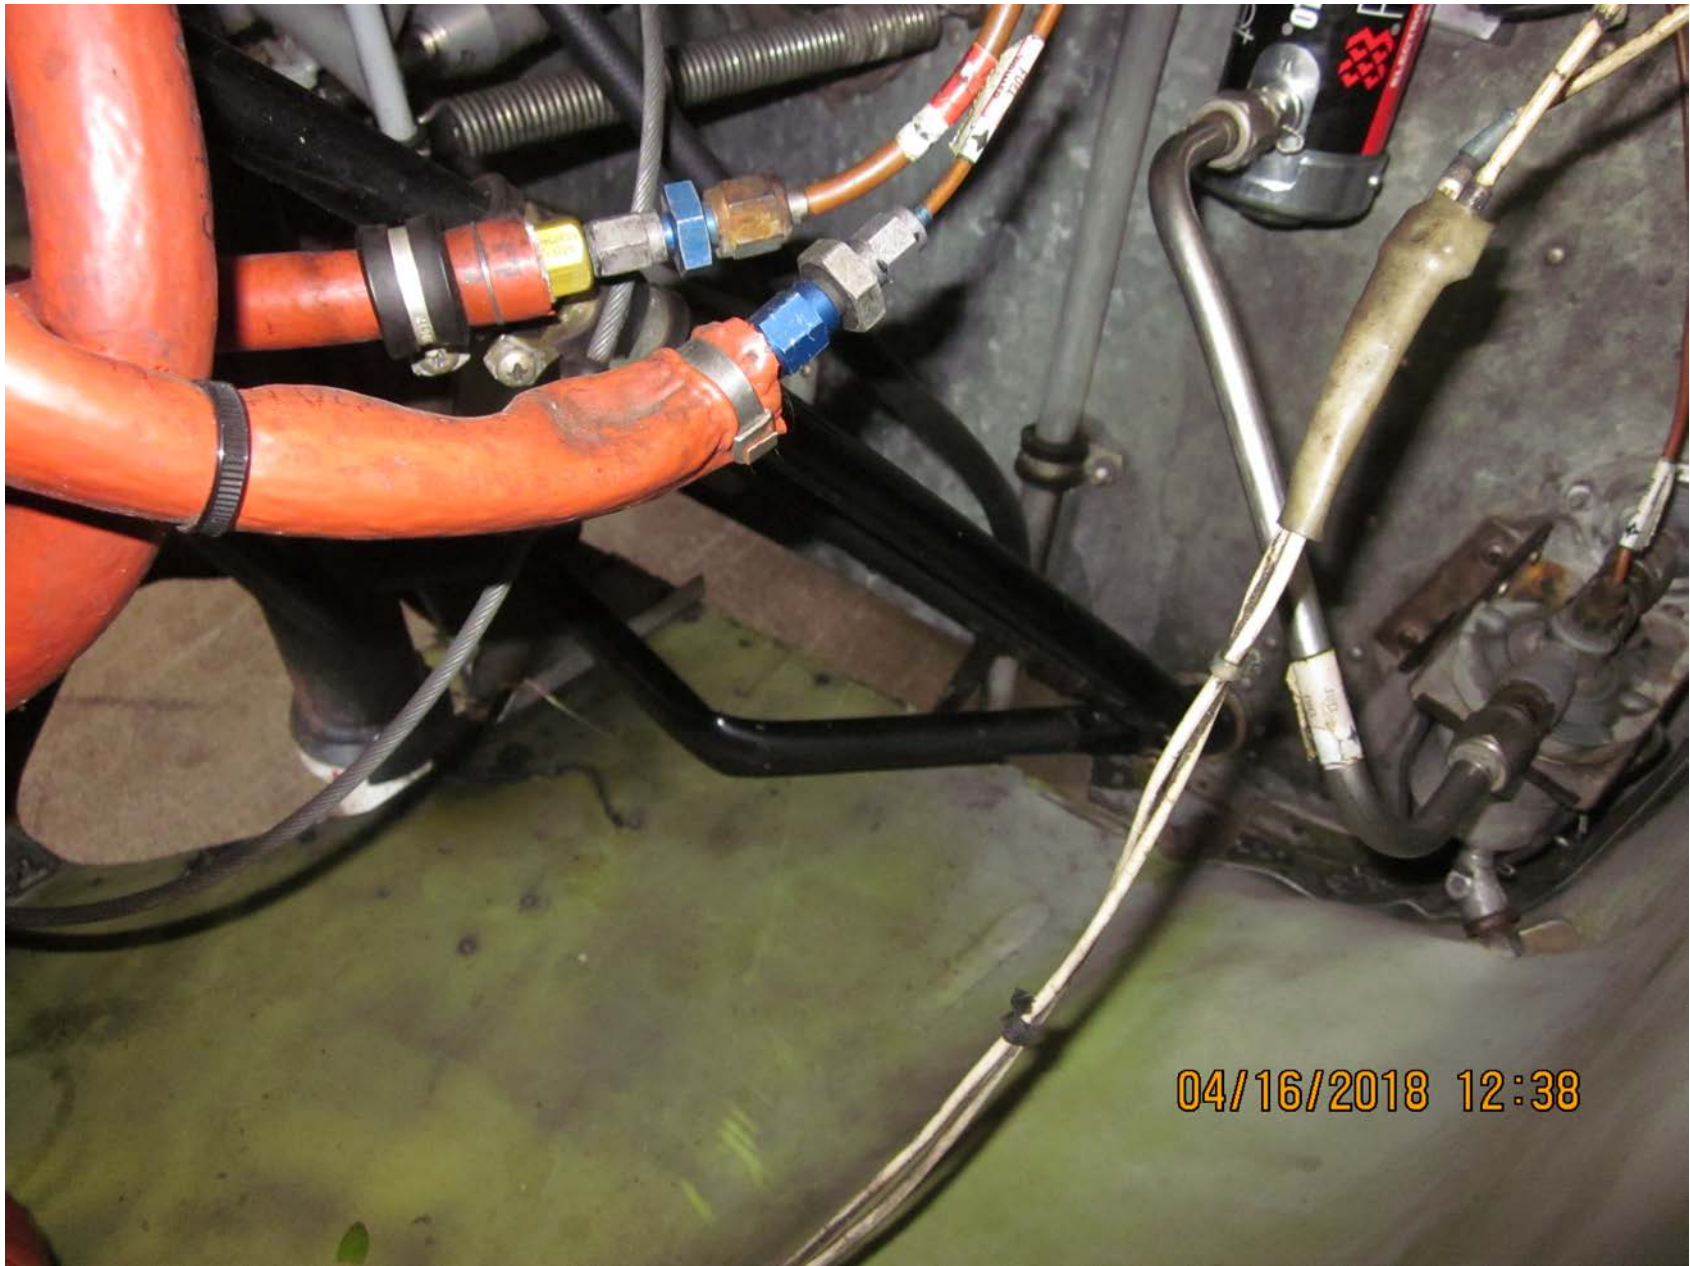
**Photo 1 – View of damage to engine mount (Courtesy of FAA)**
