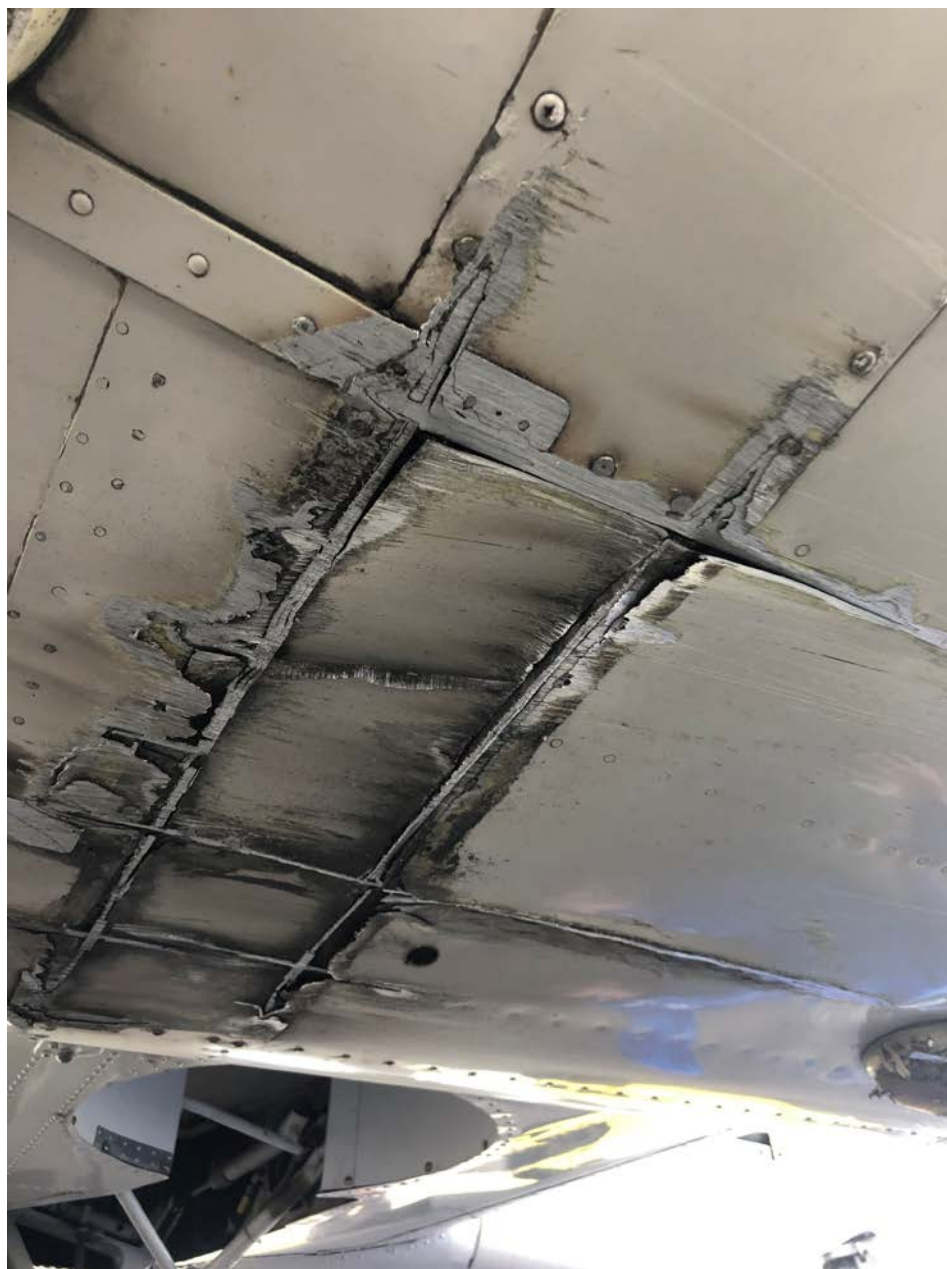
**Photo 1 – View of damage to the longerons and spar carry through (Courtesy of FAA)**
