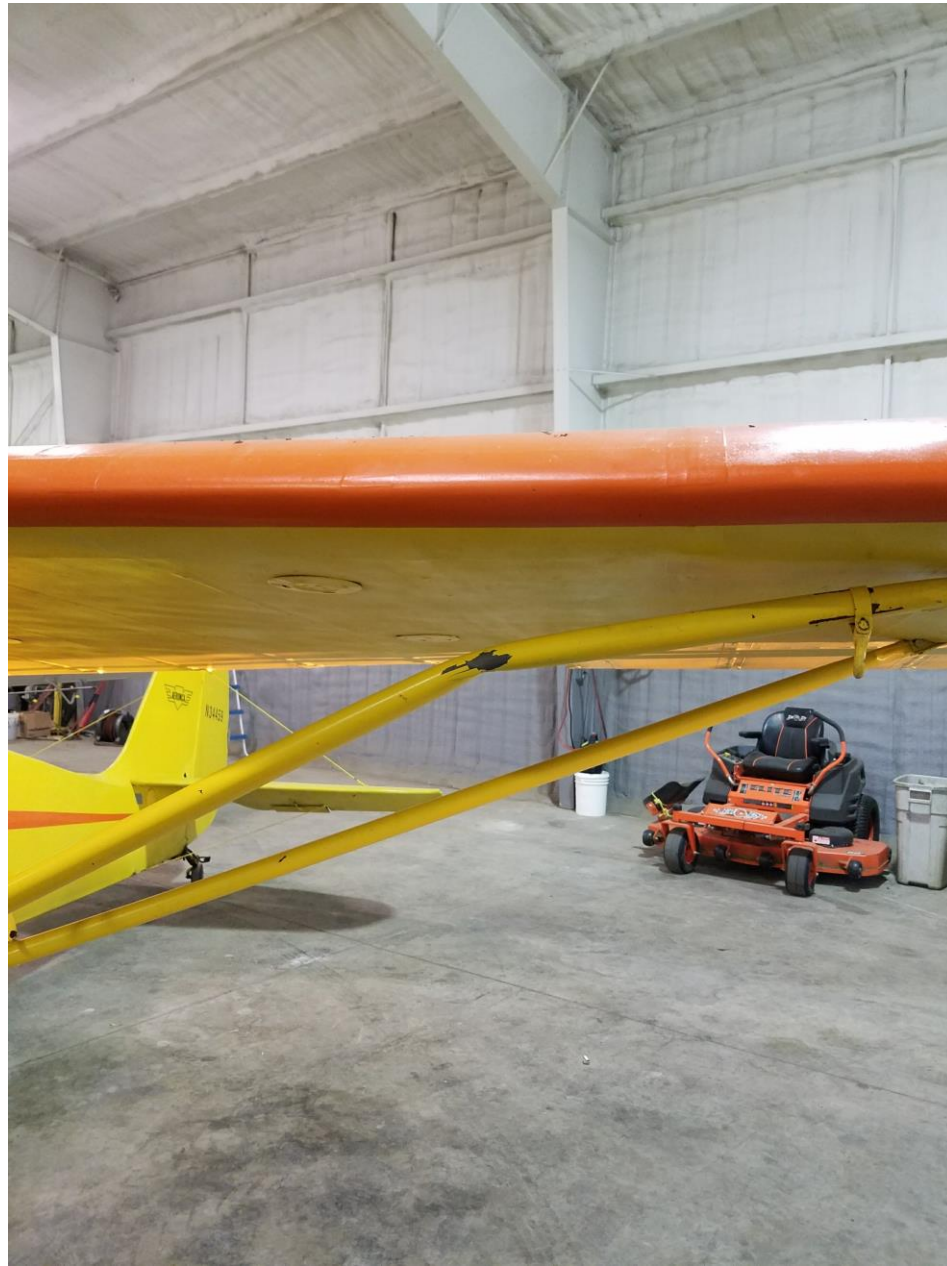
**Photo 1 – View of damaged left wing lift strut (Photo courtesy of the owner)**
