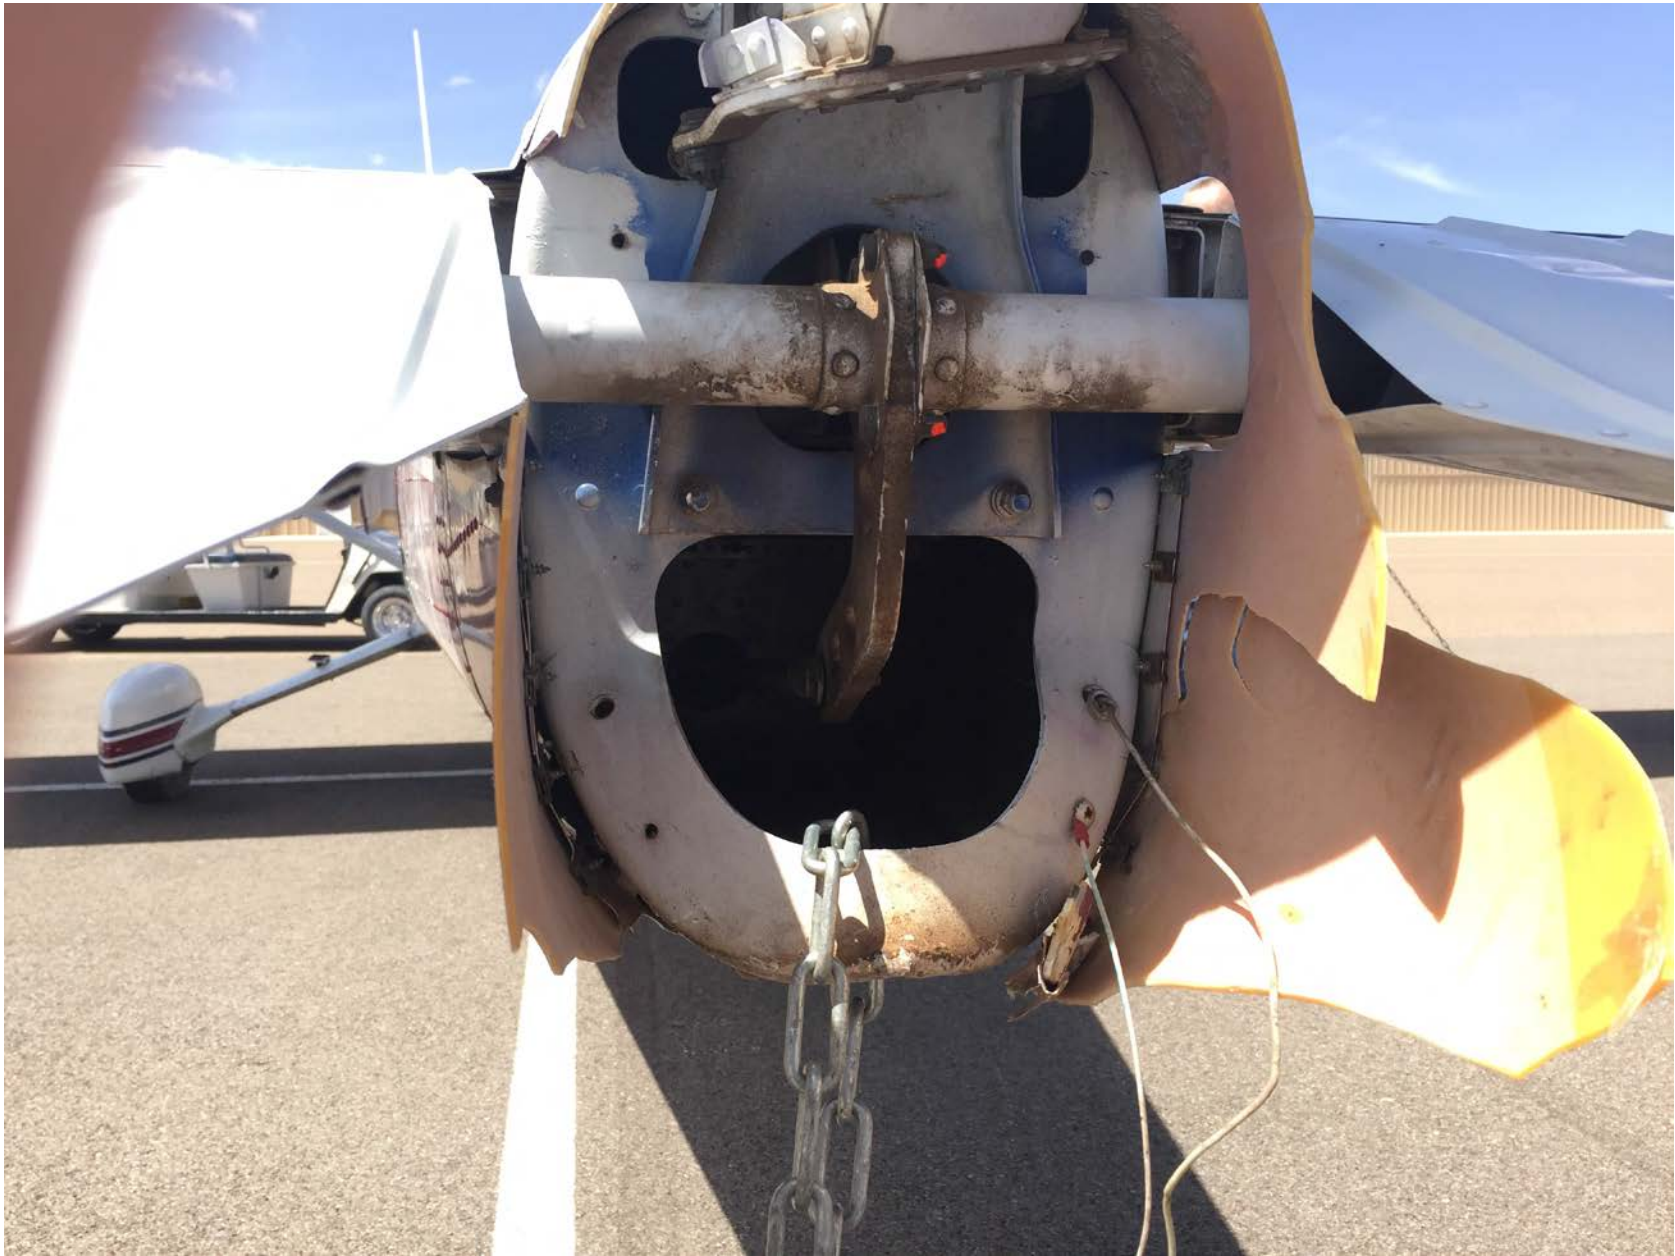
**Photo 1 – View of damaged empennage (Photo courtesy unknown)**
