N82XC, CC19-180, S/N CC19-0018,  
Ground Loop accident, FFZ, 05/10/2018

Tom Vernon, Jr. – FAA IIC

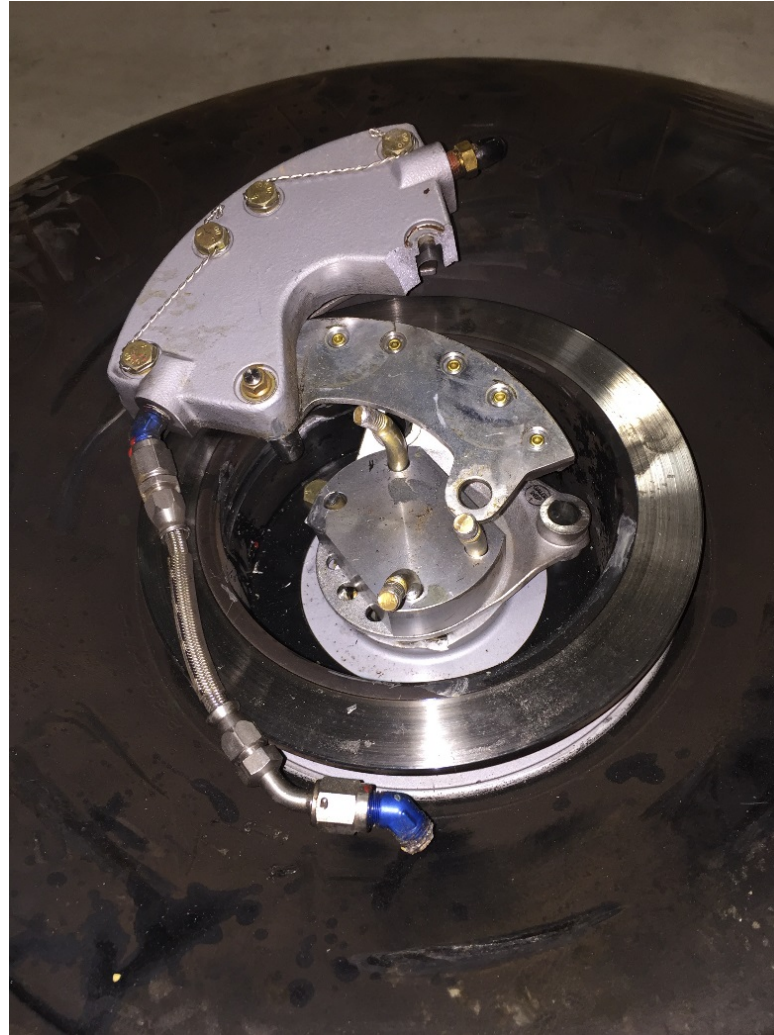
Pilot reports perfect weather, perfect flight, perfect landing. After landing, while rolling down centerline, aircraft abruptly turns left, resulting in ground loop. Damage to right wing, right elevator, right main landing gear. Right wheel assy departed aircraft. It was clear that the right main wheel assy folded under the end of the gear leg and then separated.

Inner side of right main wheel assy

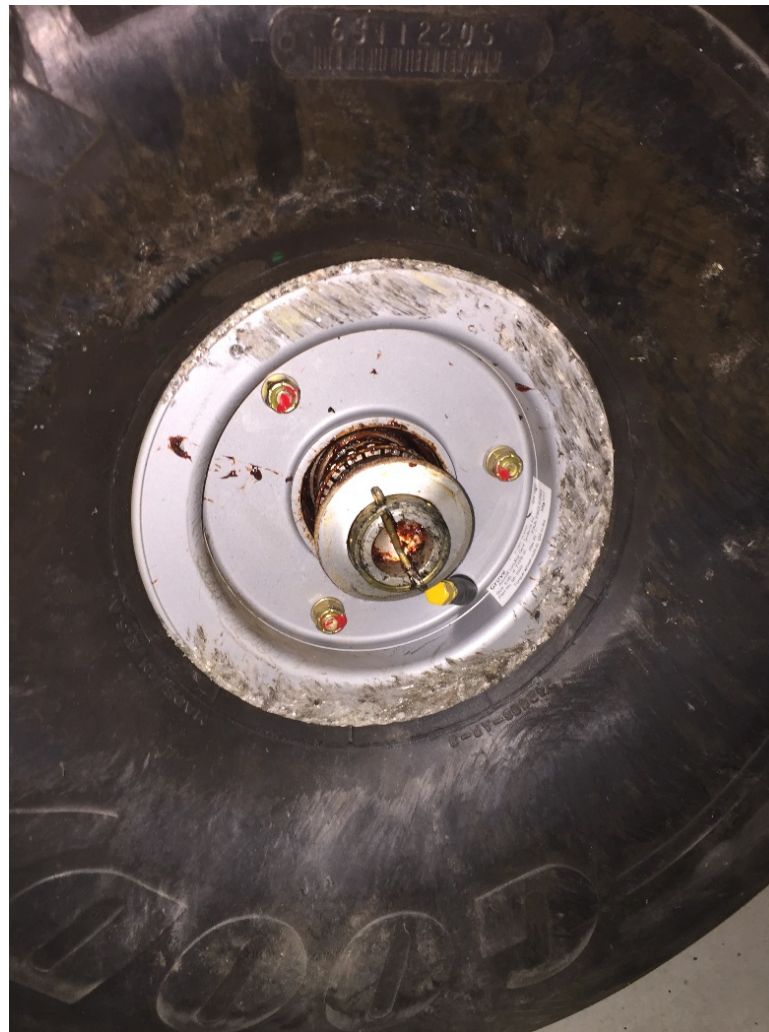
Outer side of right main wheel assy

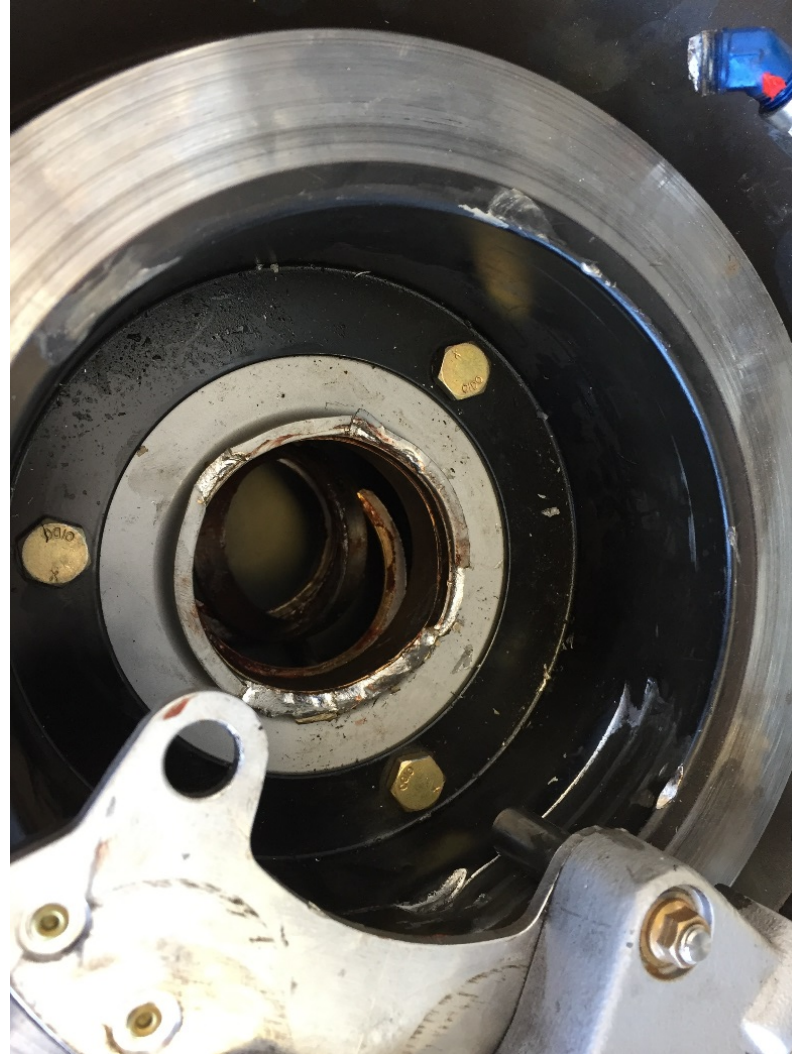
Axel removed, inner race and bearing loose  
inside of wheel assy

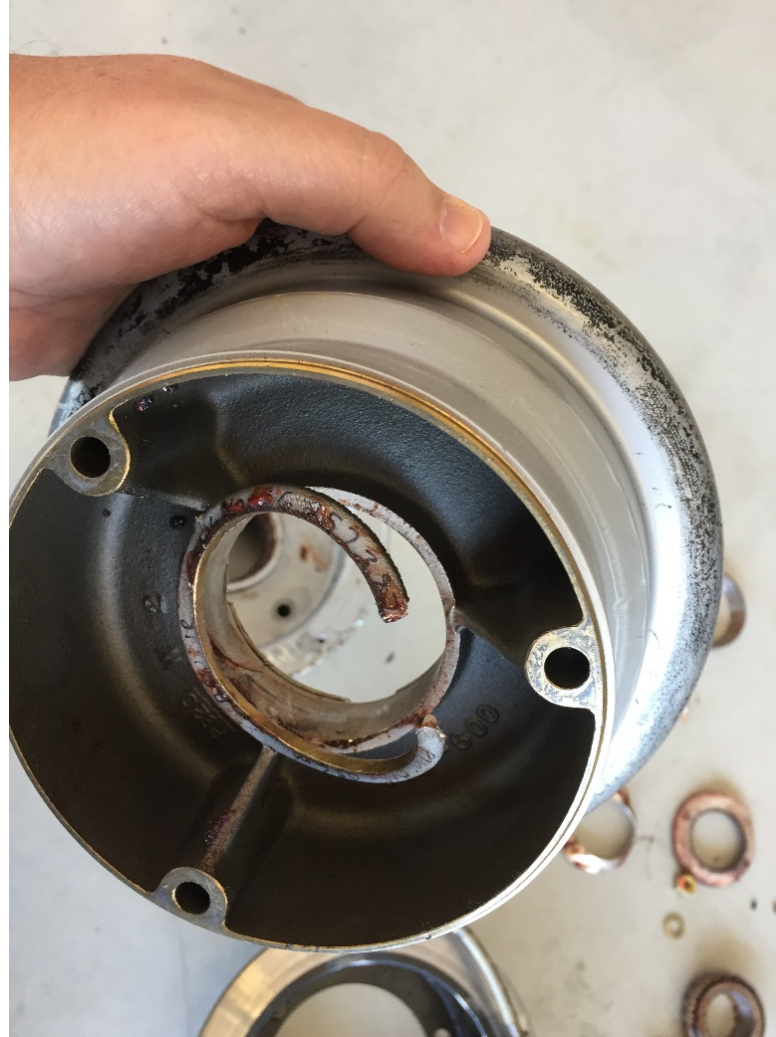
Inner wheel half, race and bearing no longer captured in proper position

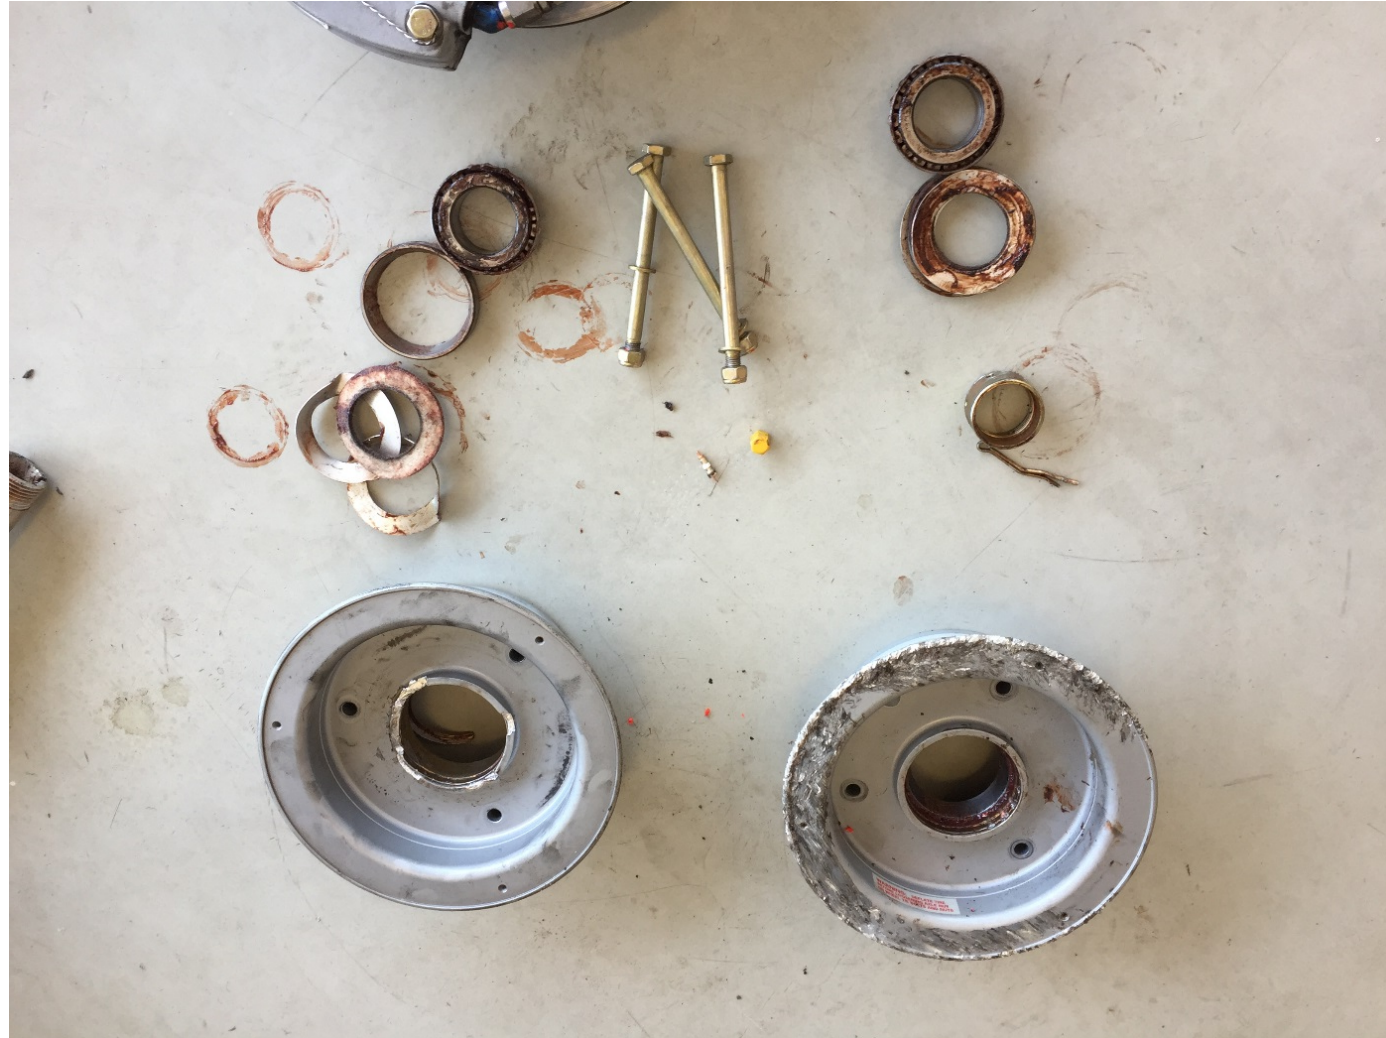
Inner half on left with race and bearing removed,  
outer half on right, bearing removed and race still  
in place

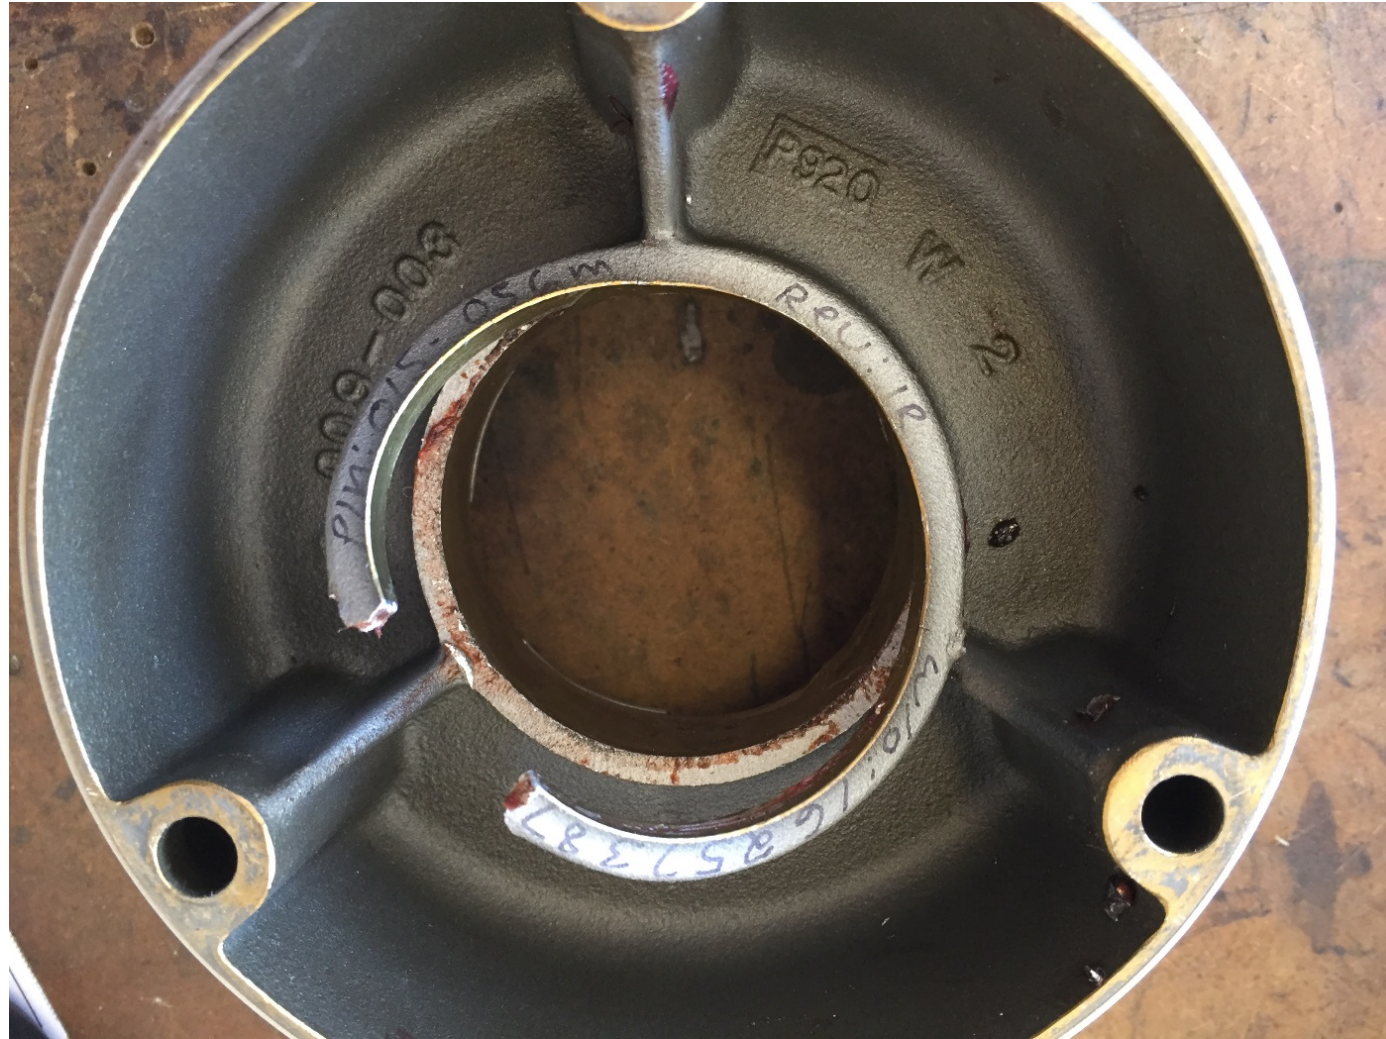
Inner half cleaned up a little, markings visible

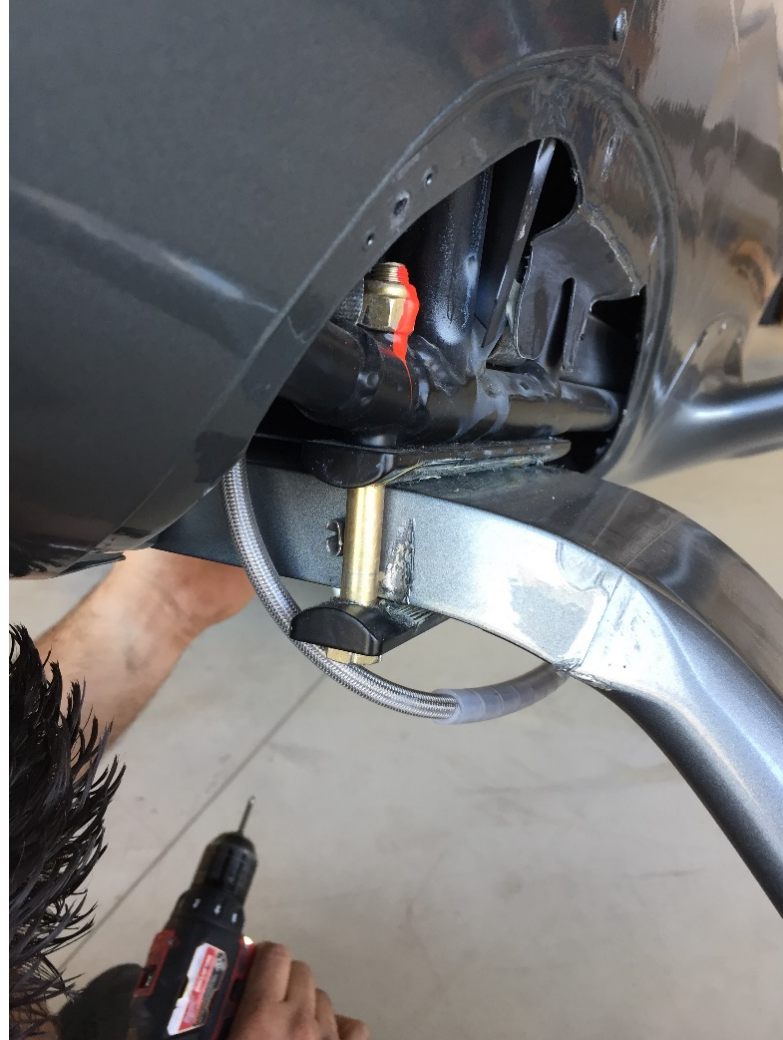
Front side of Left gear attachment, gear shifted to the Left, crushing roll pin

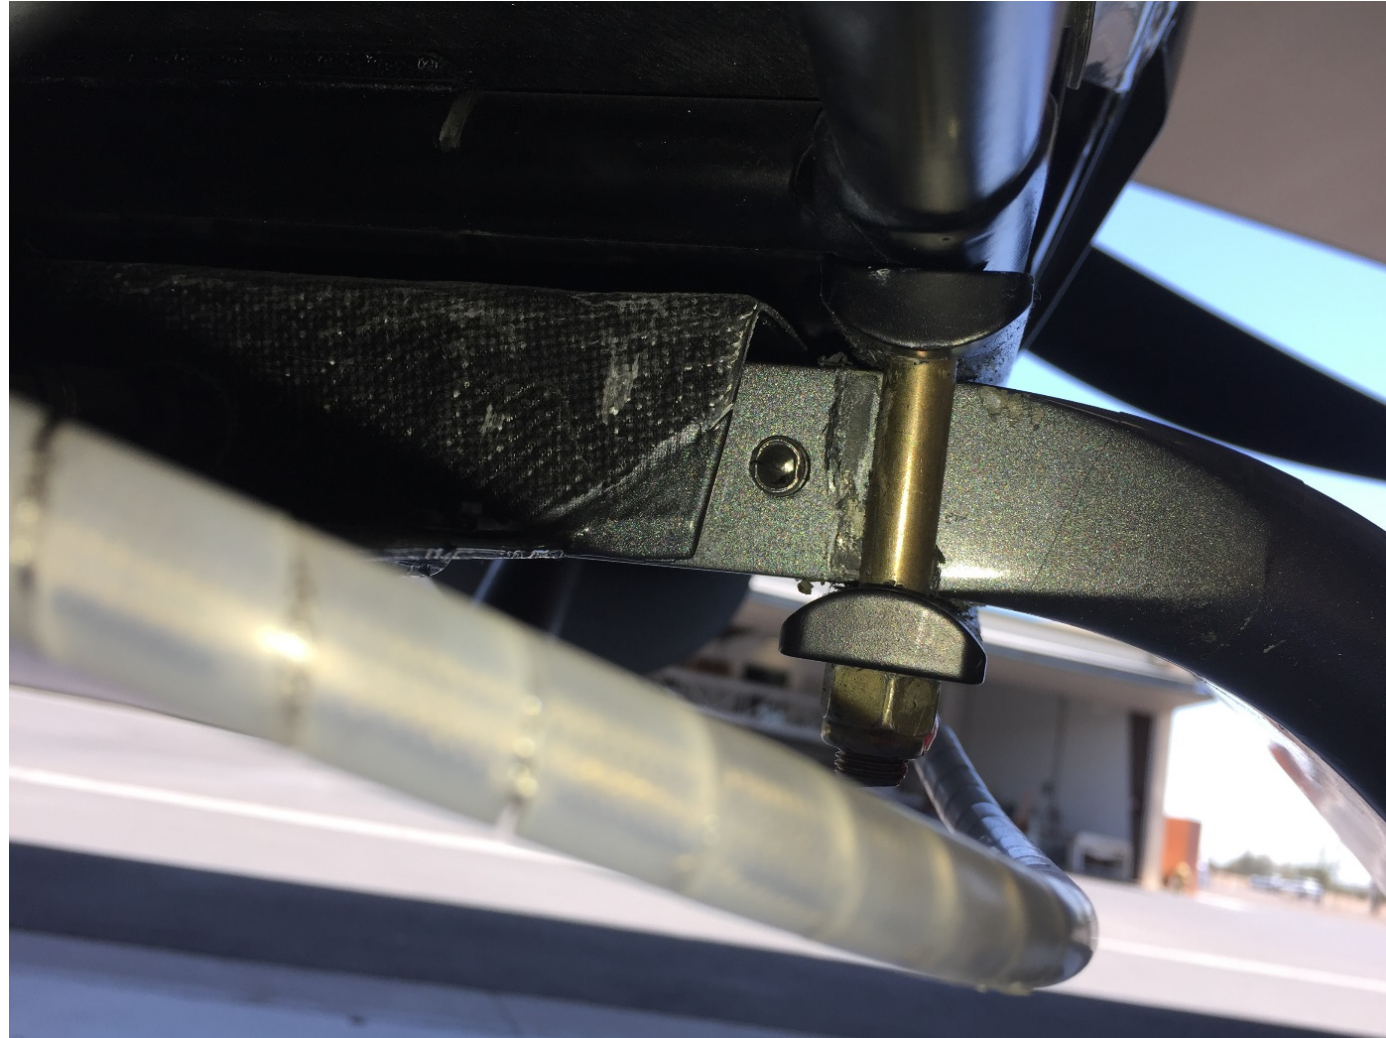
Back side of Right gear attachment, gear shifted to the left

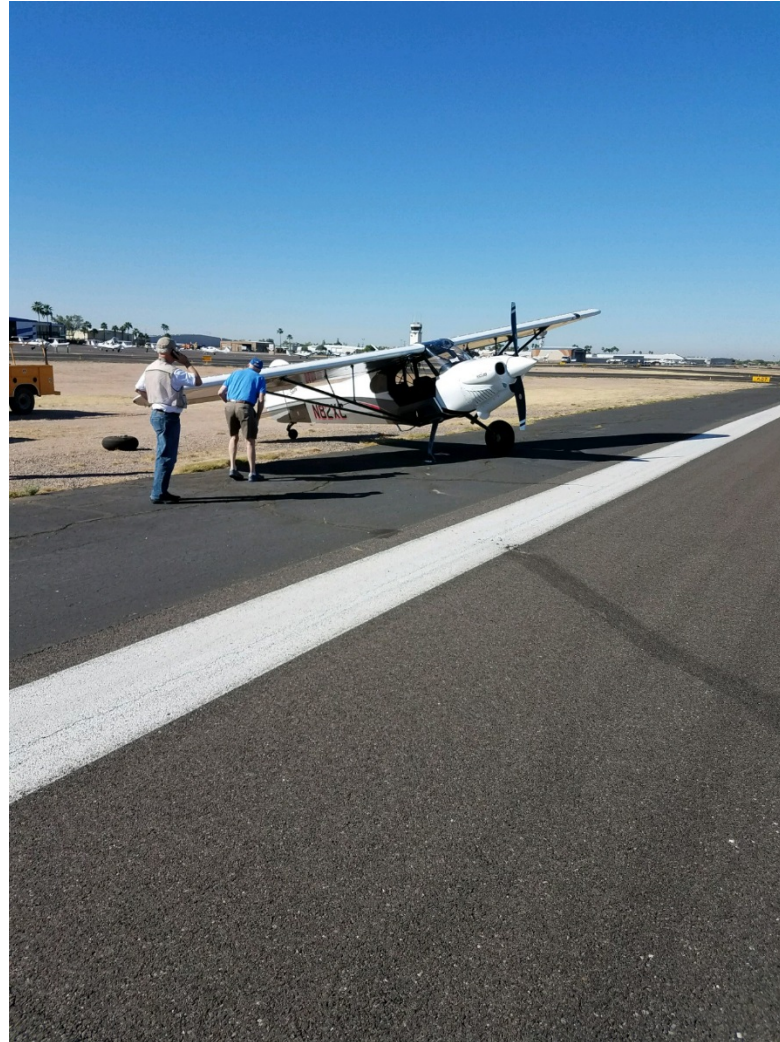
Aircraft as it came to rest. Tire mark is from the right main, it broke off at the white line and the aircraft skidded, hopped on right gear leg then spun to the right and stopped as seen here.
