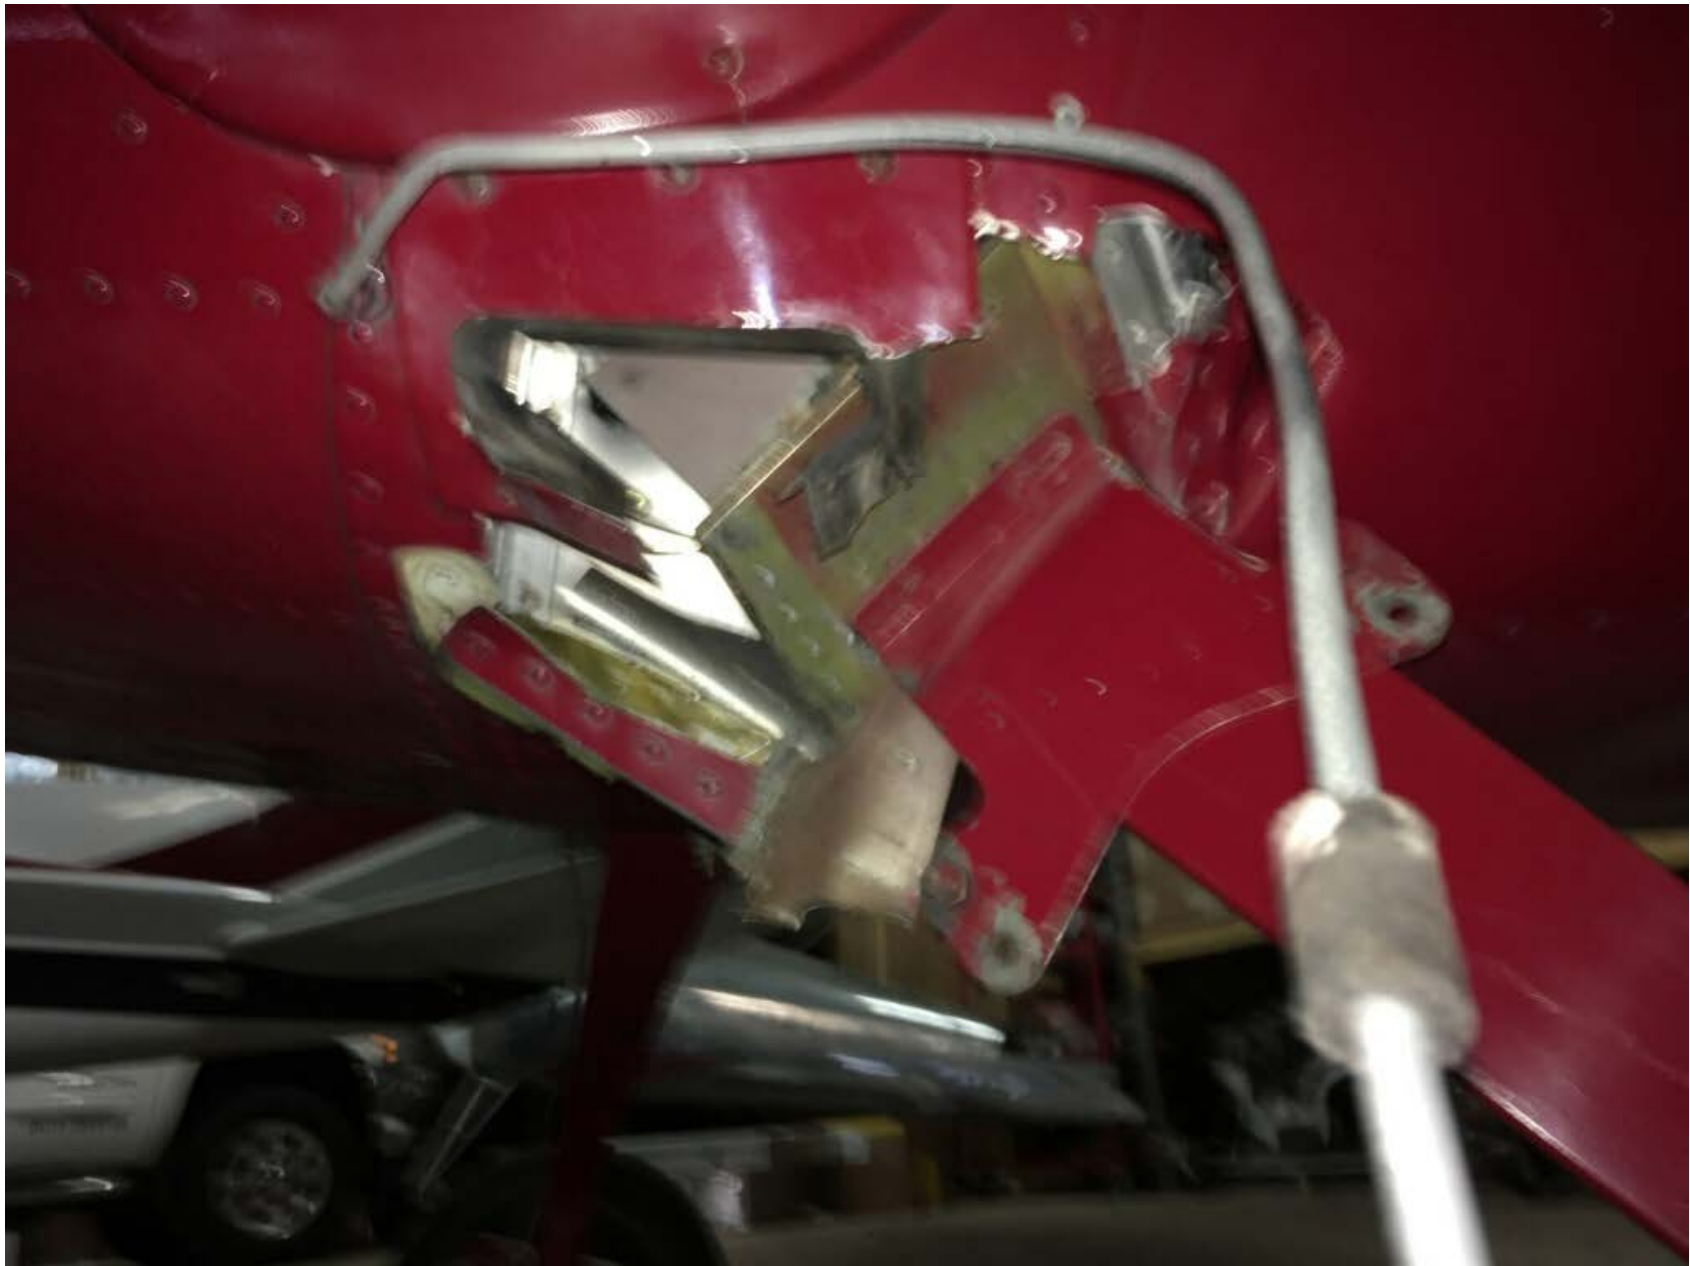
**Photo – View of damage to left main landing gear attachment point (Courtesy of FAA)**

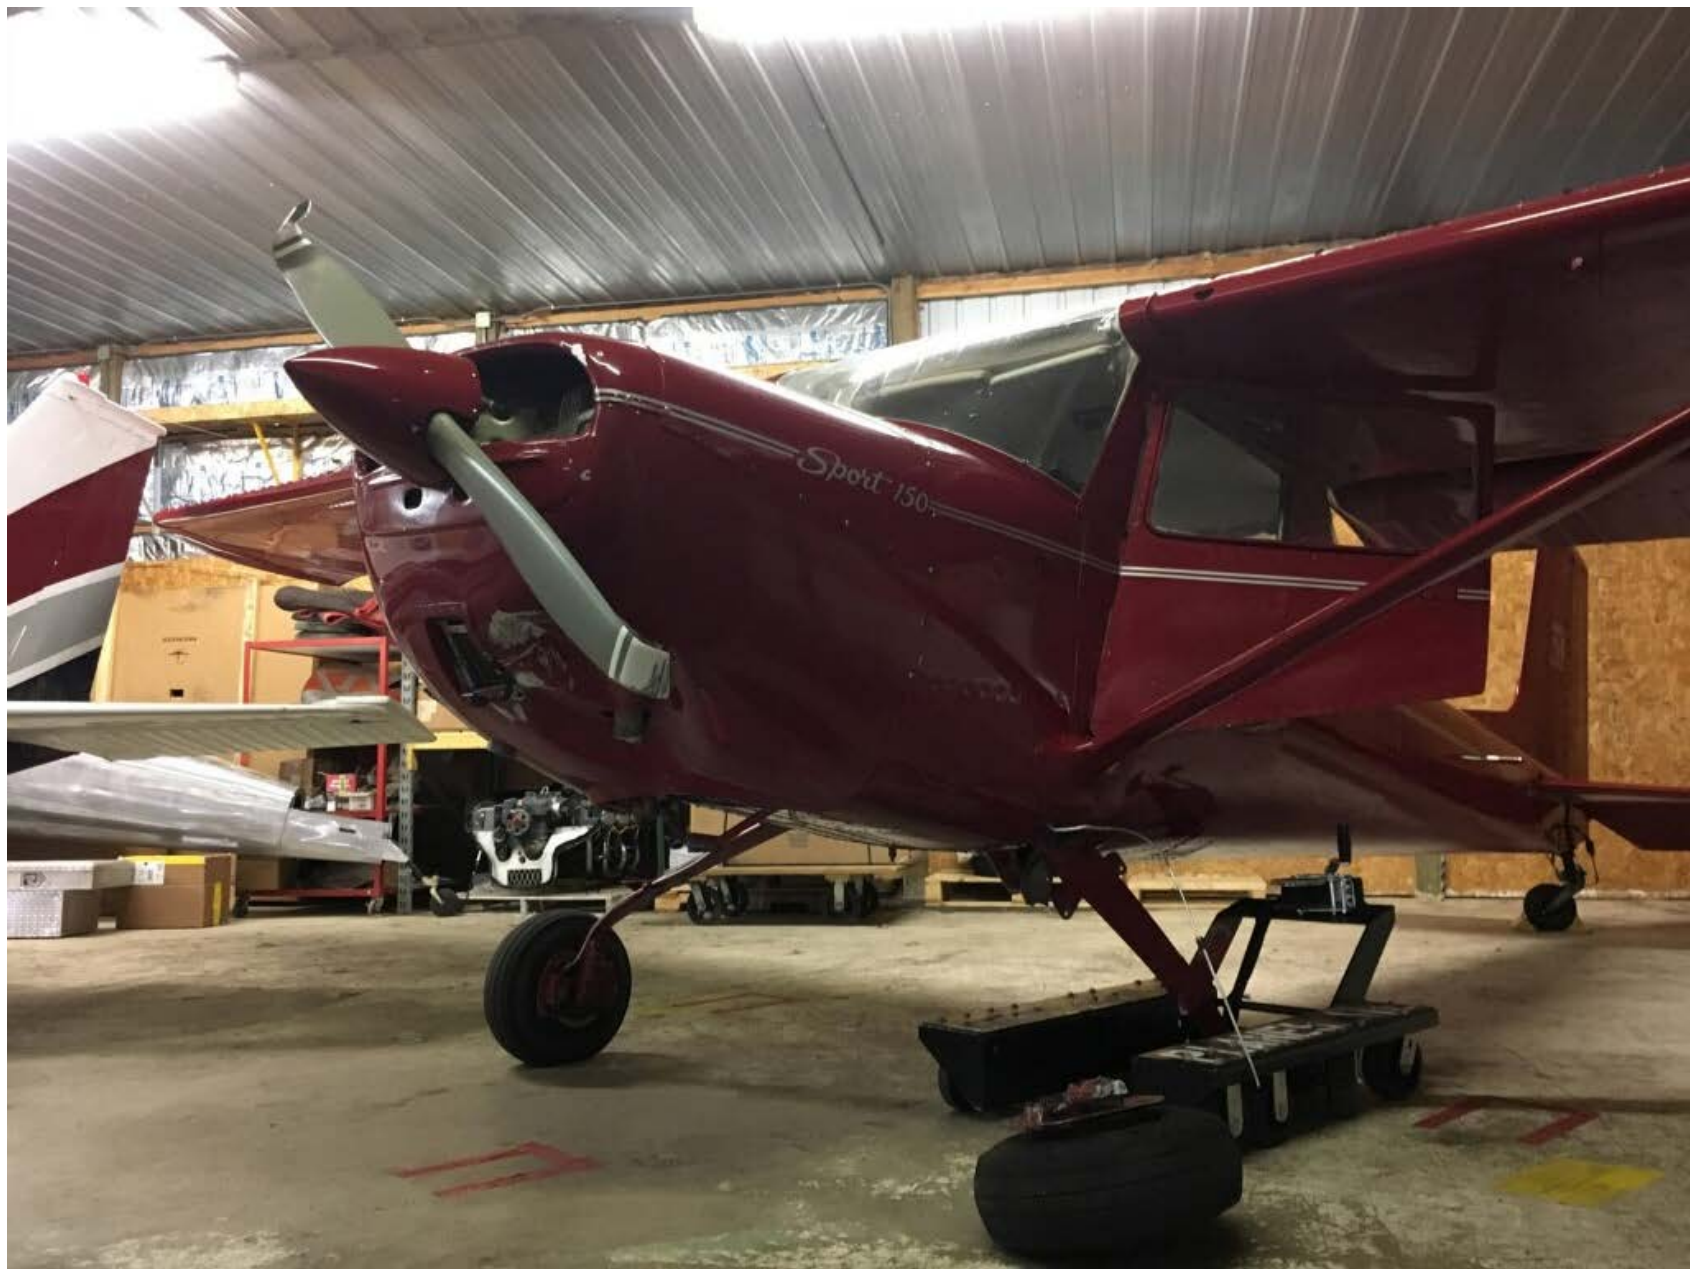
**Photo 2 – View of damage to the left main landing gear strut and wheel (Courtesy of FAA)**

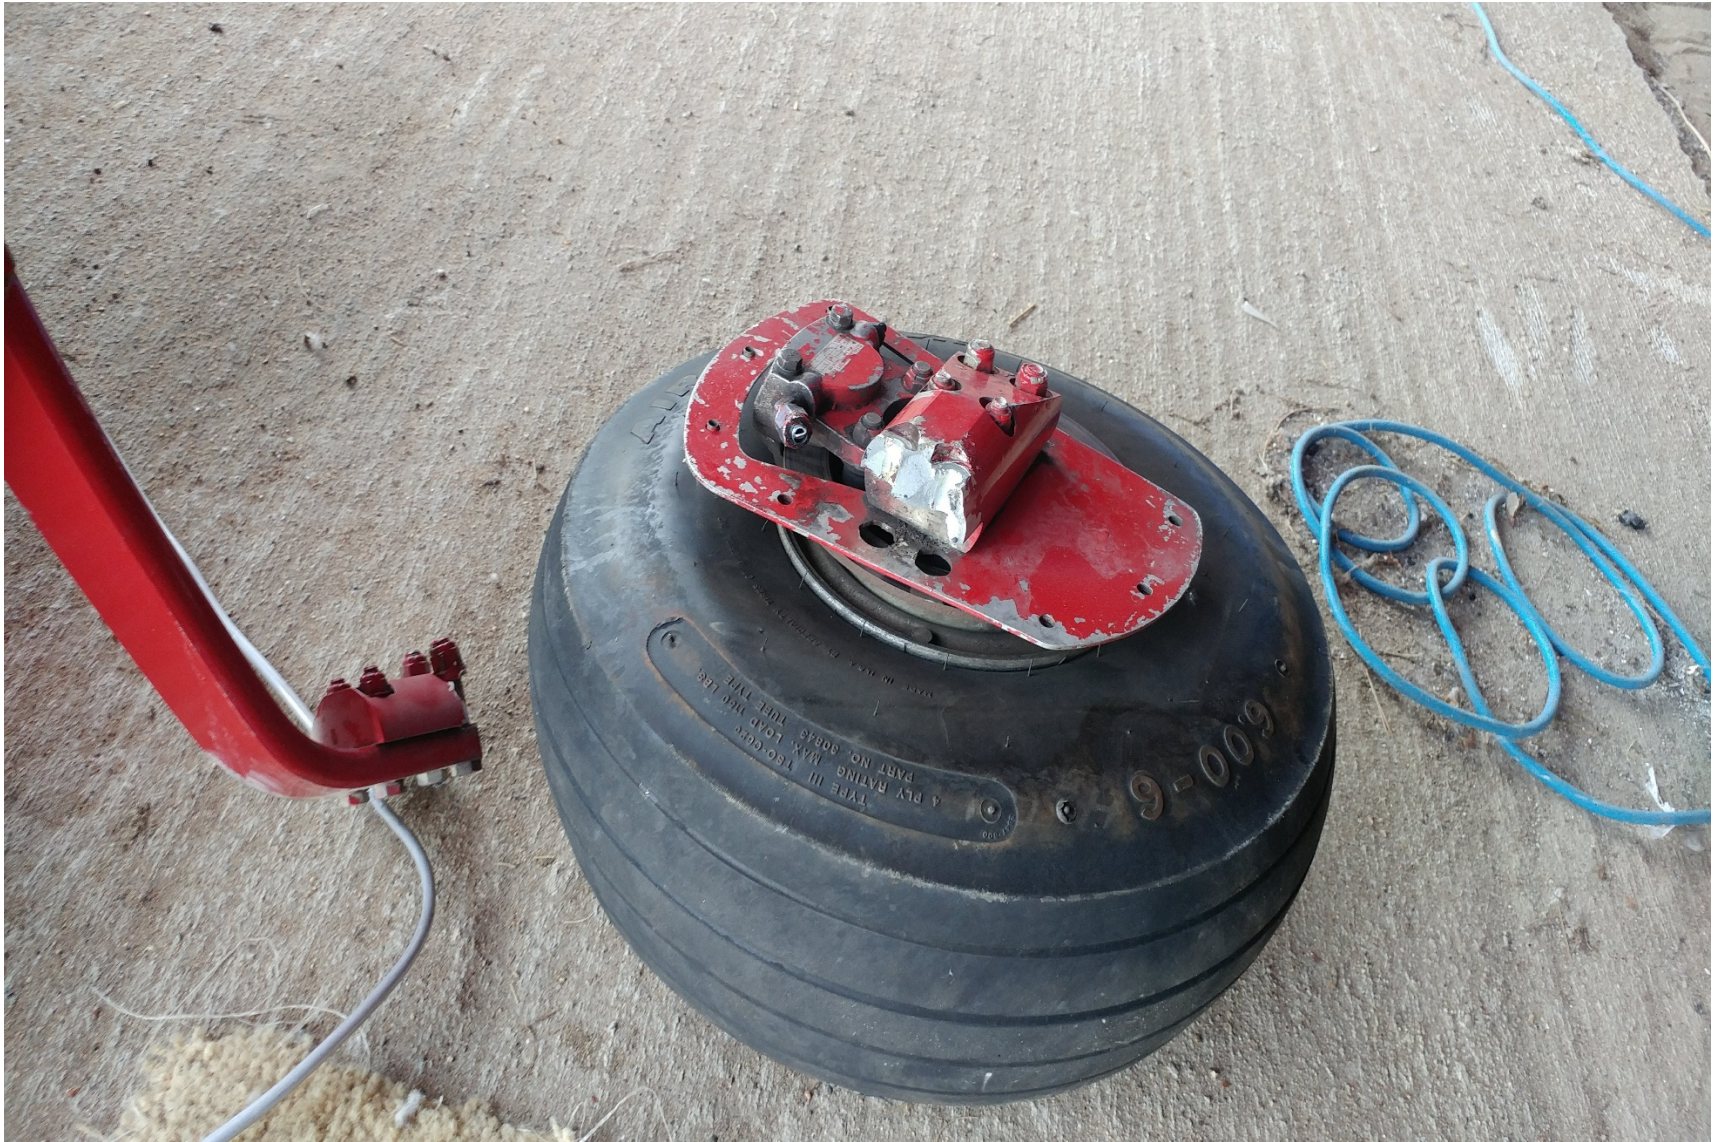
**Photo 3 – View of the extension casting failure at the landing gear strut attachment points (Courtesy of Operator)**
