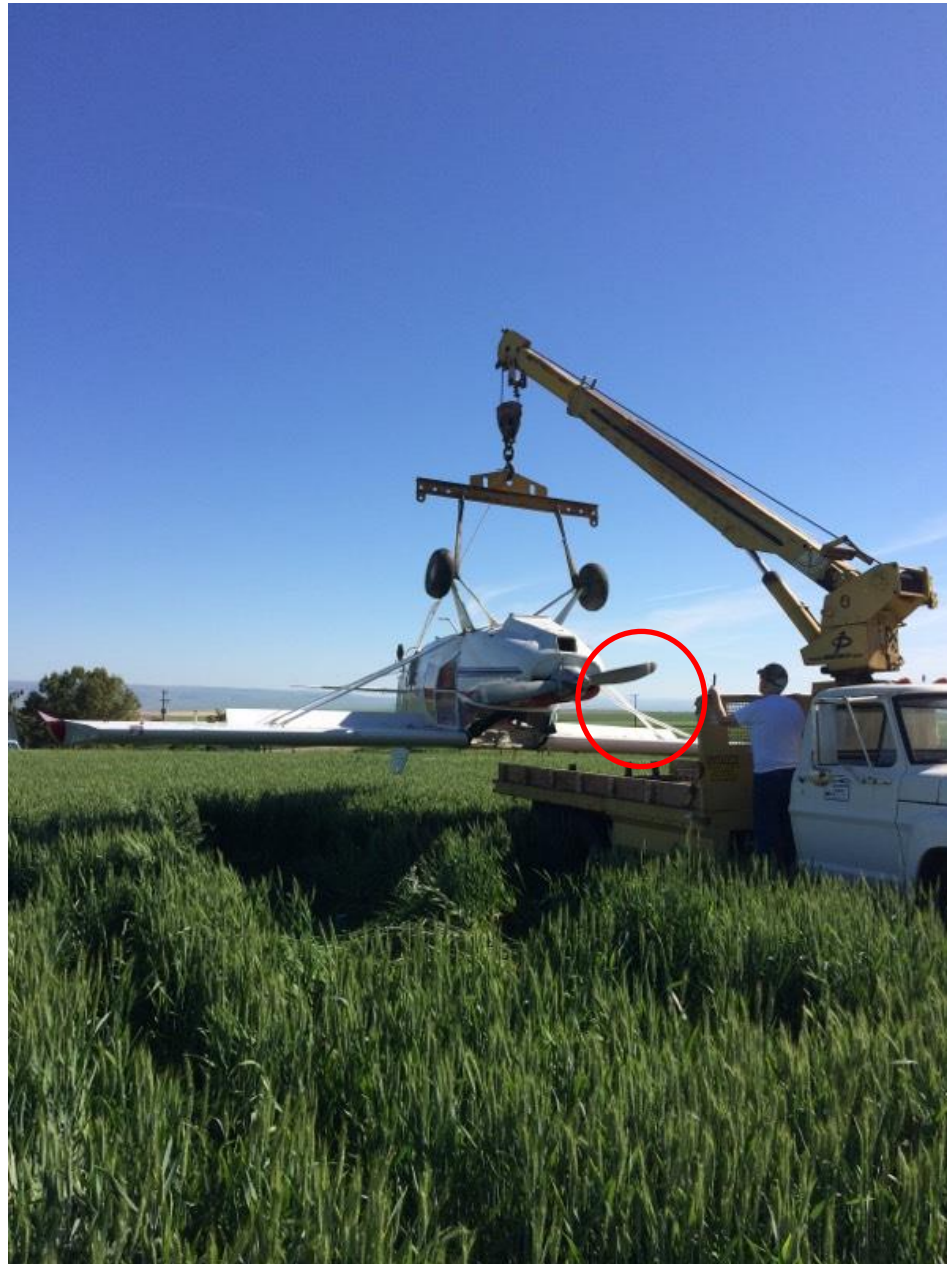
**Photo 1 – View of damage to right lift strut (photo courtesy of the pilot)**
