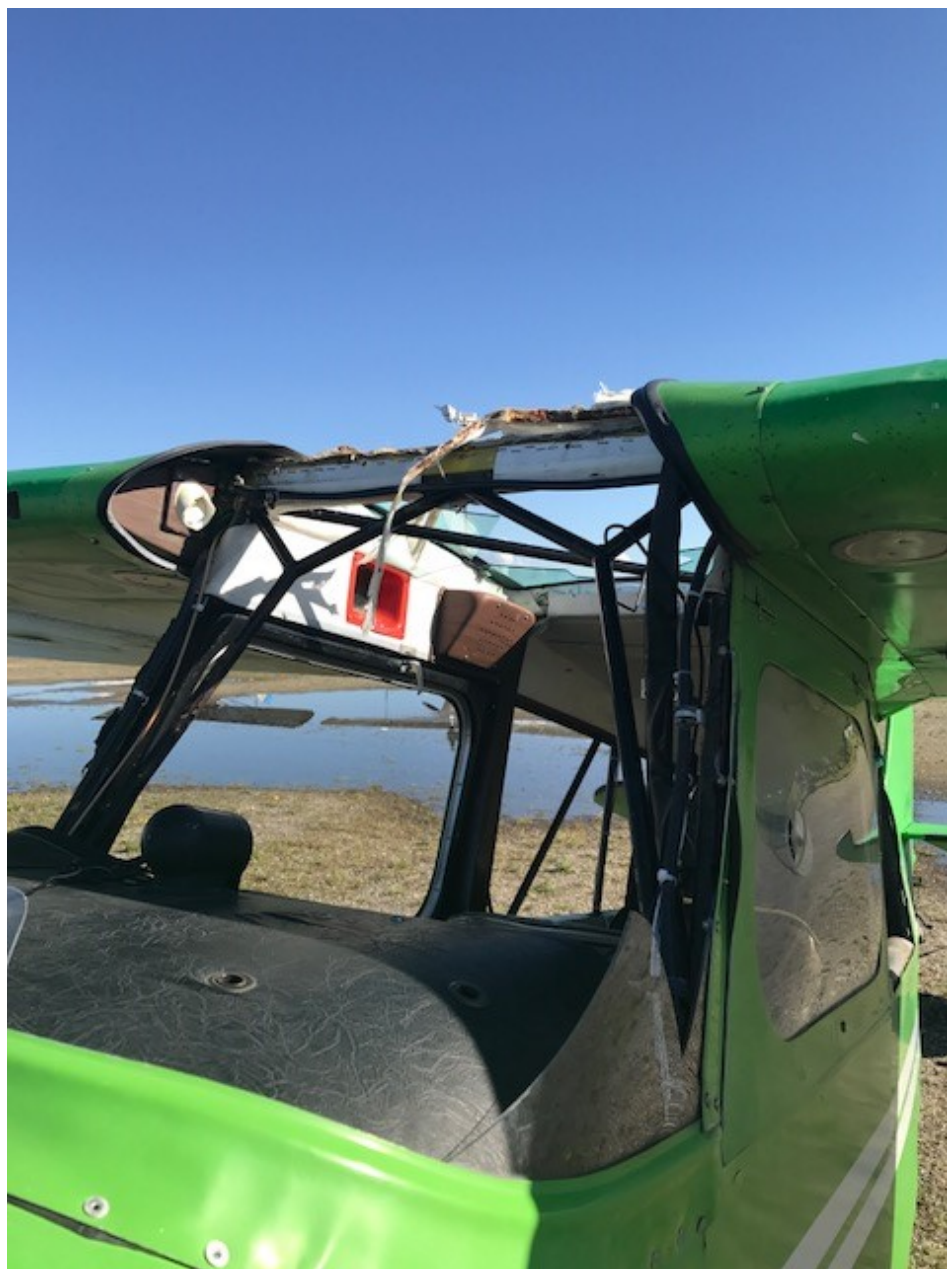
**Photo 1 – View of missing windscreen, windows, and greenhouse (Courtesy of FAA)**

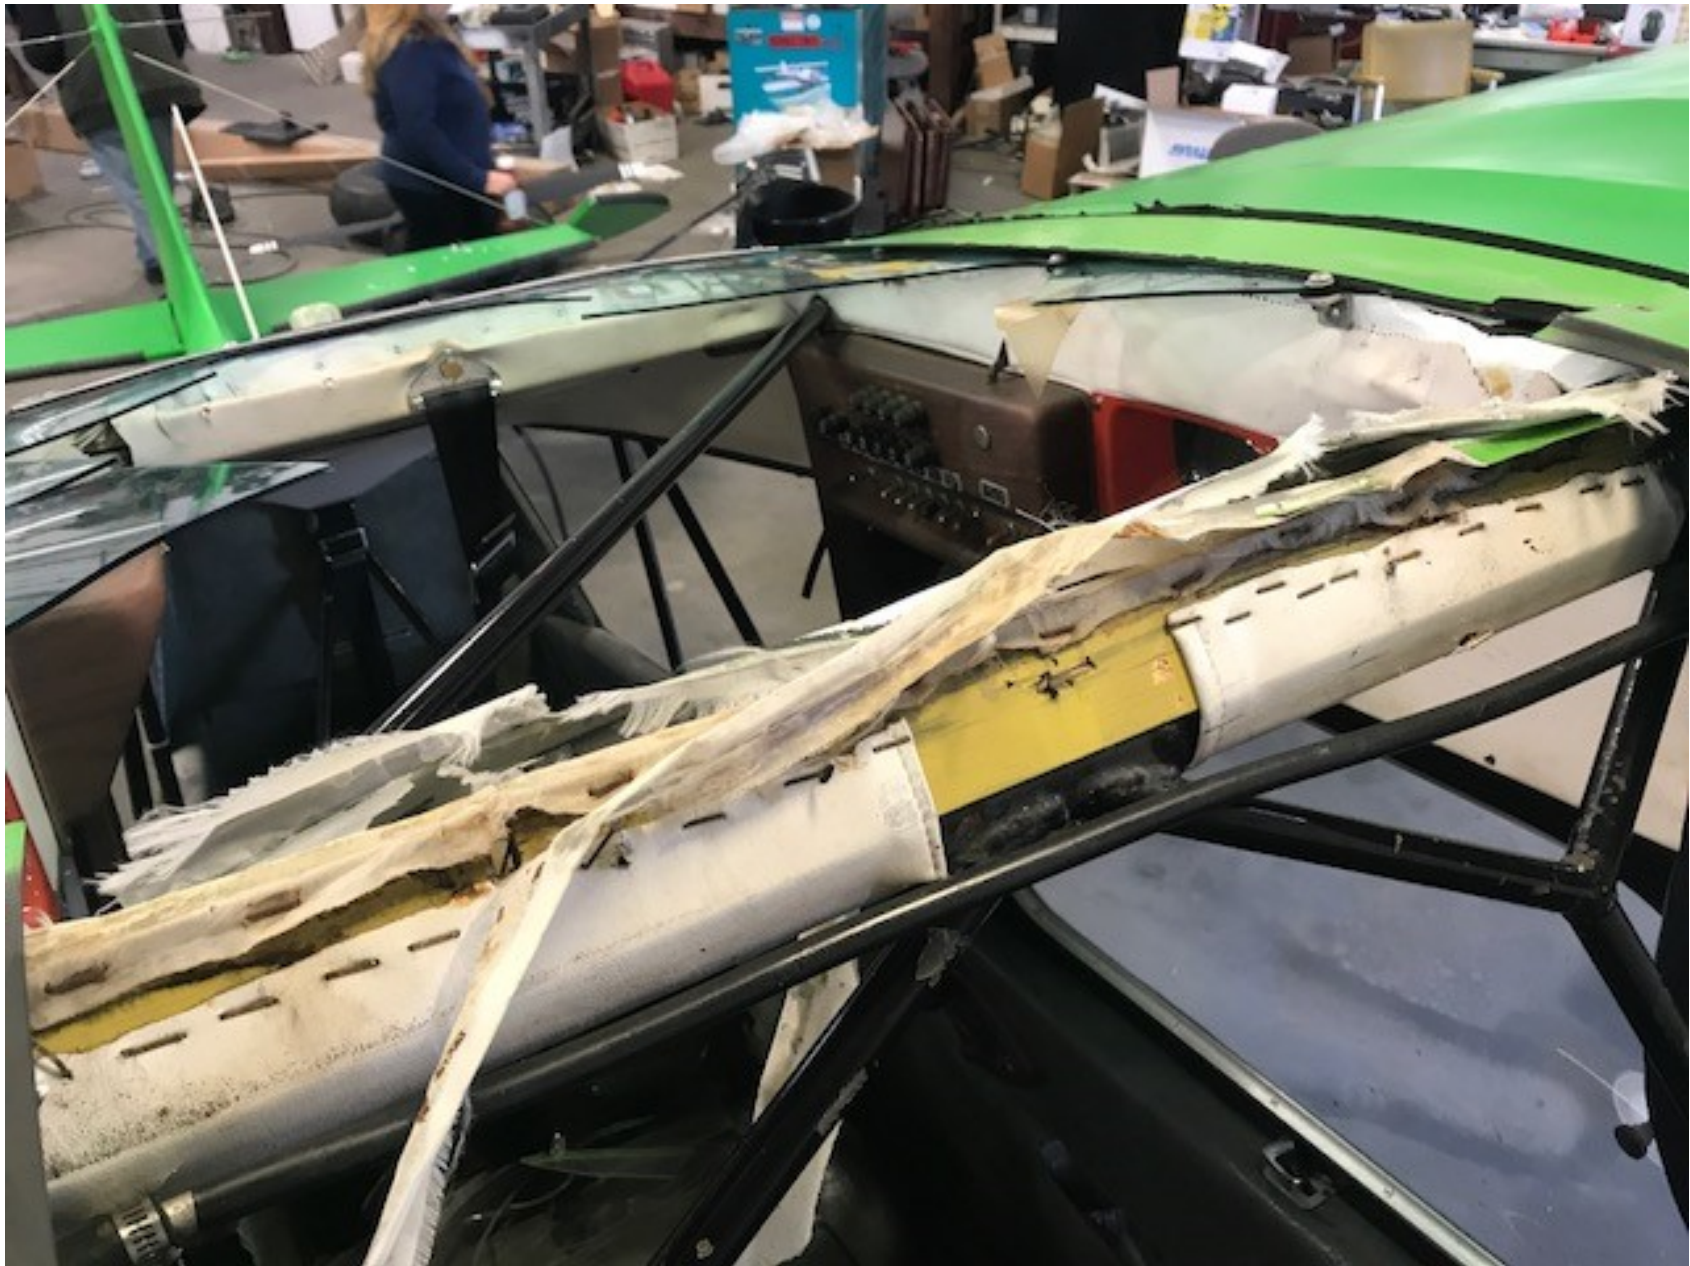
**Photo 2 – View of retainer windshield top missing through-bolts and greenhouse support (Courtesy of FAA)**
