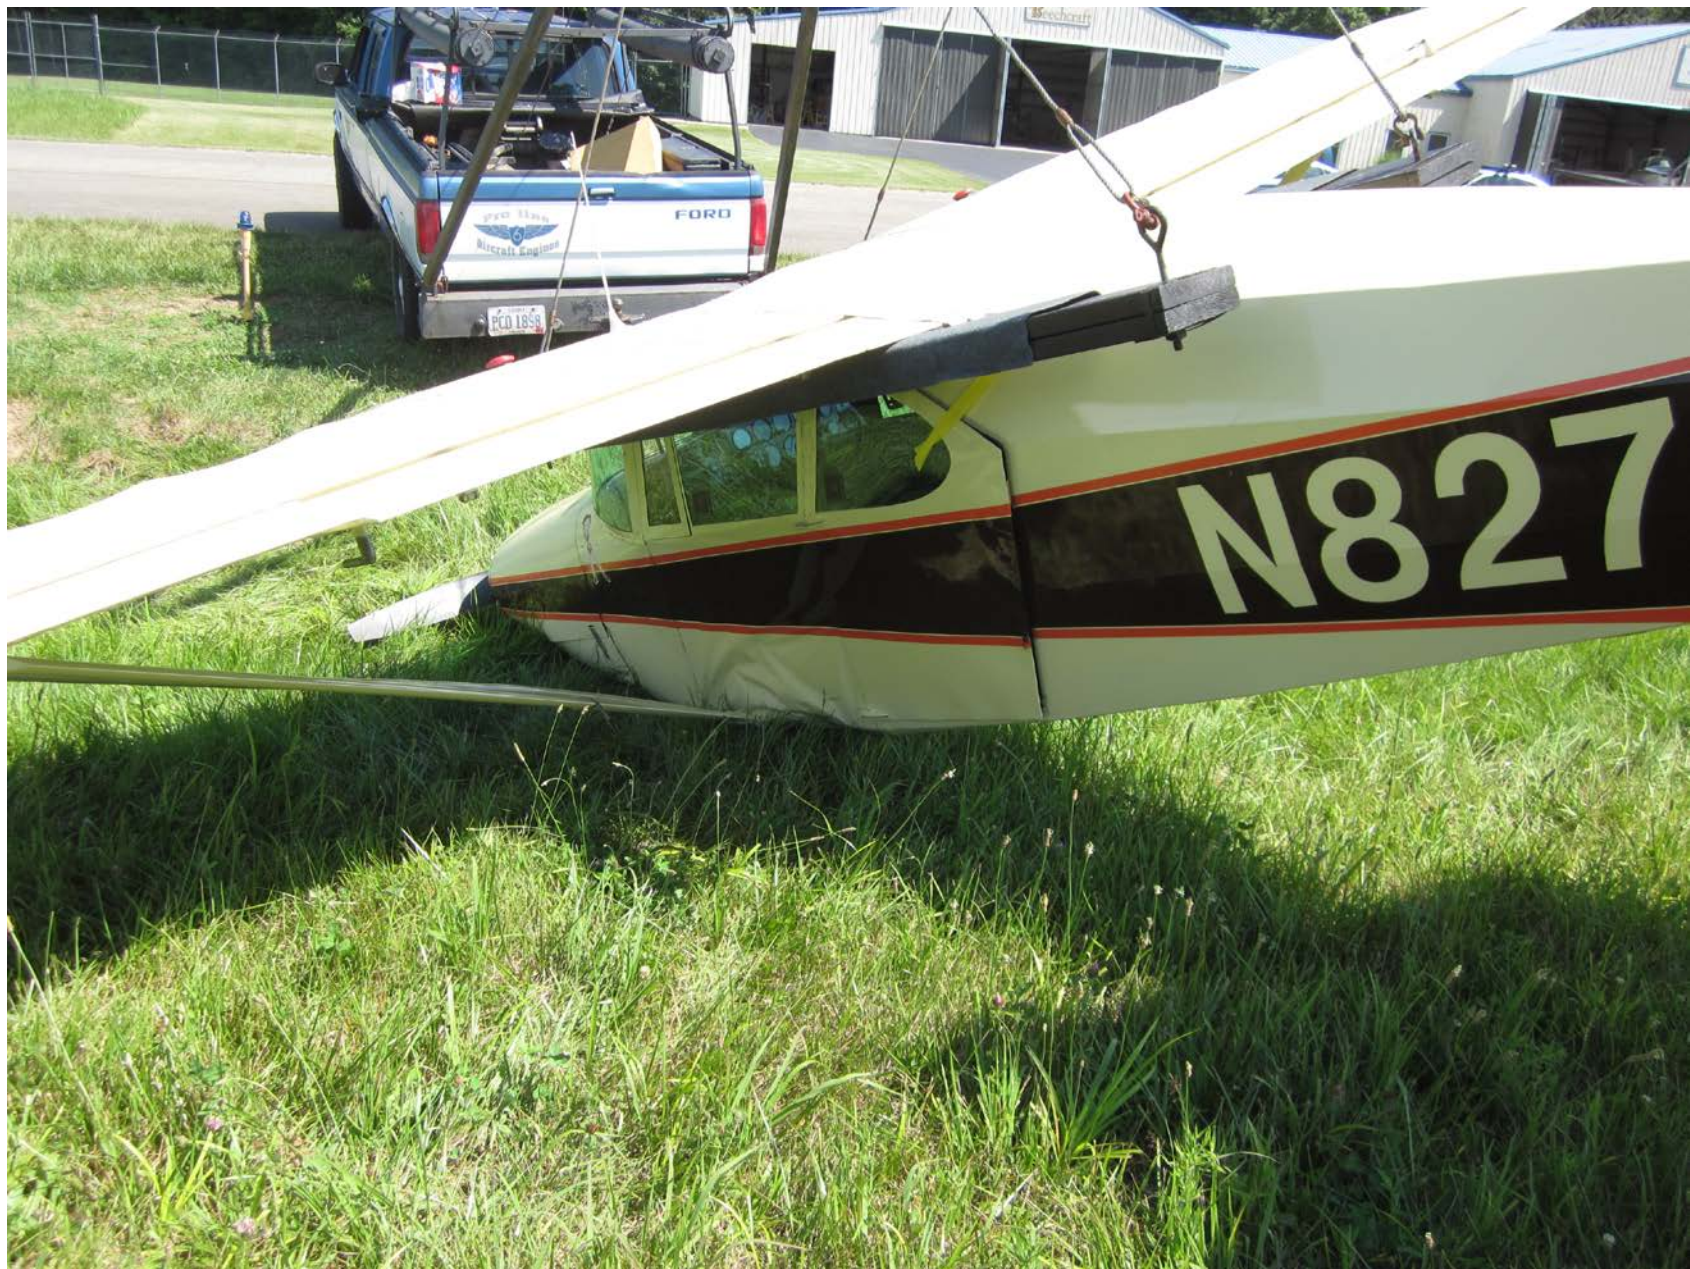
**Photo 1 – View of left lower fuselage damage (courtesy of the FAA)**

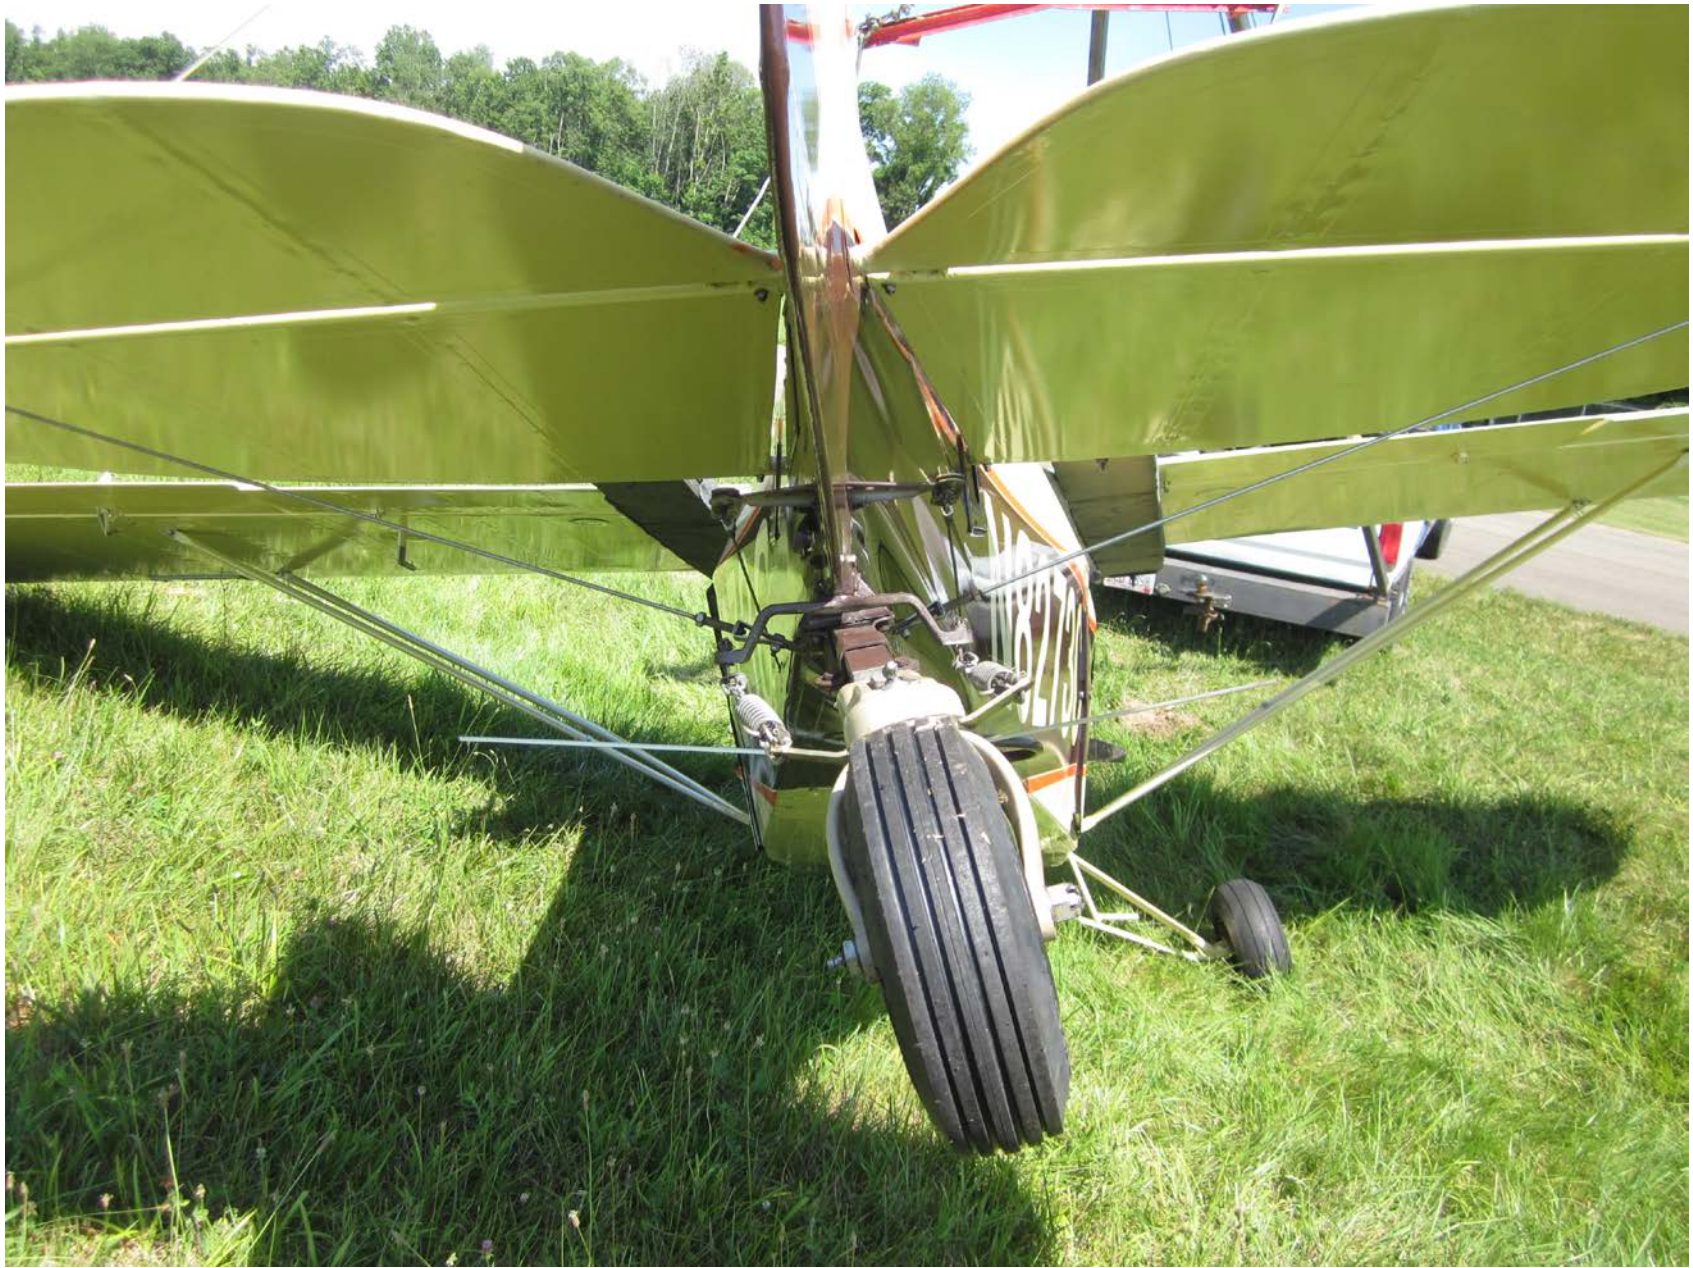
**Photo 2 – View of bent tailwheel (courtesy of the FAA)**
