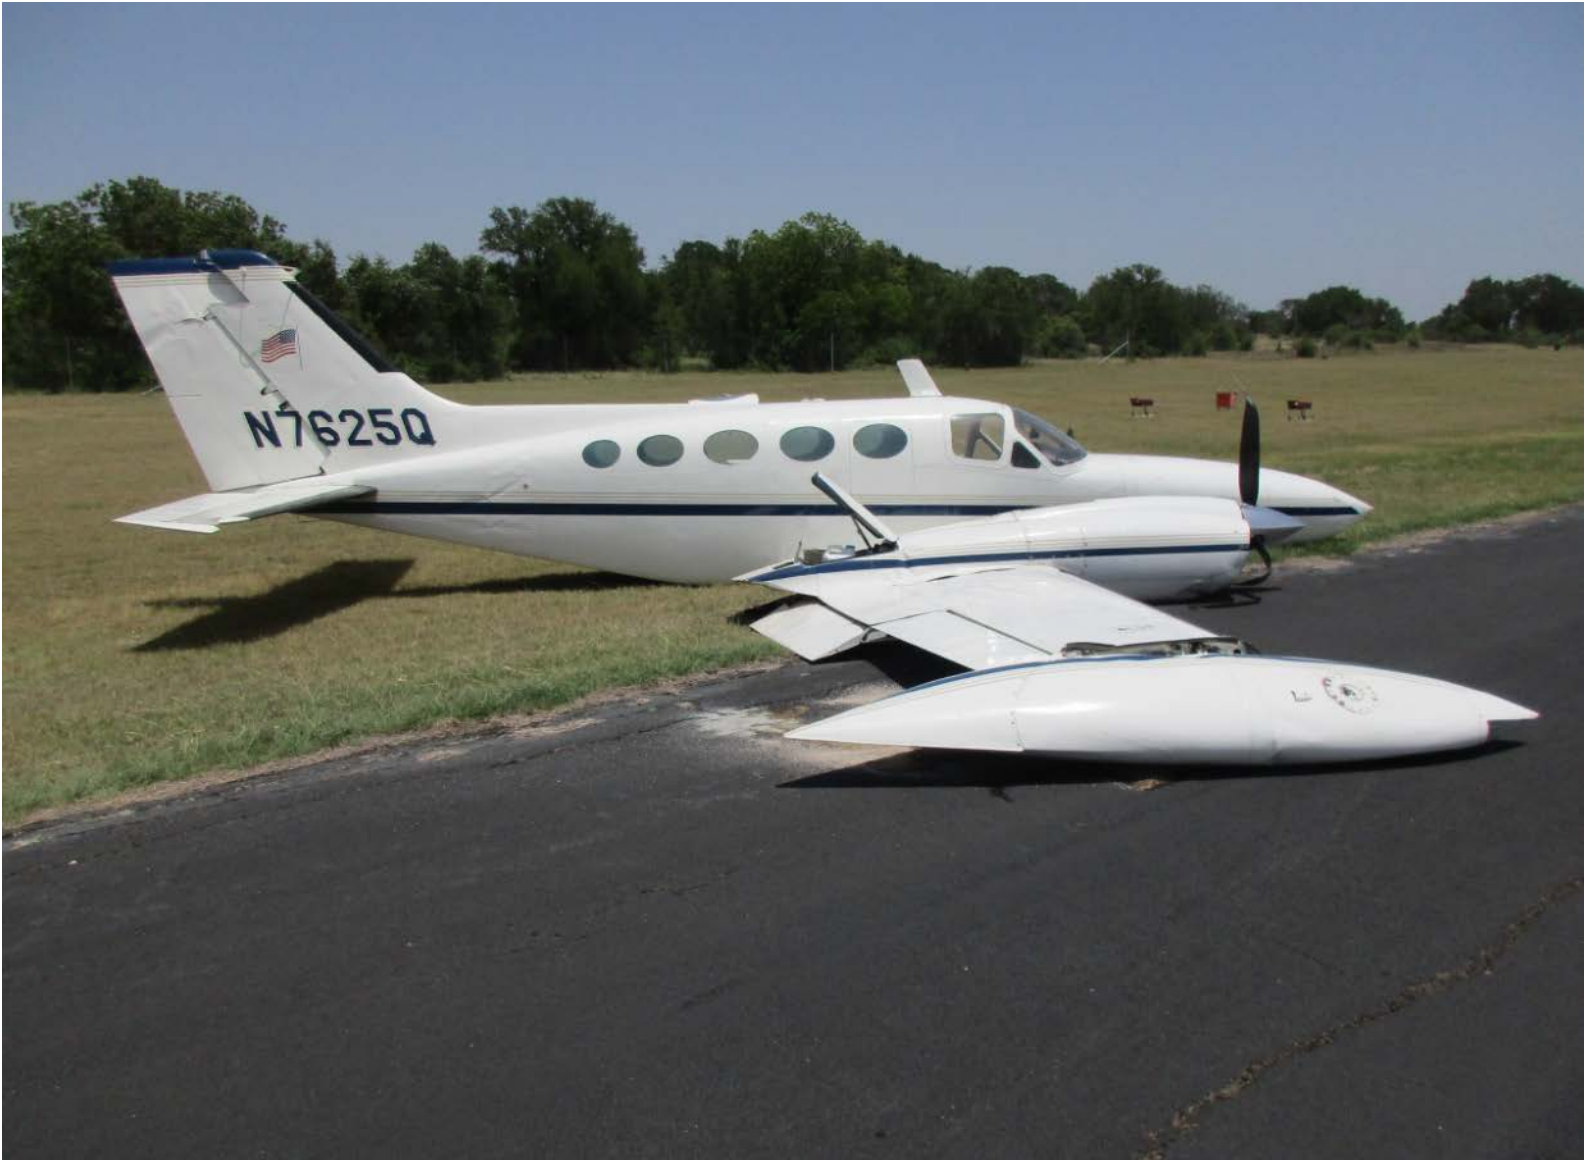
**Photo 1 – View of damaged right wing (Photo courtesy of FAA)**

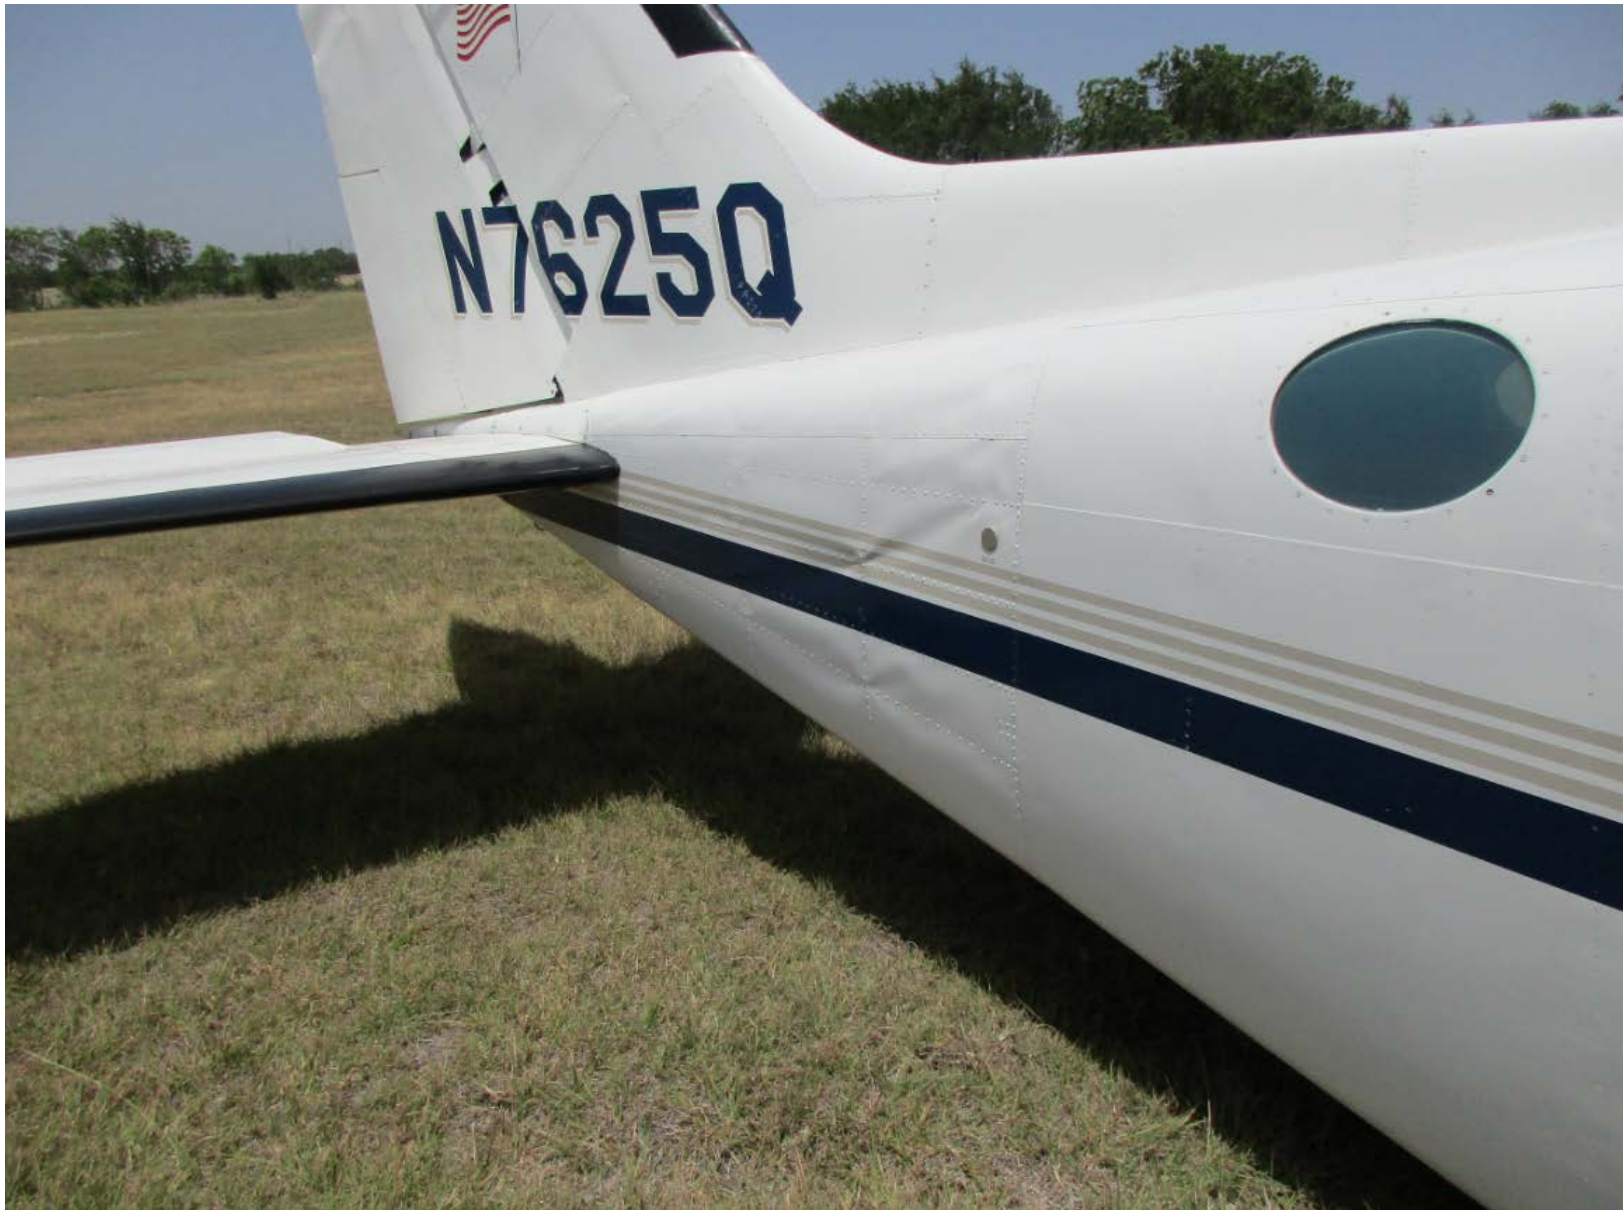
**Photo 2 – View of damaged tail cone (Photo courtesy of FAA)**

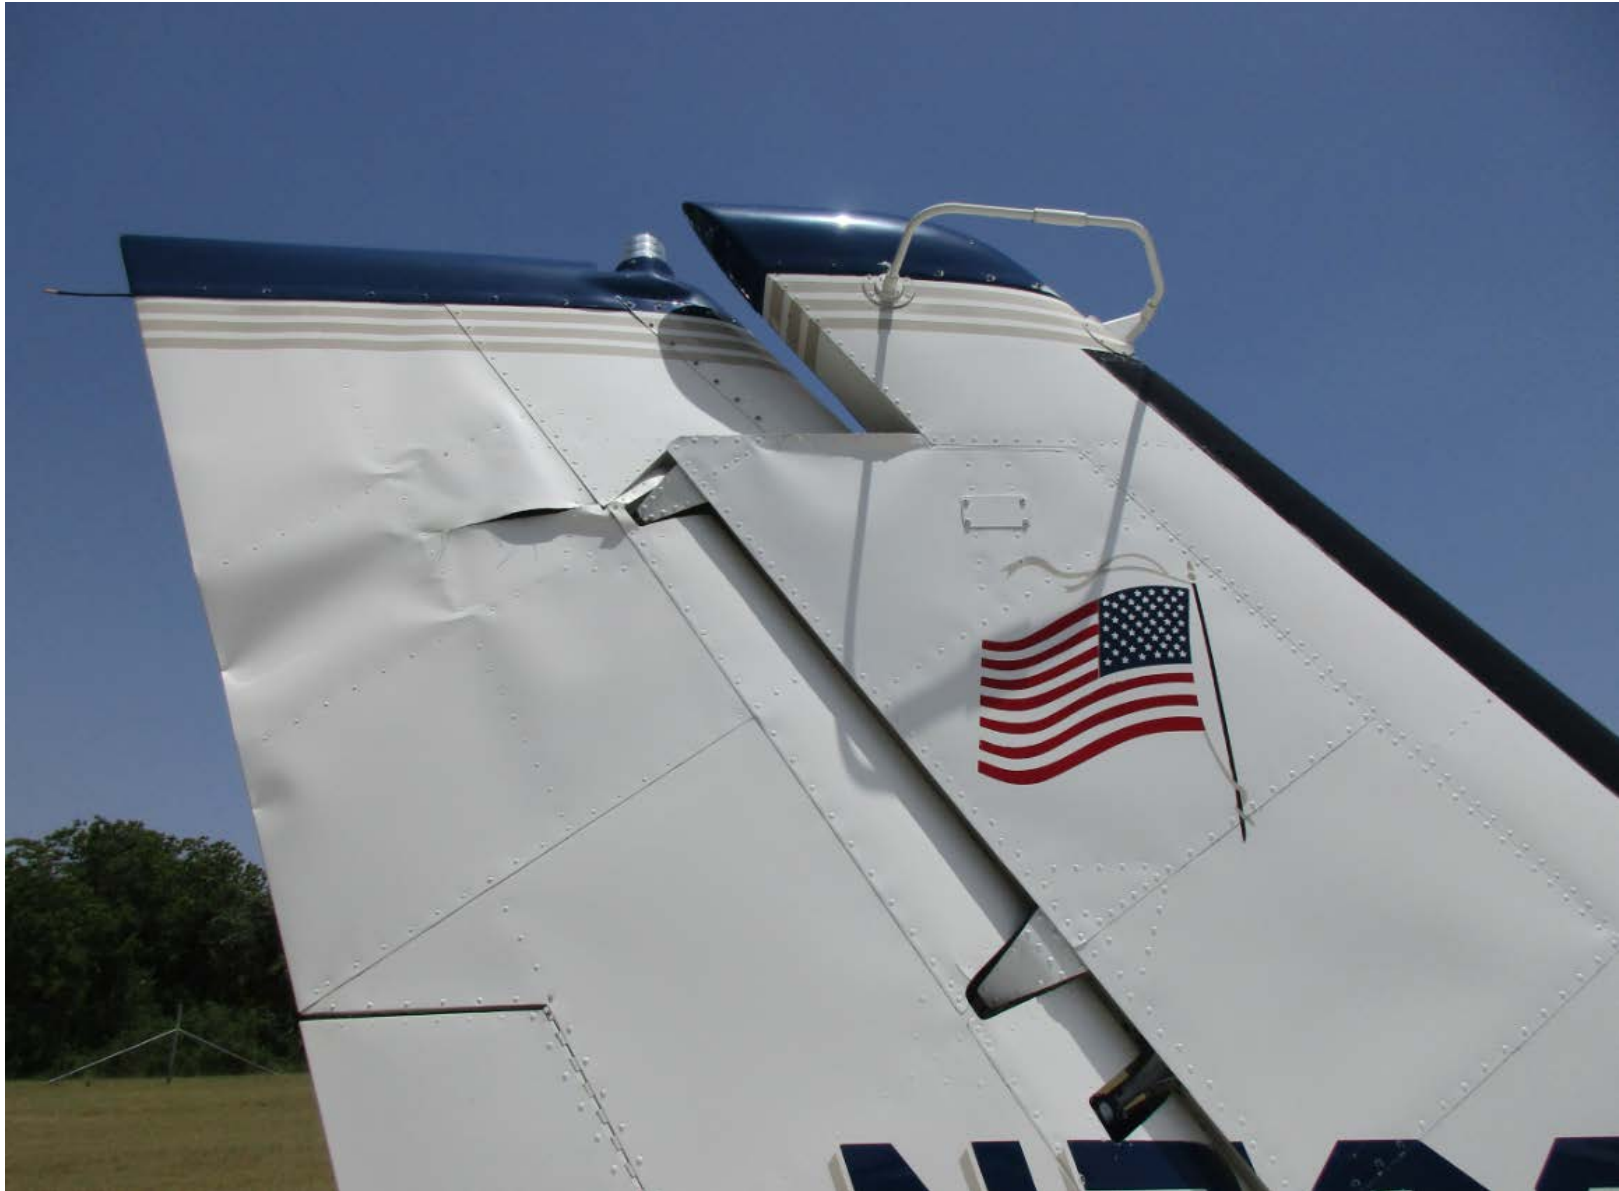
**Photo 3 – View of damaged rudder (Photo Courtesy of FAA)**
