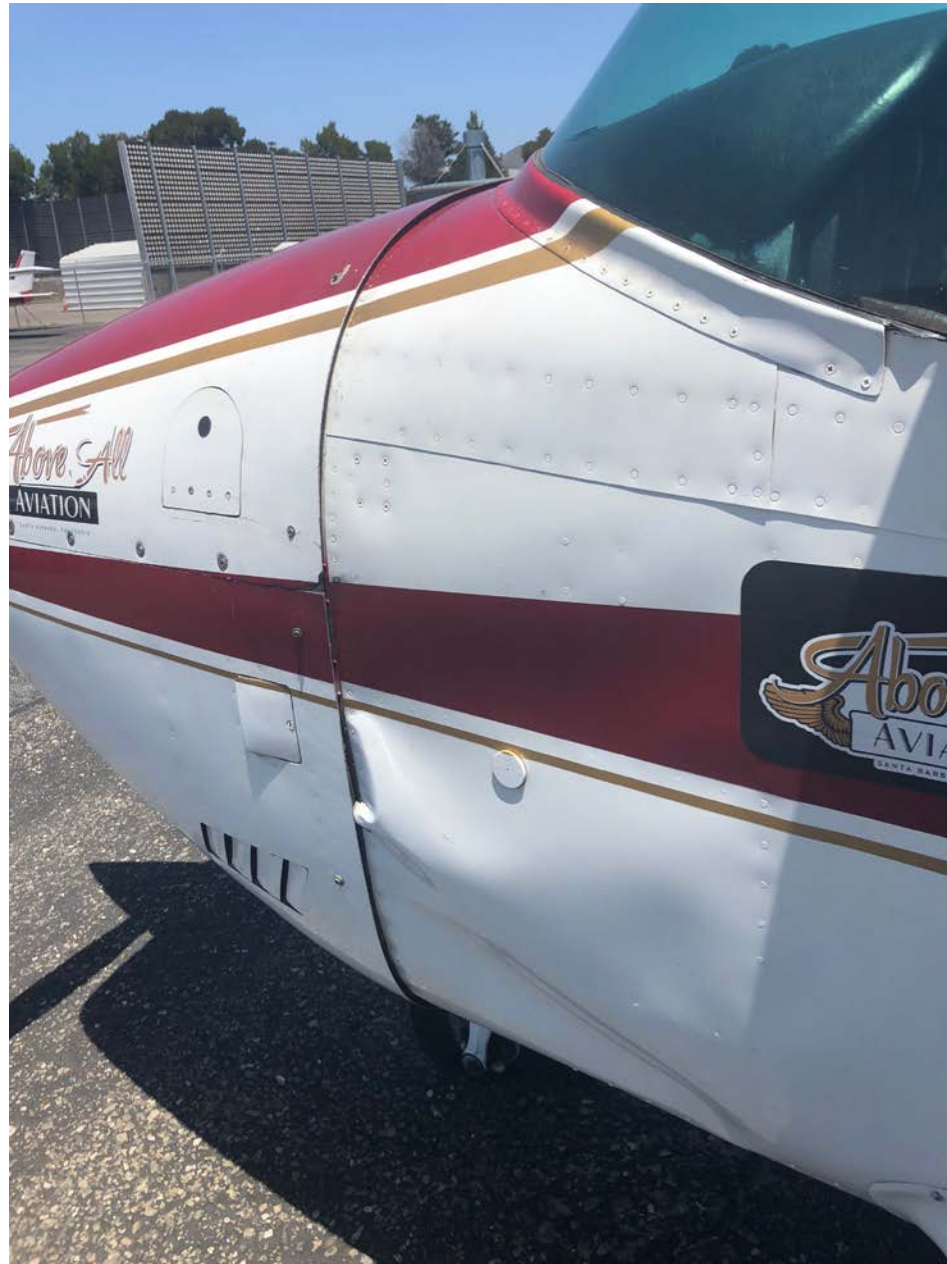
**Photo 1 – View of damage to the lower left fuselage stringer (Courtesy of Operator)**

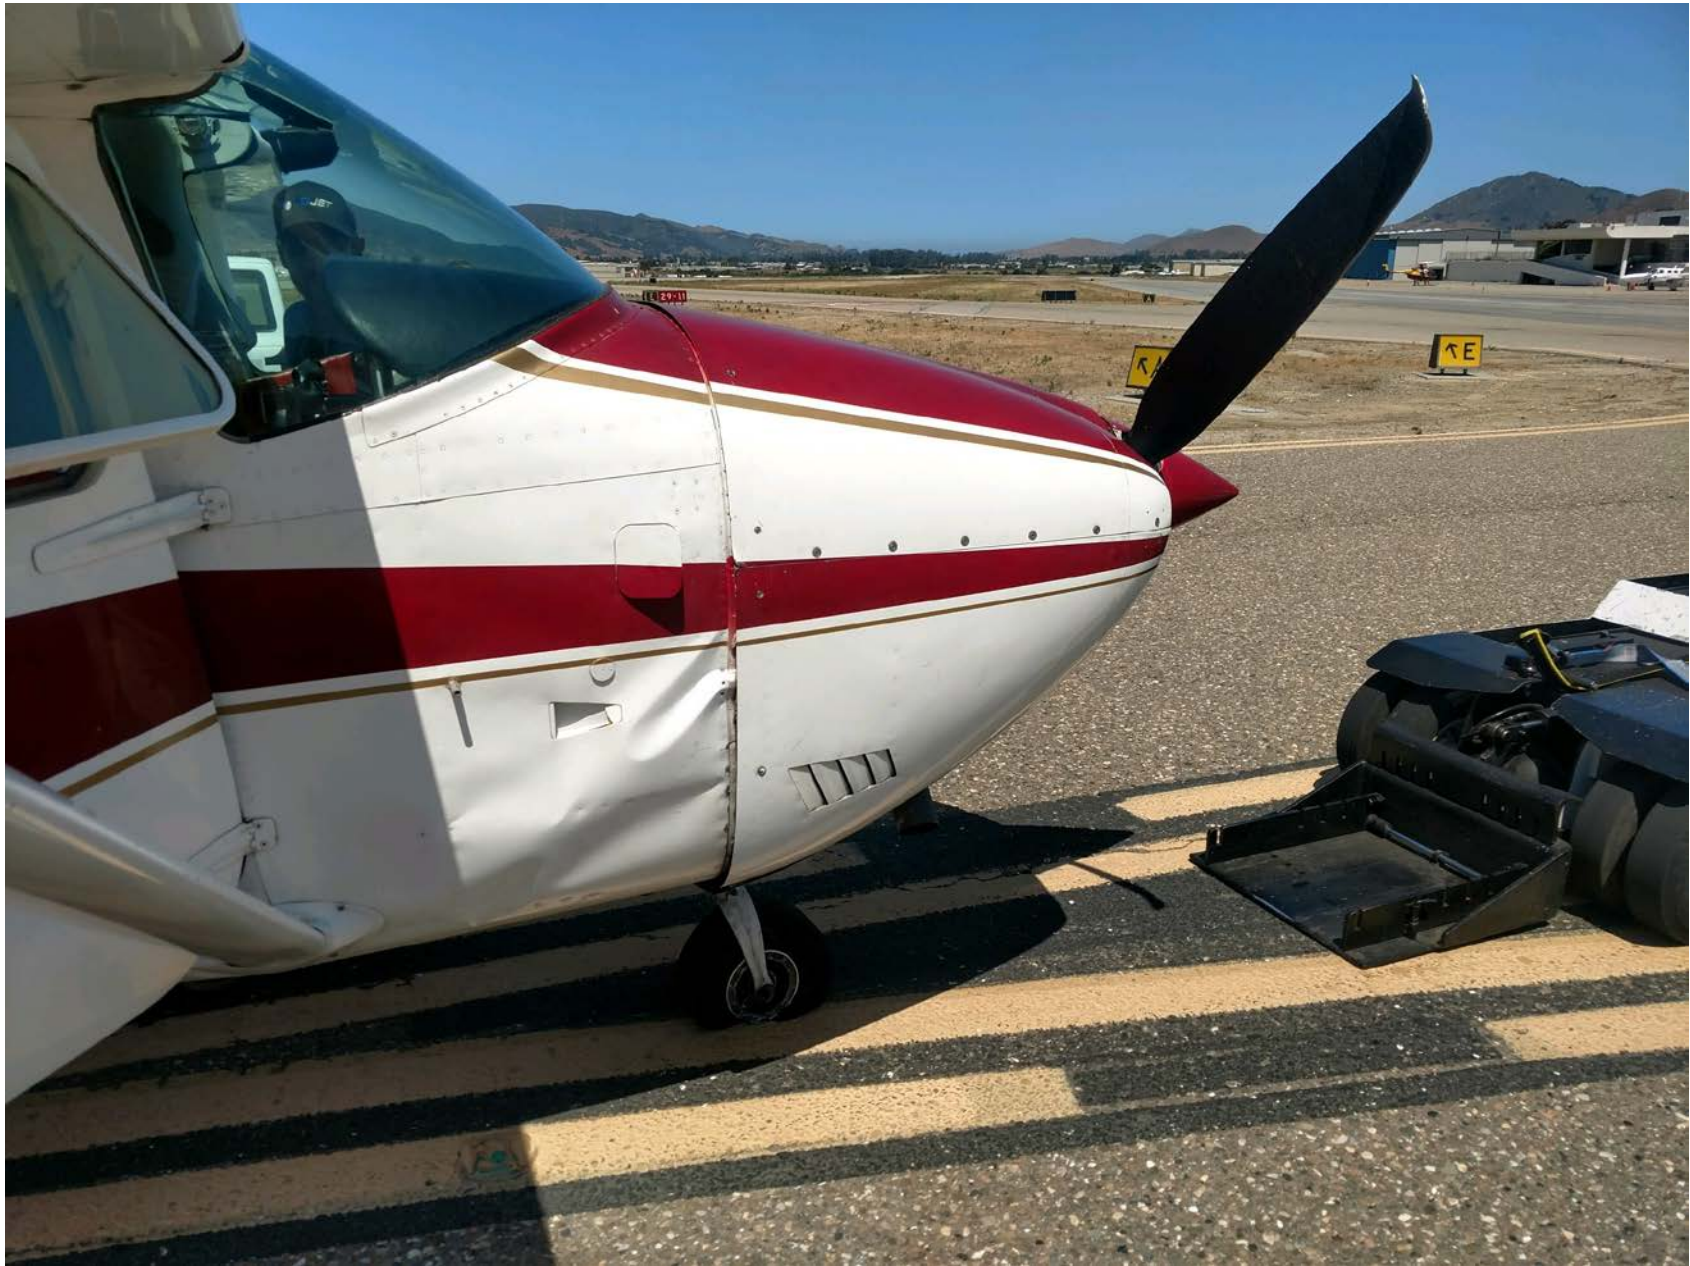
**Photo 2 – View of damage to the lower right fuselage stringers (Courtesy of Operator)**
