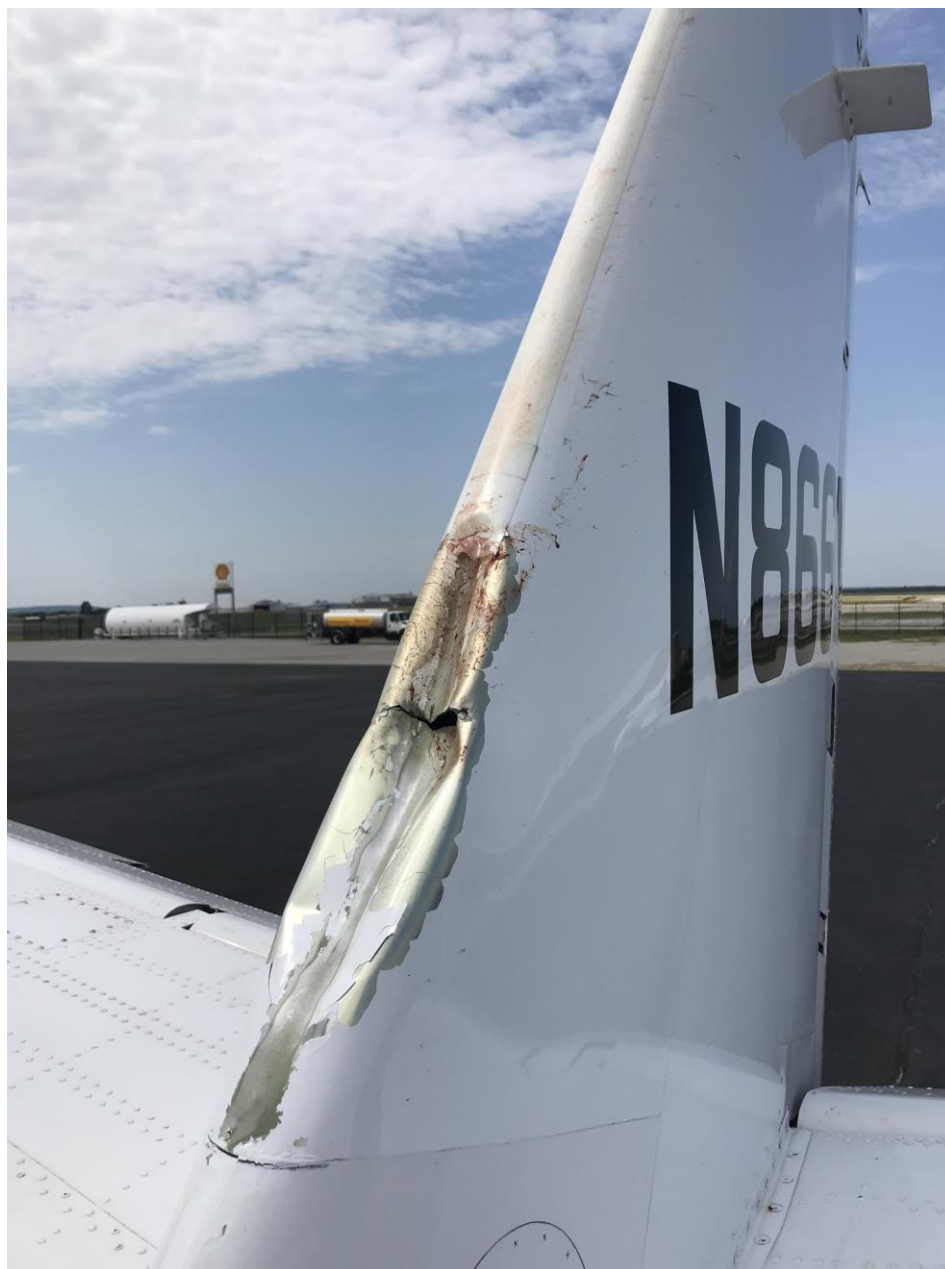
**Photo 1 – View of damaged vertical stabilizer (Photo courtesy of the Operator)**
