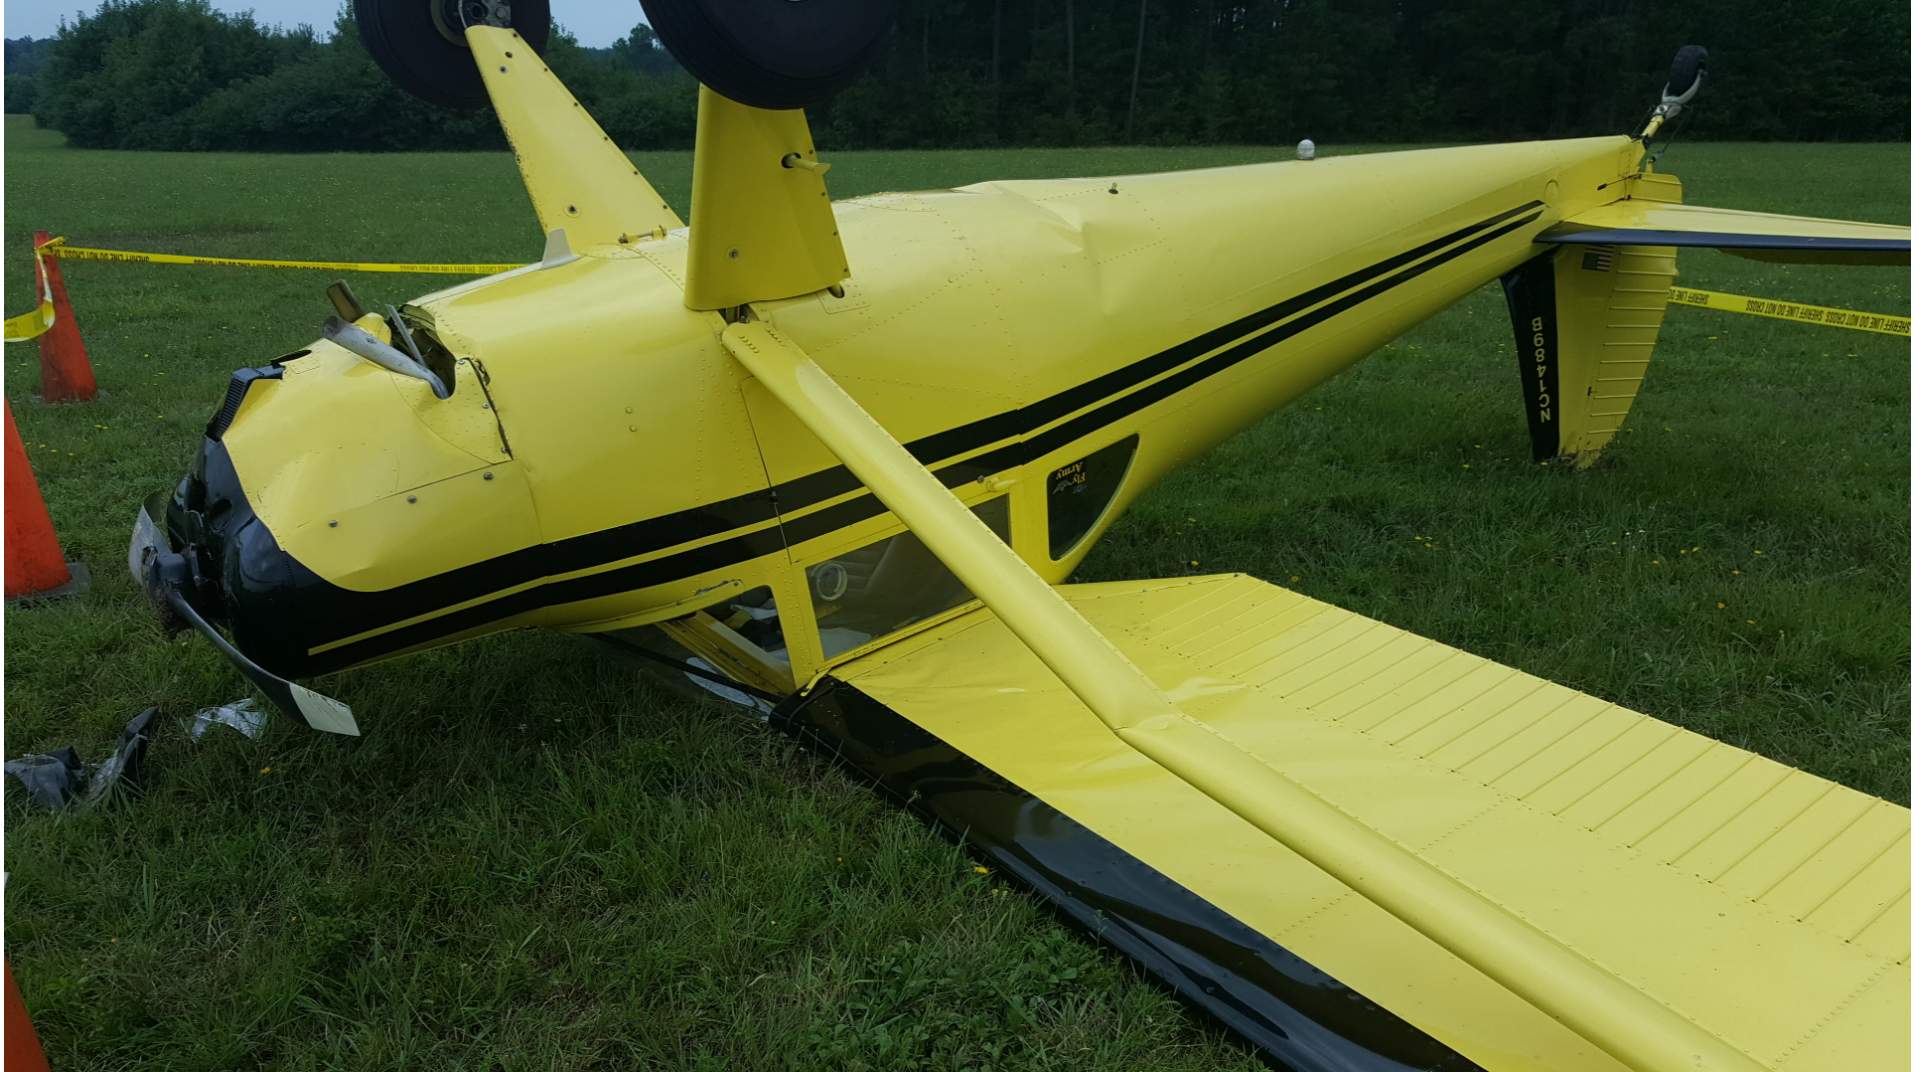
**Photo 1 – View of damaged right wing lift strut, fuselage, and empennage (Photo courtesy of the FAA)**
