**Main reason:** windsock broken providing inaccurate information on the wind direction

**Description of the event:**

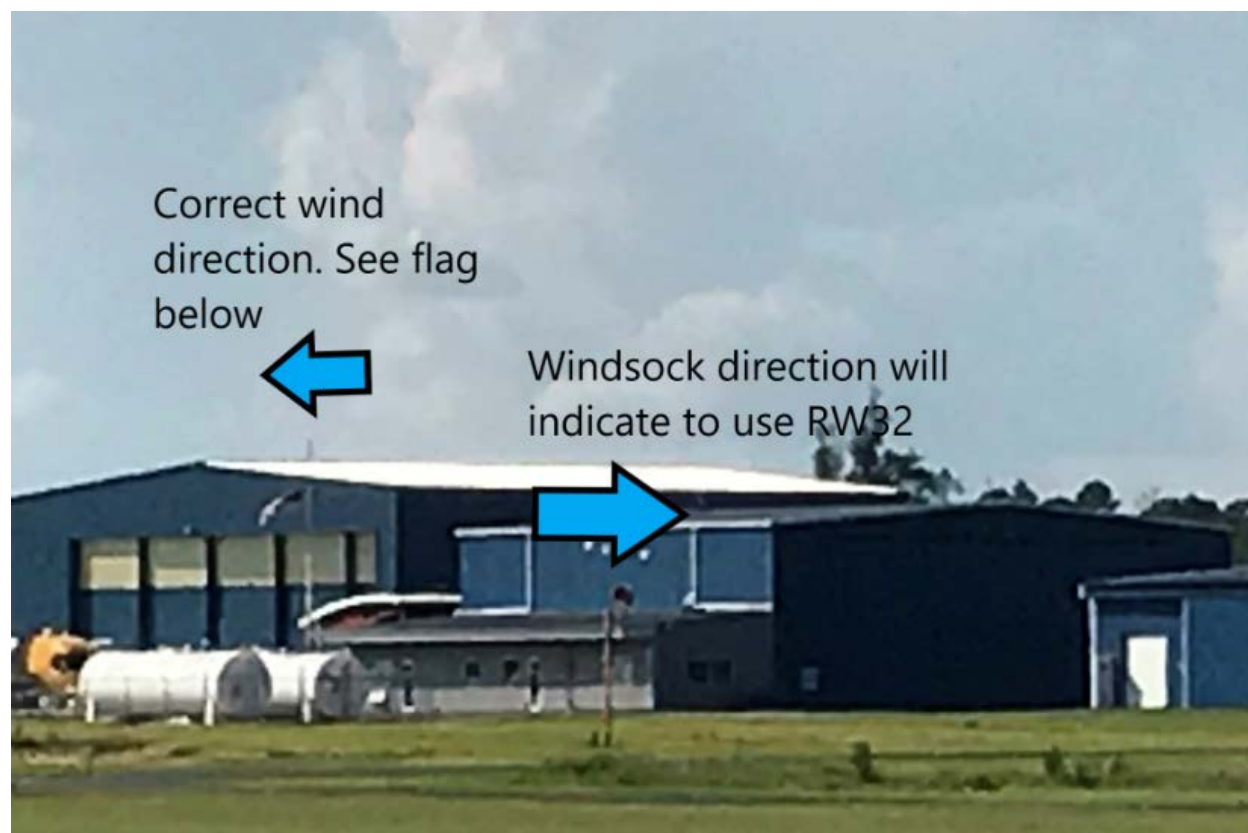
Please find attached pictures of the ripped/broken windsock that confused the direction of the wind

After landing i realized the  
windsock was ripped  
providing inappropriate  
wind information

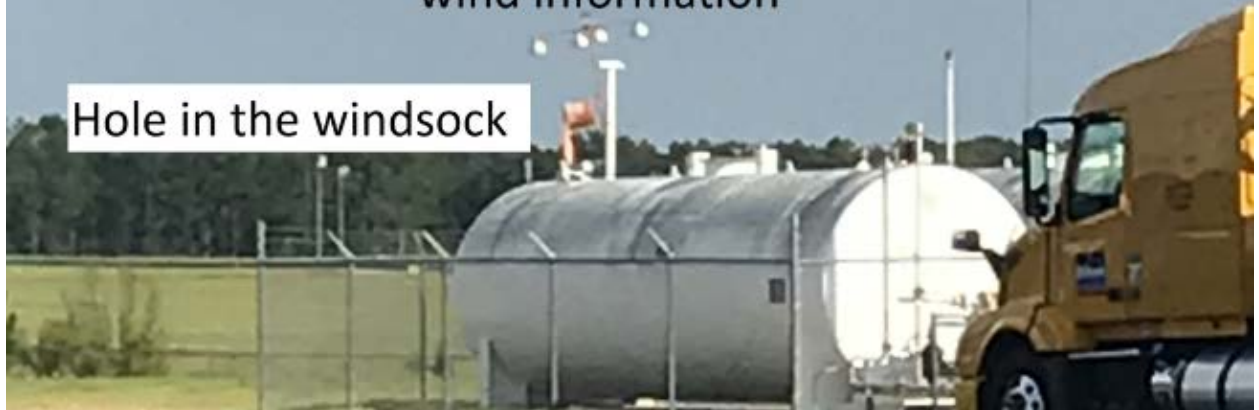
Hole in the windsock
