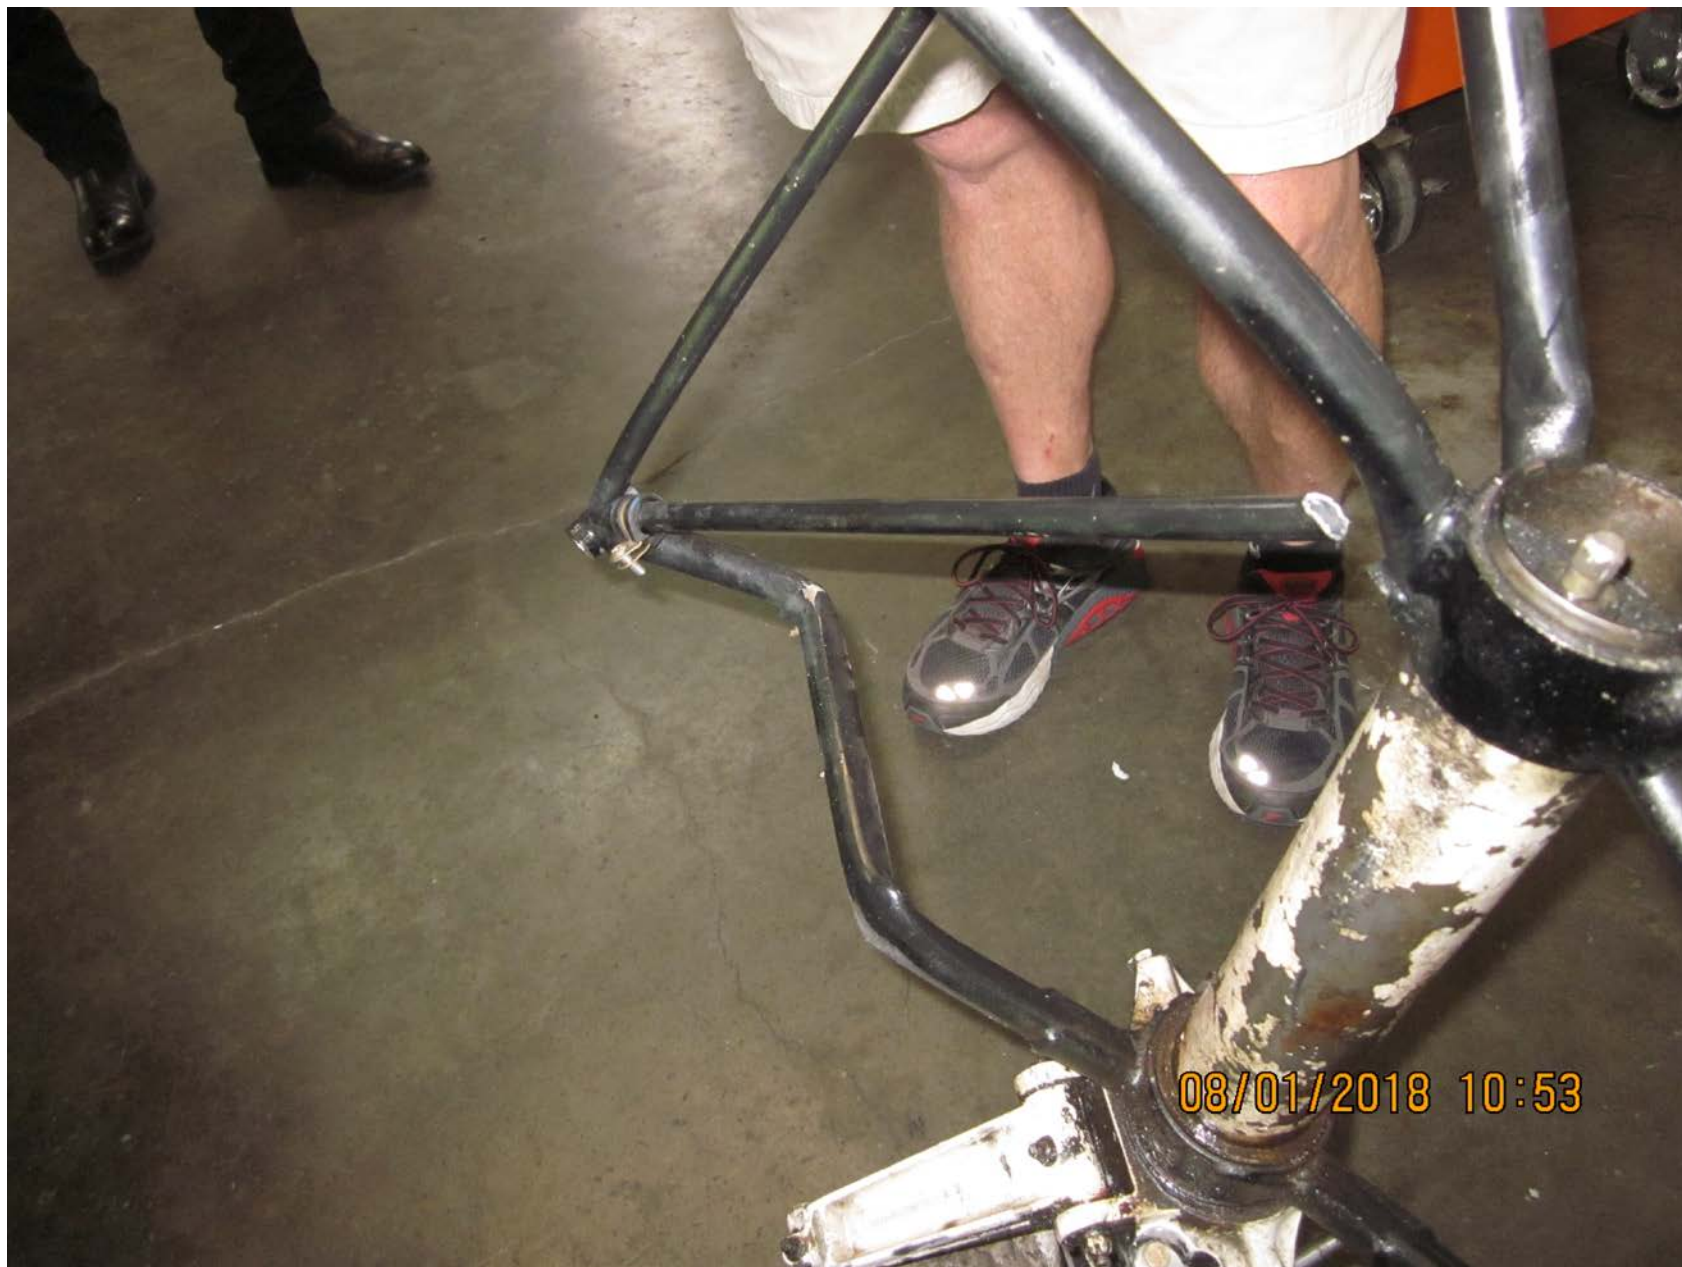
**Photo 1 – View of the damaged engine mounts (Courtesy of FAA)**
