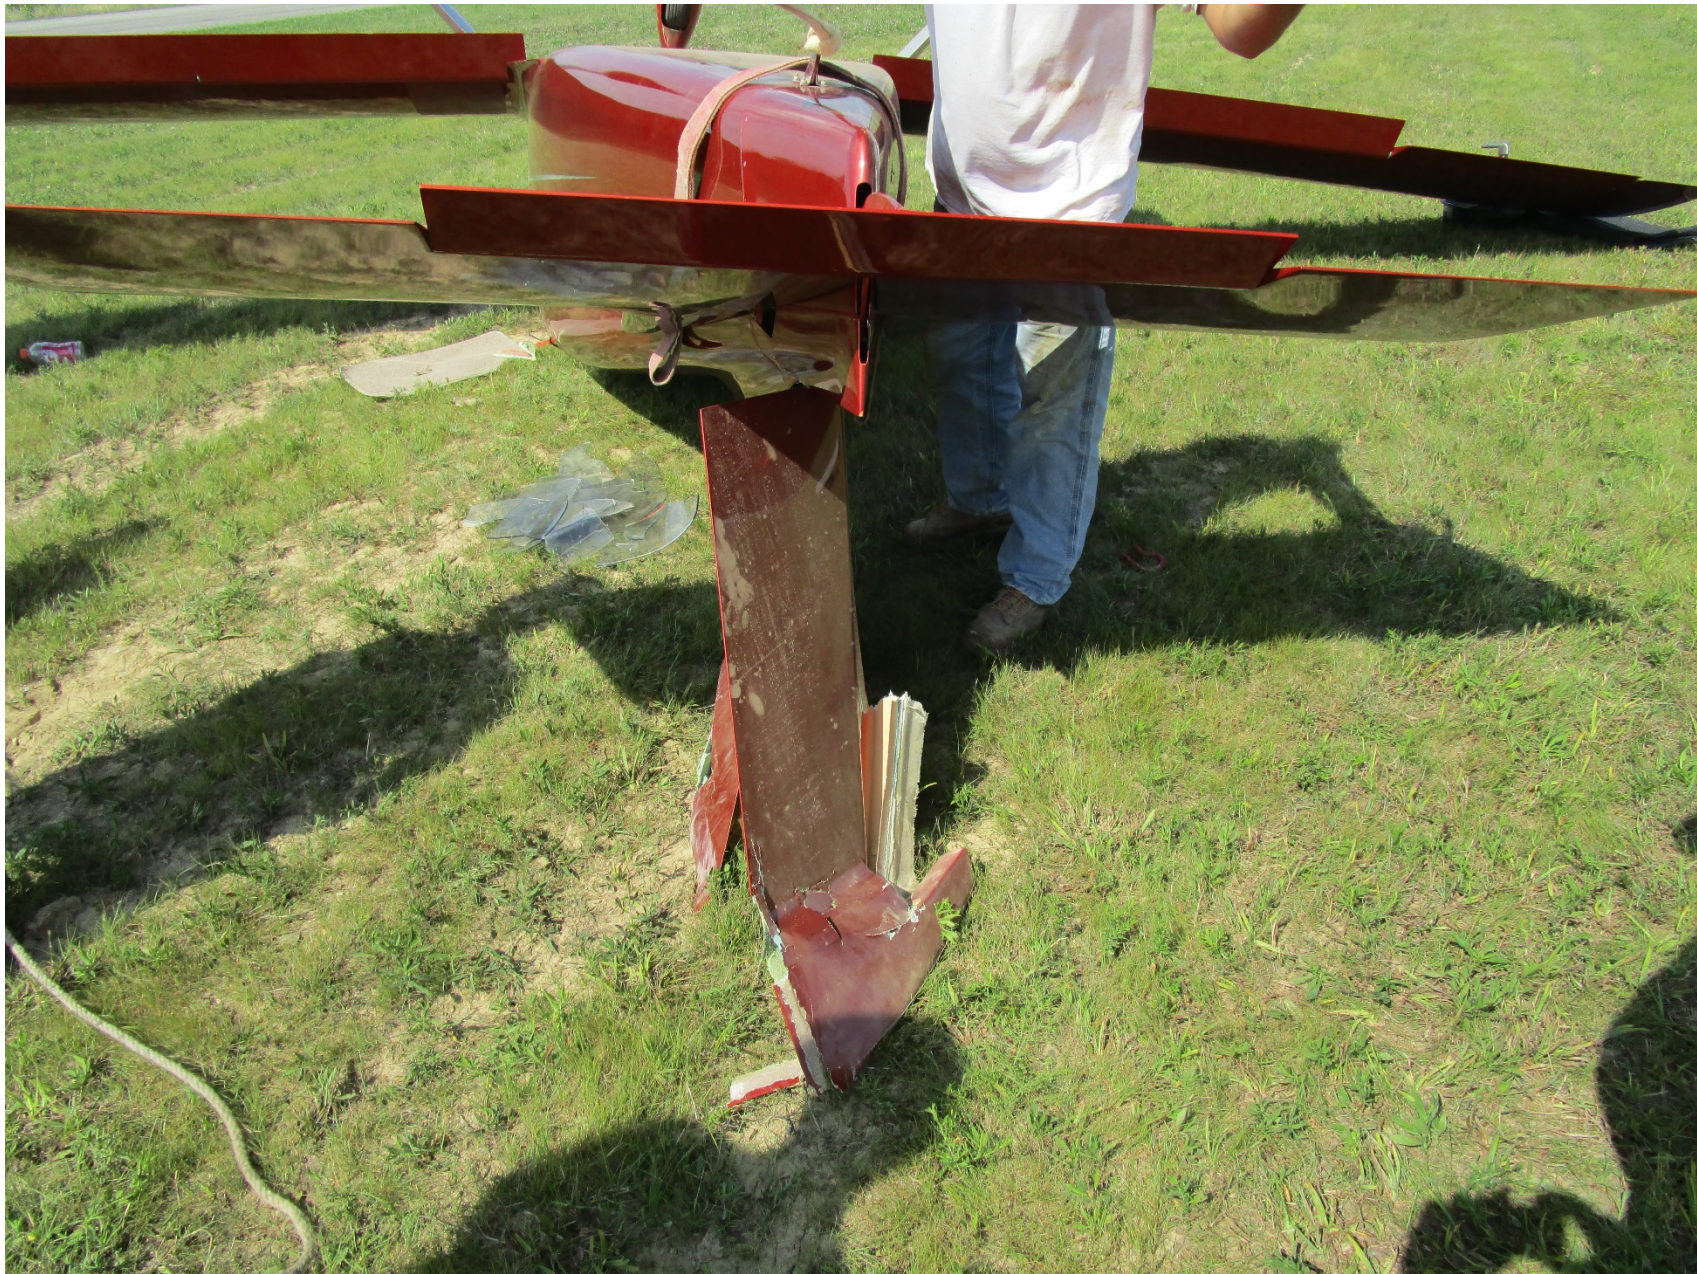
**Photo 1 – View of damaged empennage from rear (Photo courtesy of the FAA)**
