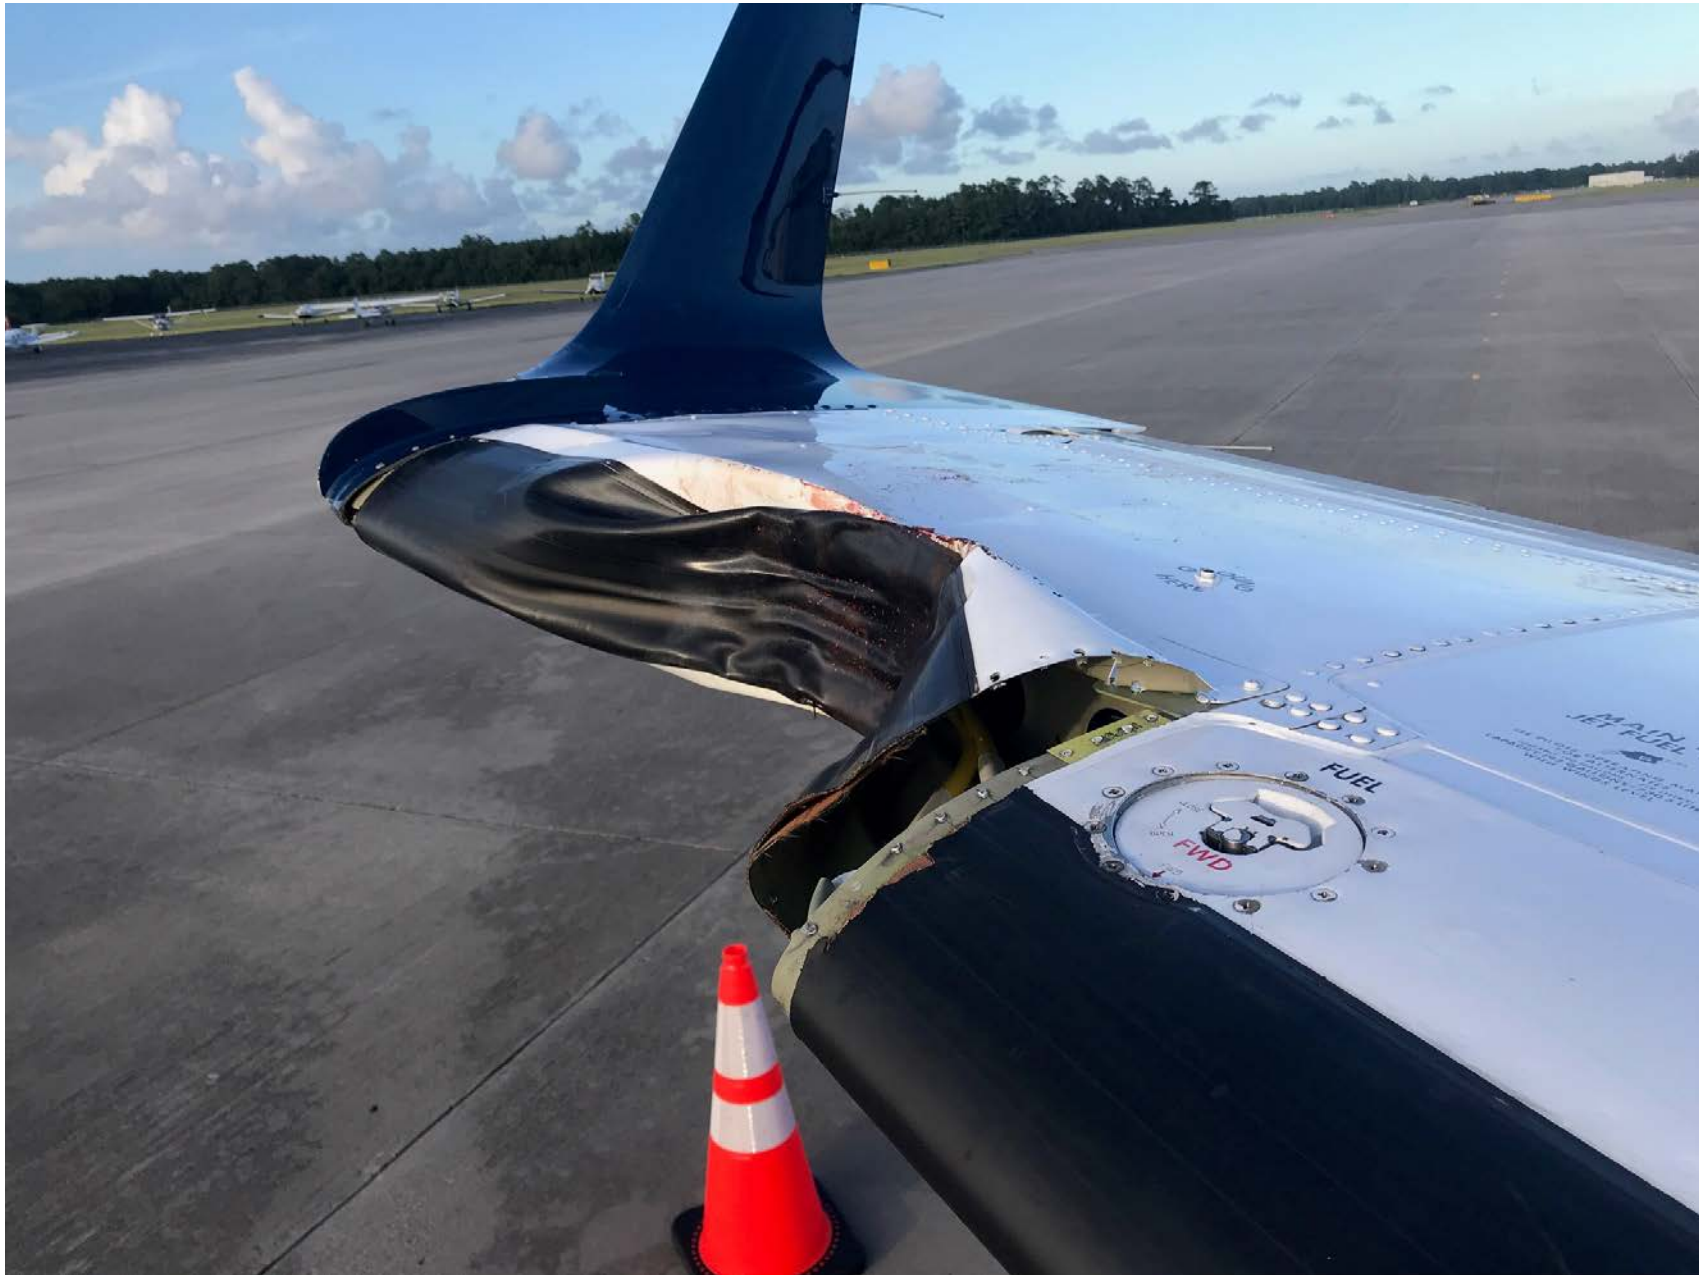
**Photo 1 – View of damaged right wing leading edge (Photo courtesy of the operator)**

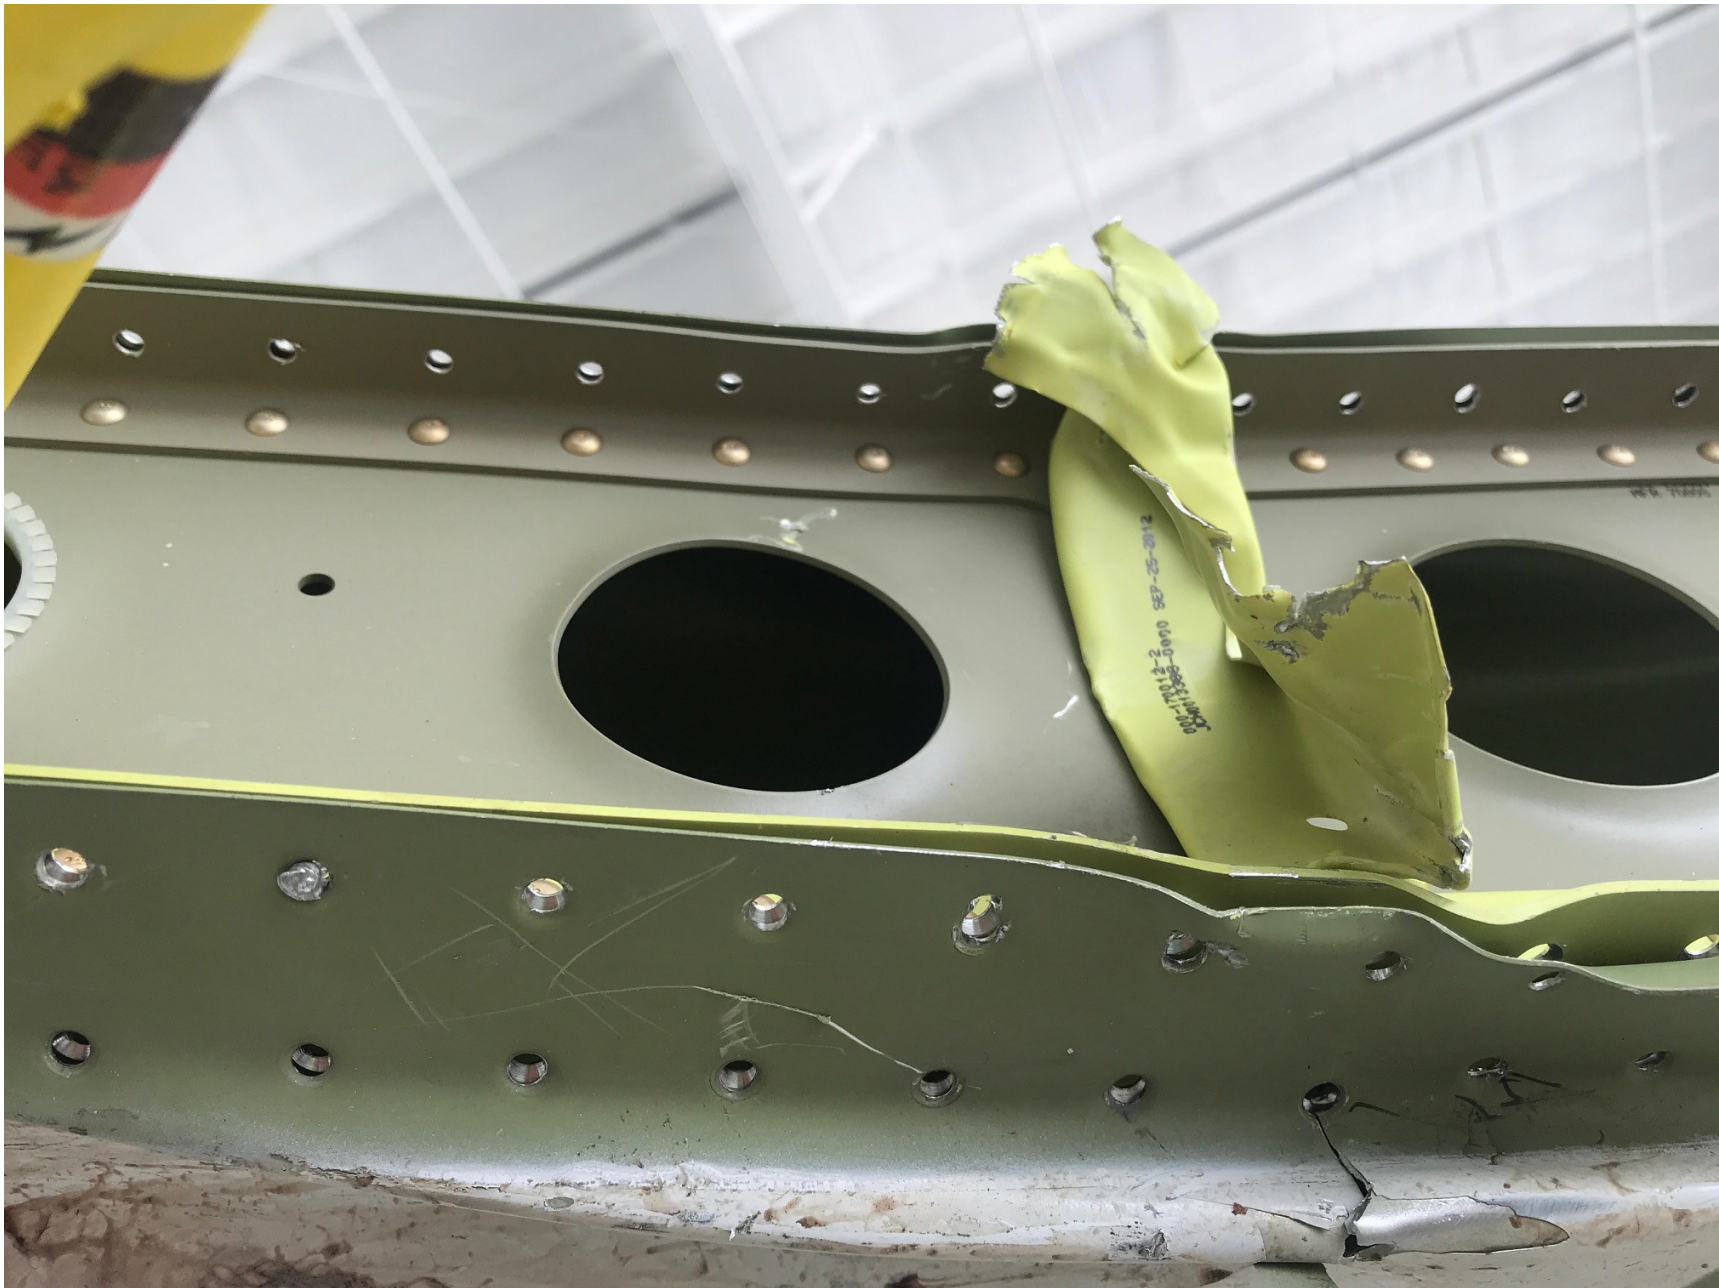
**Photo 2 – View of damaged spar (Photo courtesy of the operator)**
