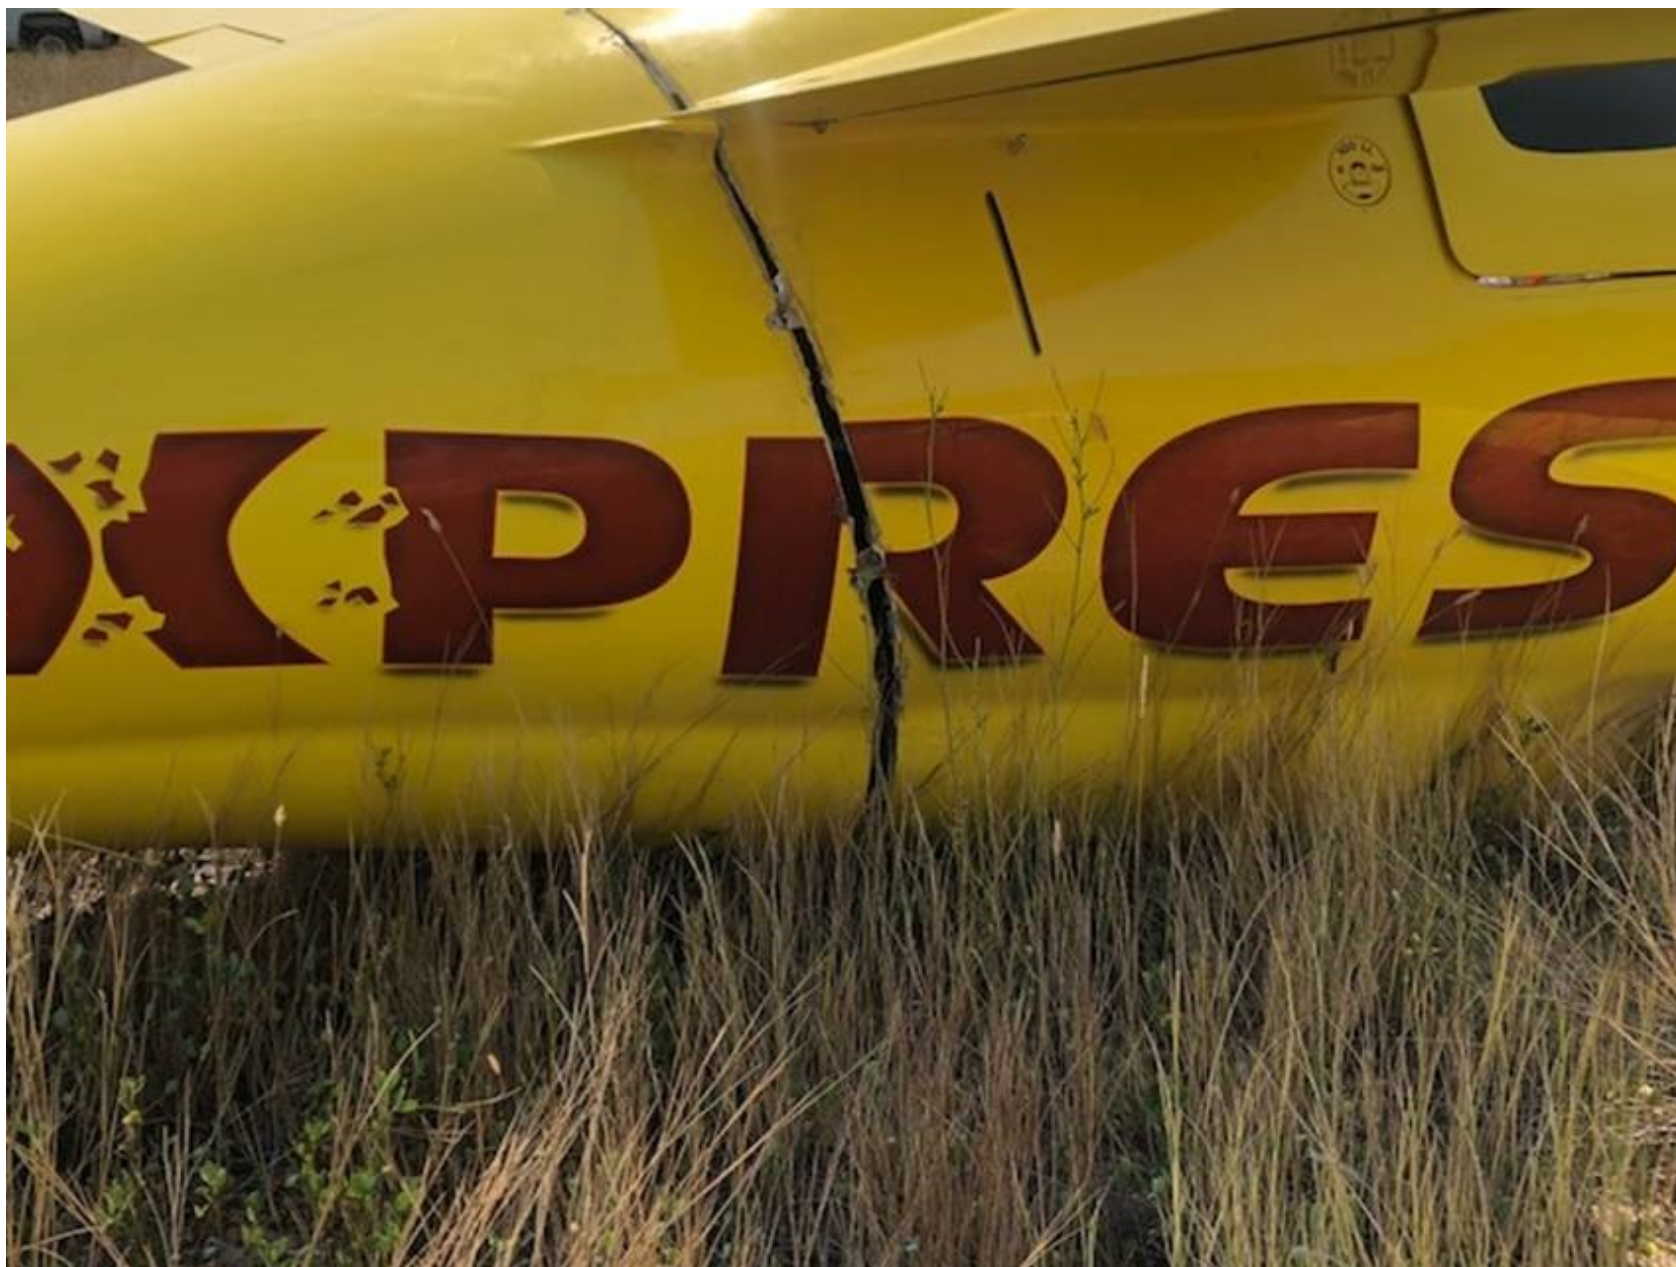
**Photo 1 – View of damaged tail cone (courtesy of the FAA)**
