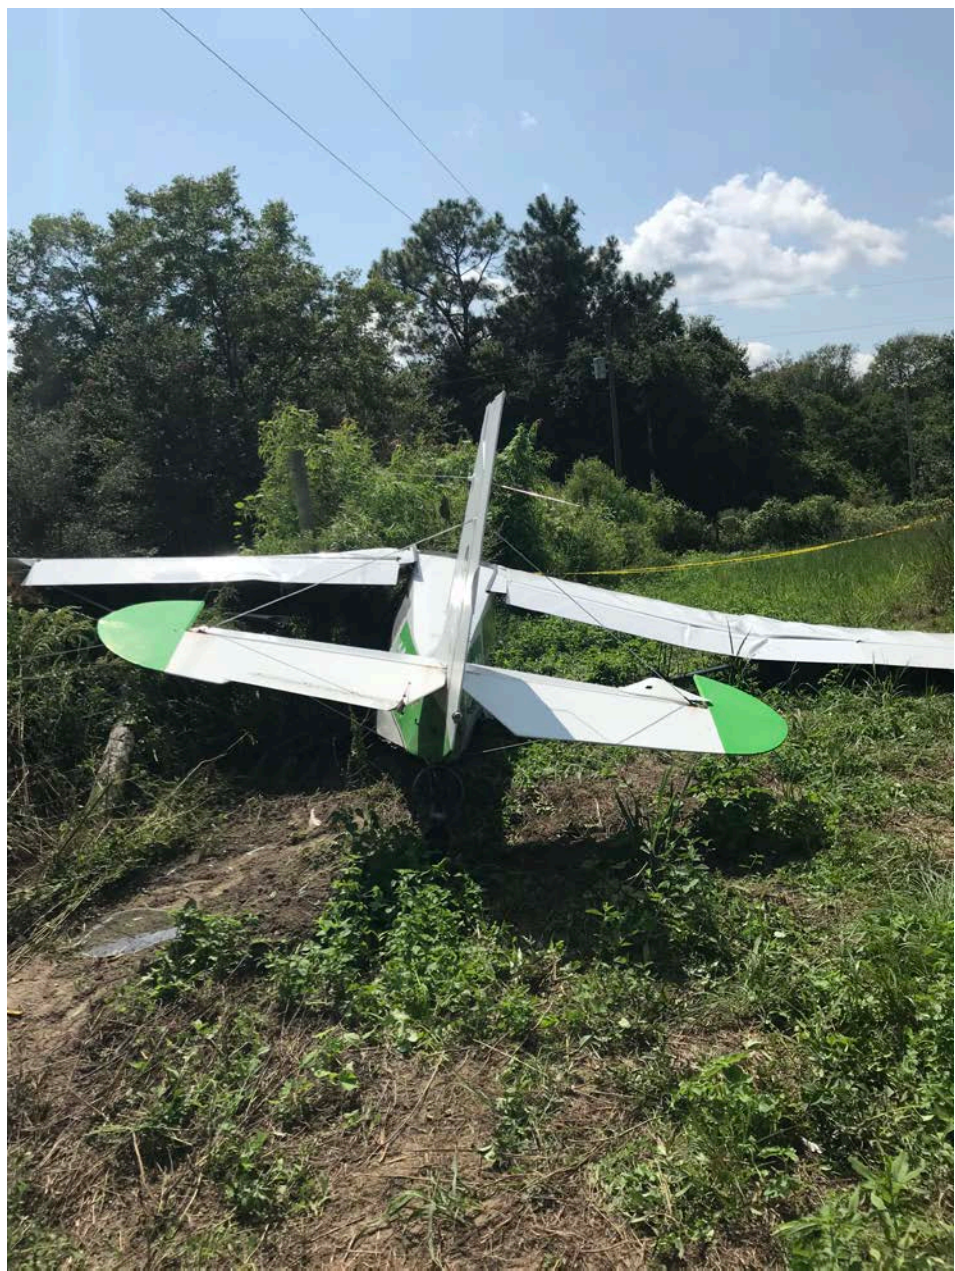
**Photo 1 – View of damage to both wings (Courtesy of FAA)**

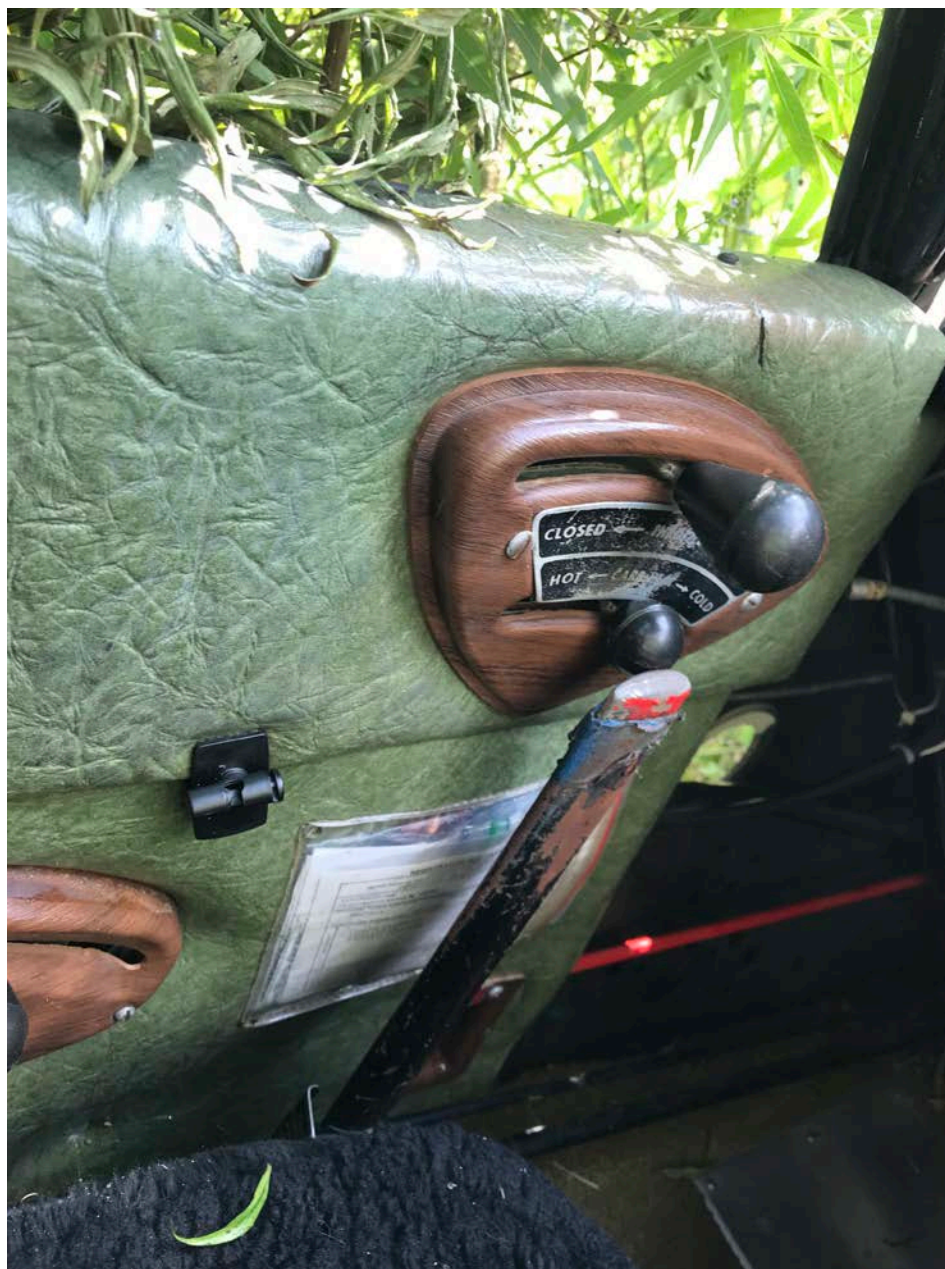
**Photo 2 – View of carburetor heat position indicator (Courtesy of FAA)**
