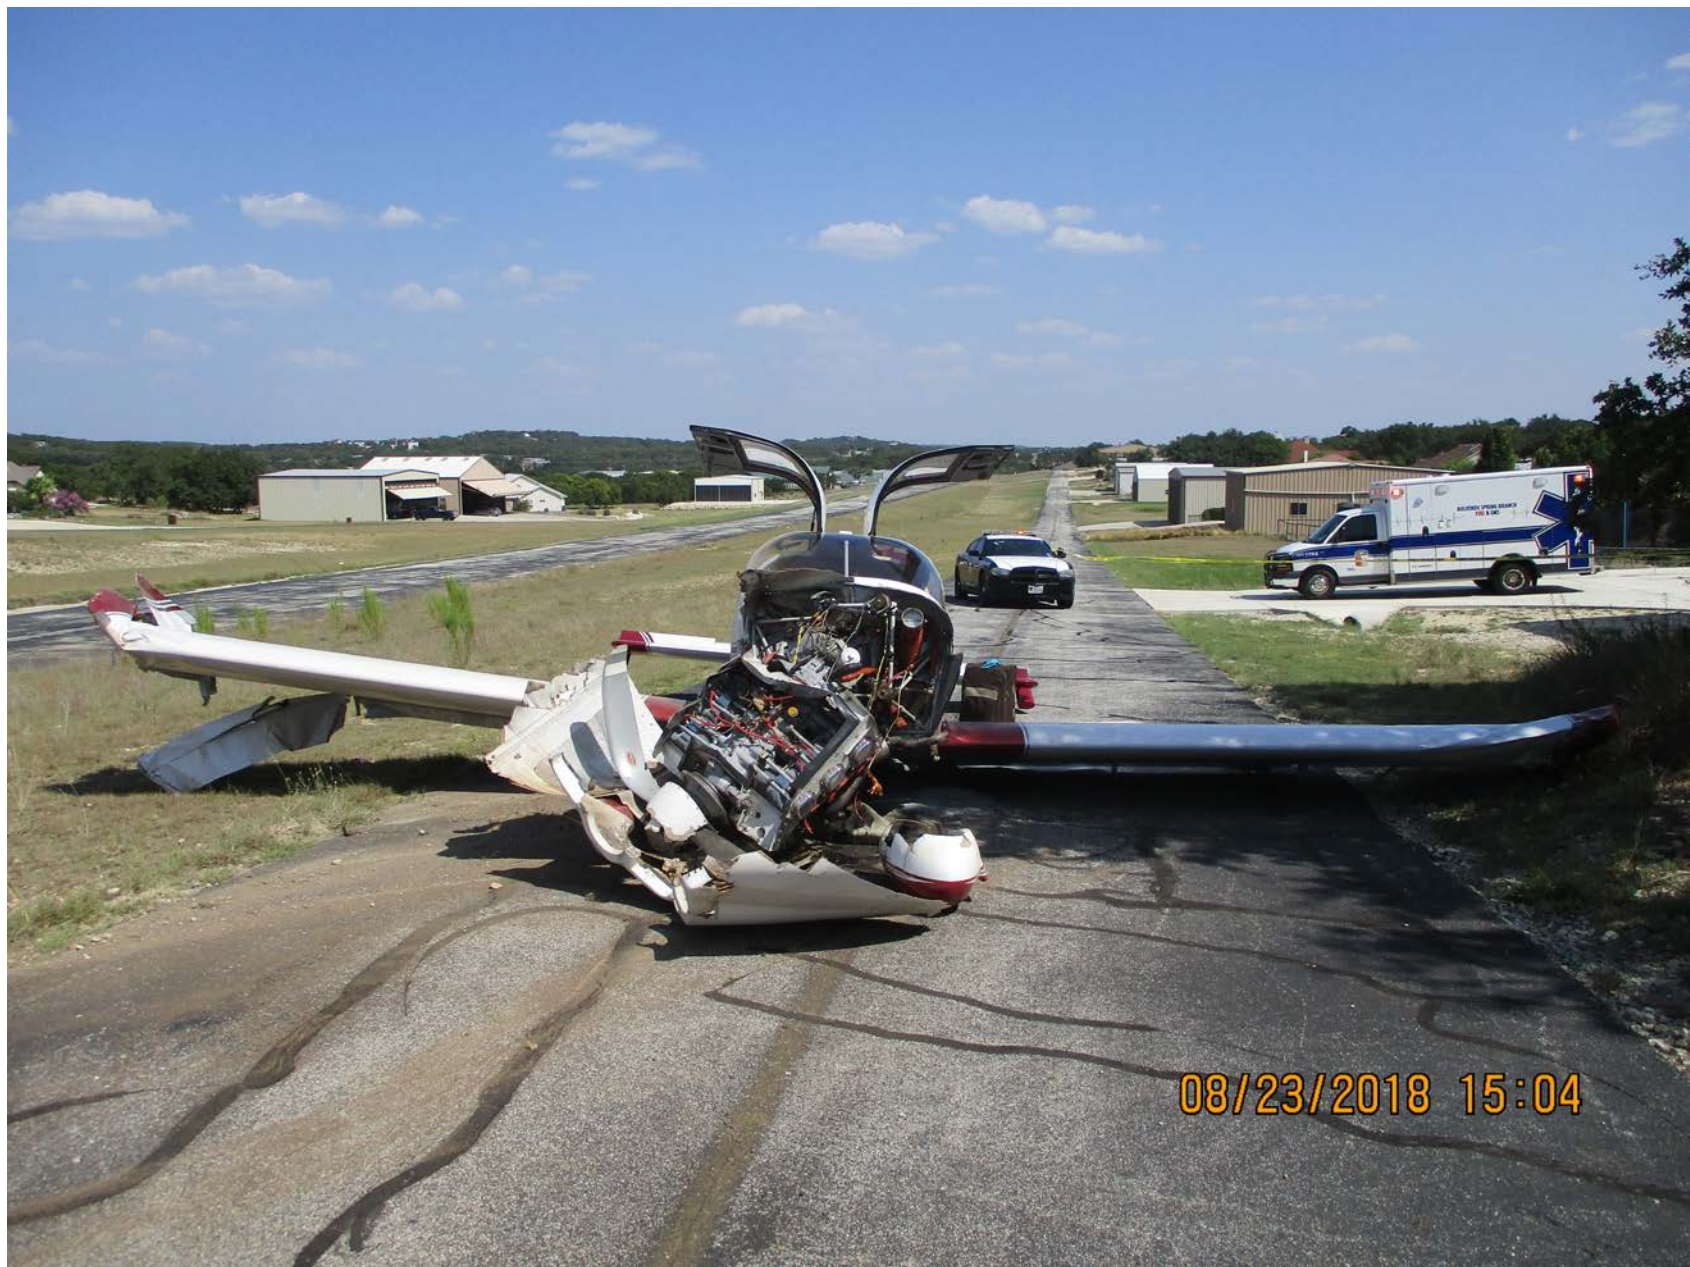
**Photo 1 – View of damage to both wings, the right aileron, and the engine mounts (Courtesy of FAA)**
