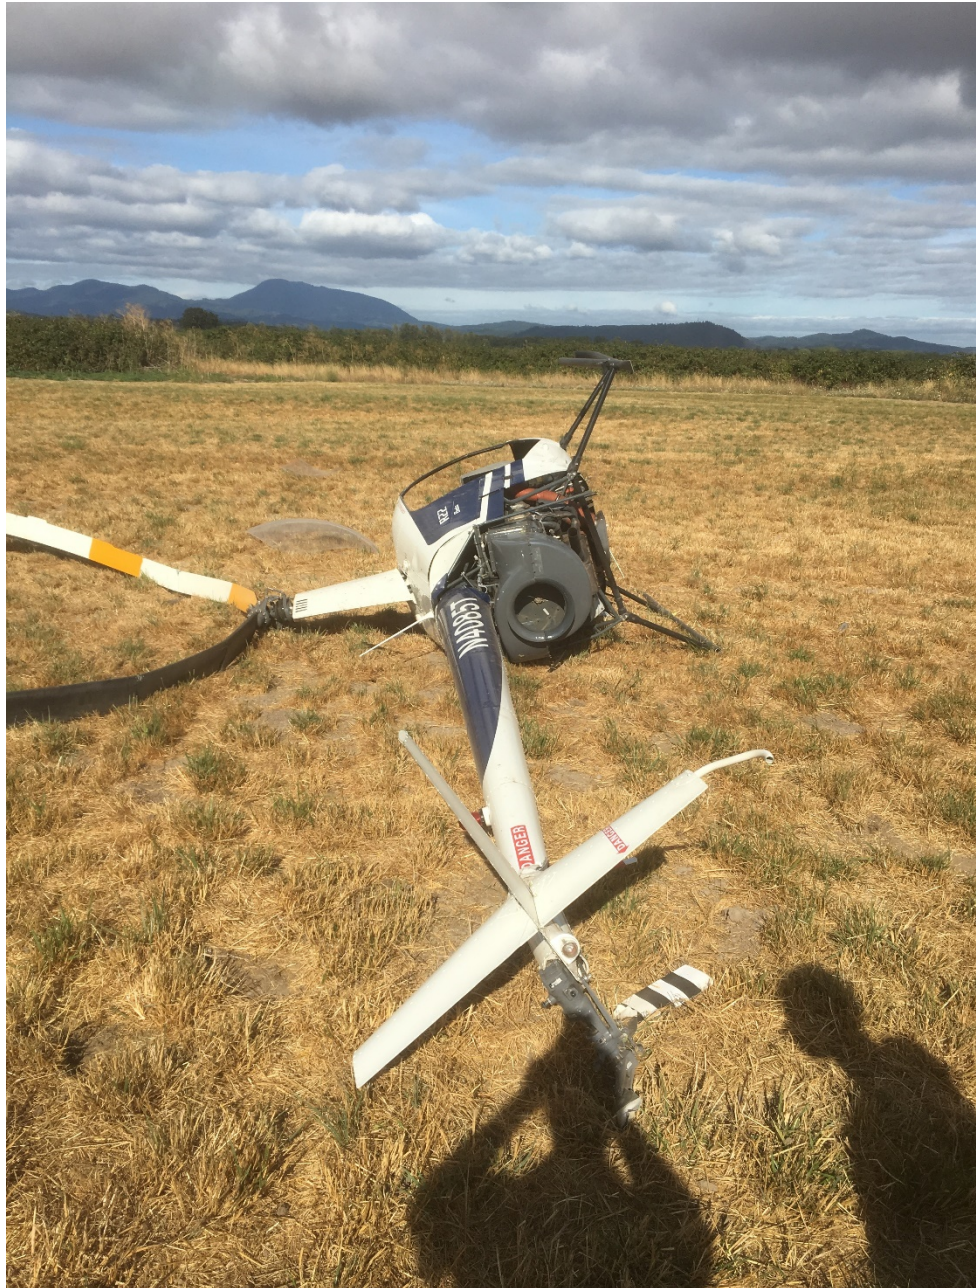
**Photo 1 – View of damaged windshield (Photo courtesy of the owner)**
