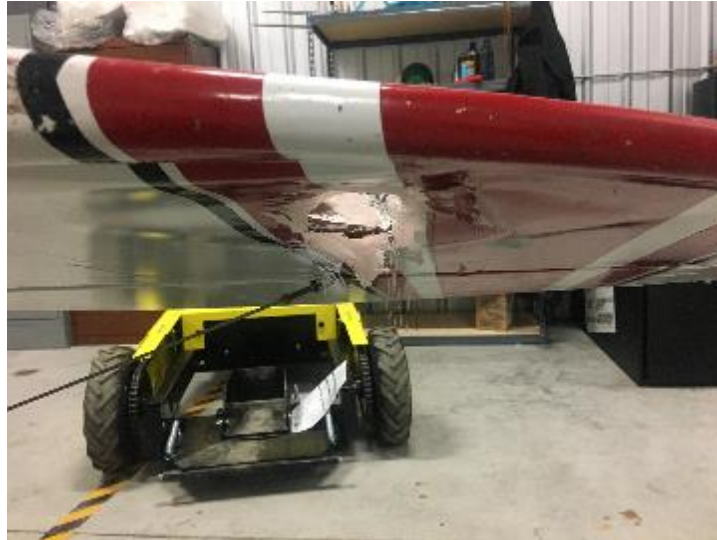
**Photo 1 – View of hole in left horizontal stabilizer (Photo courtesy of the Department of Interior)**

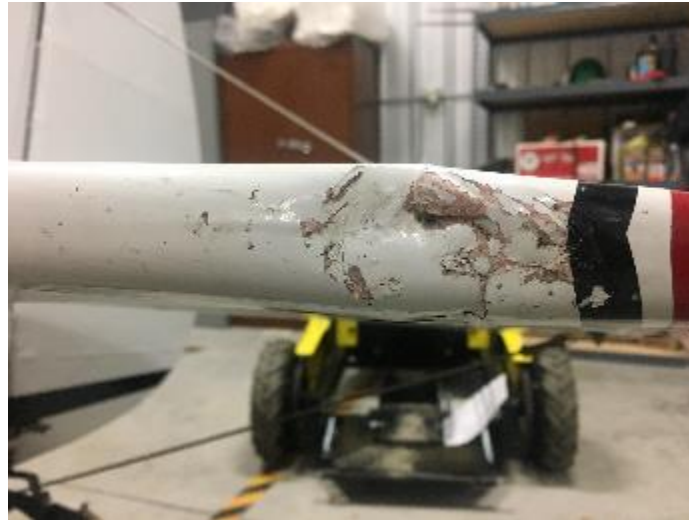
**Photo 2 – View of damaged left horizontal stabilizer tube (Photo courtesy of the Department of Interior)**
