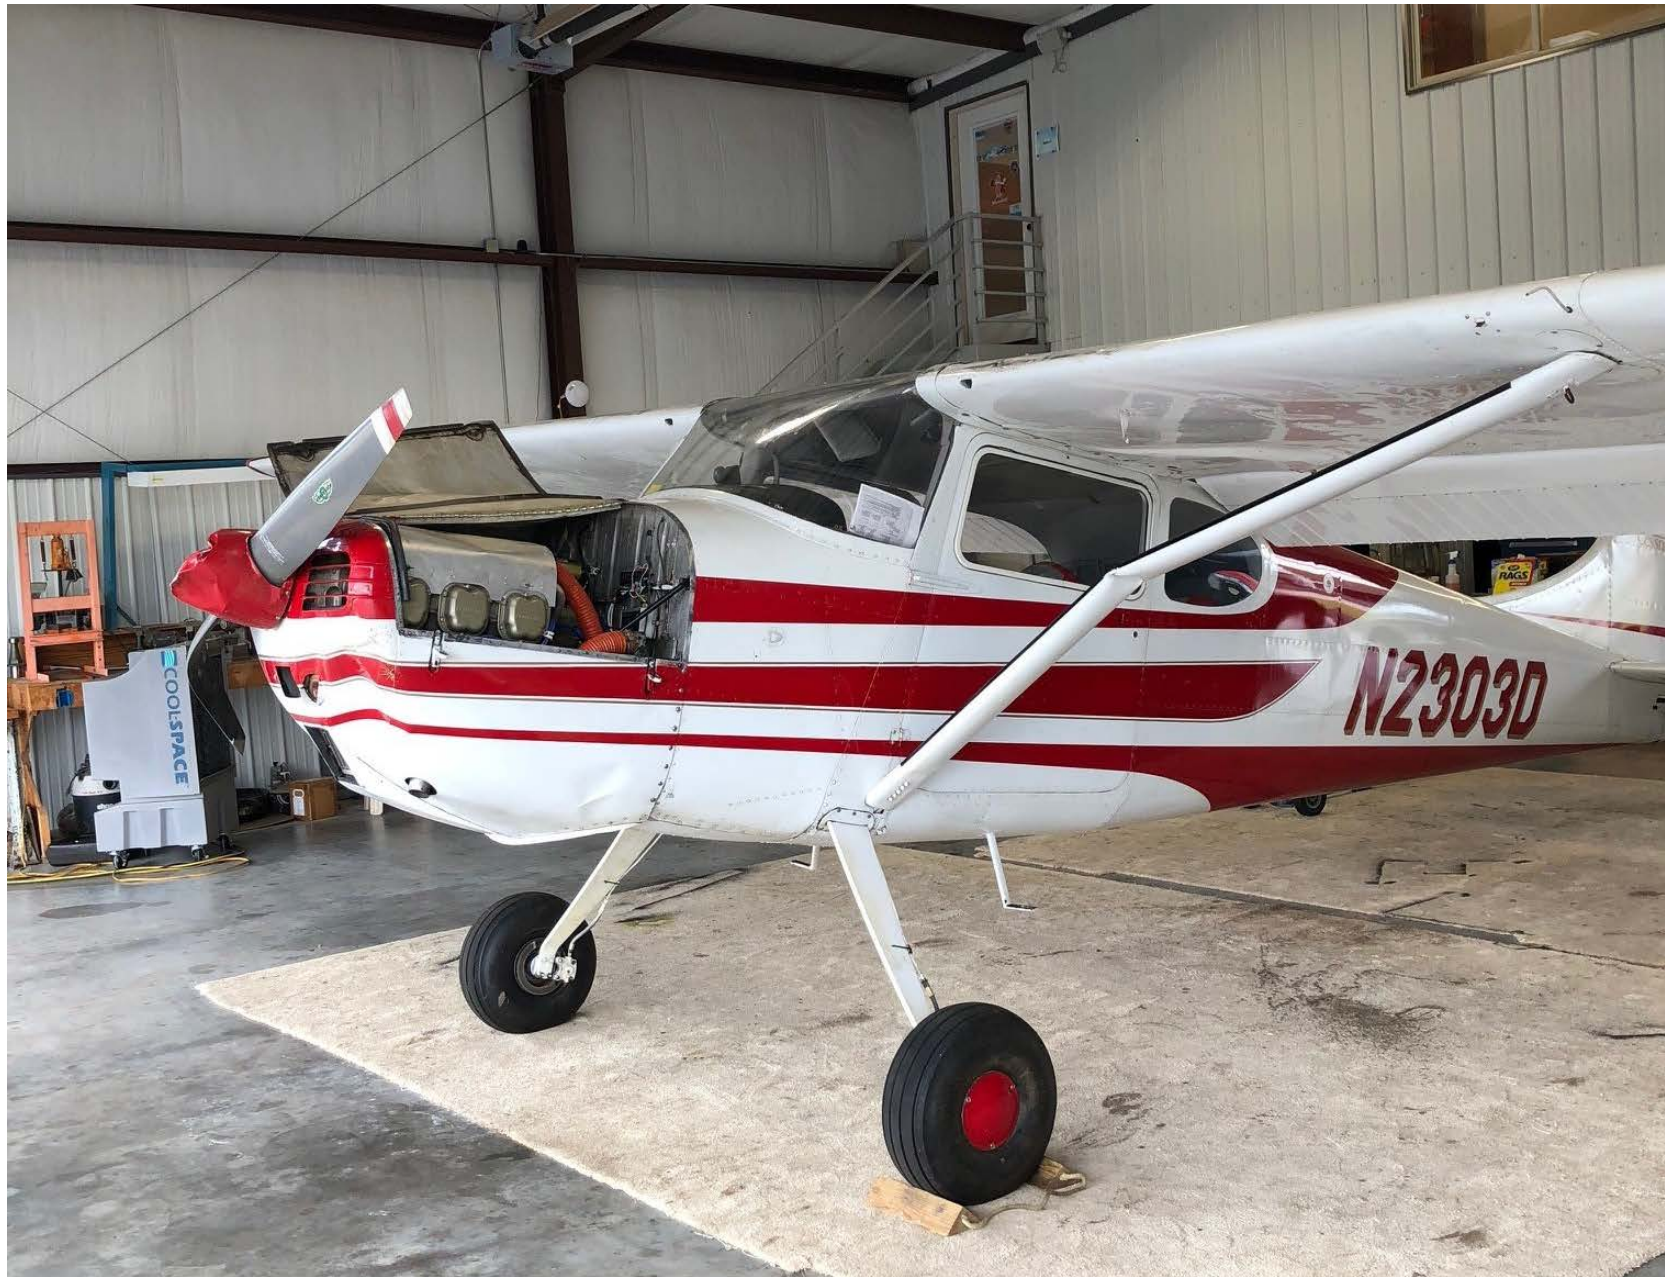
**Photo 1 – View of damaged left wing lift strut (Photo courtesy of the FAA)**

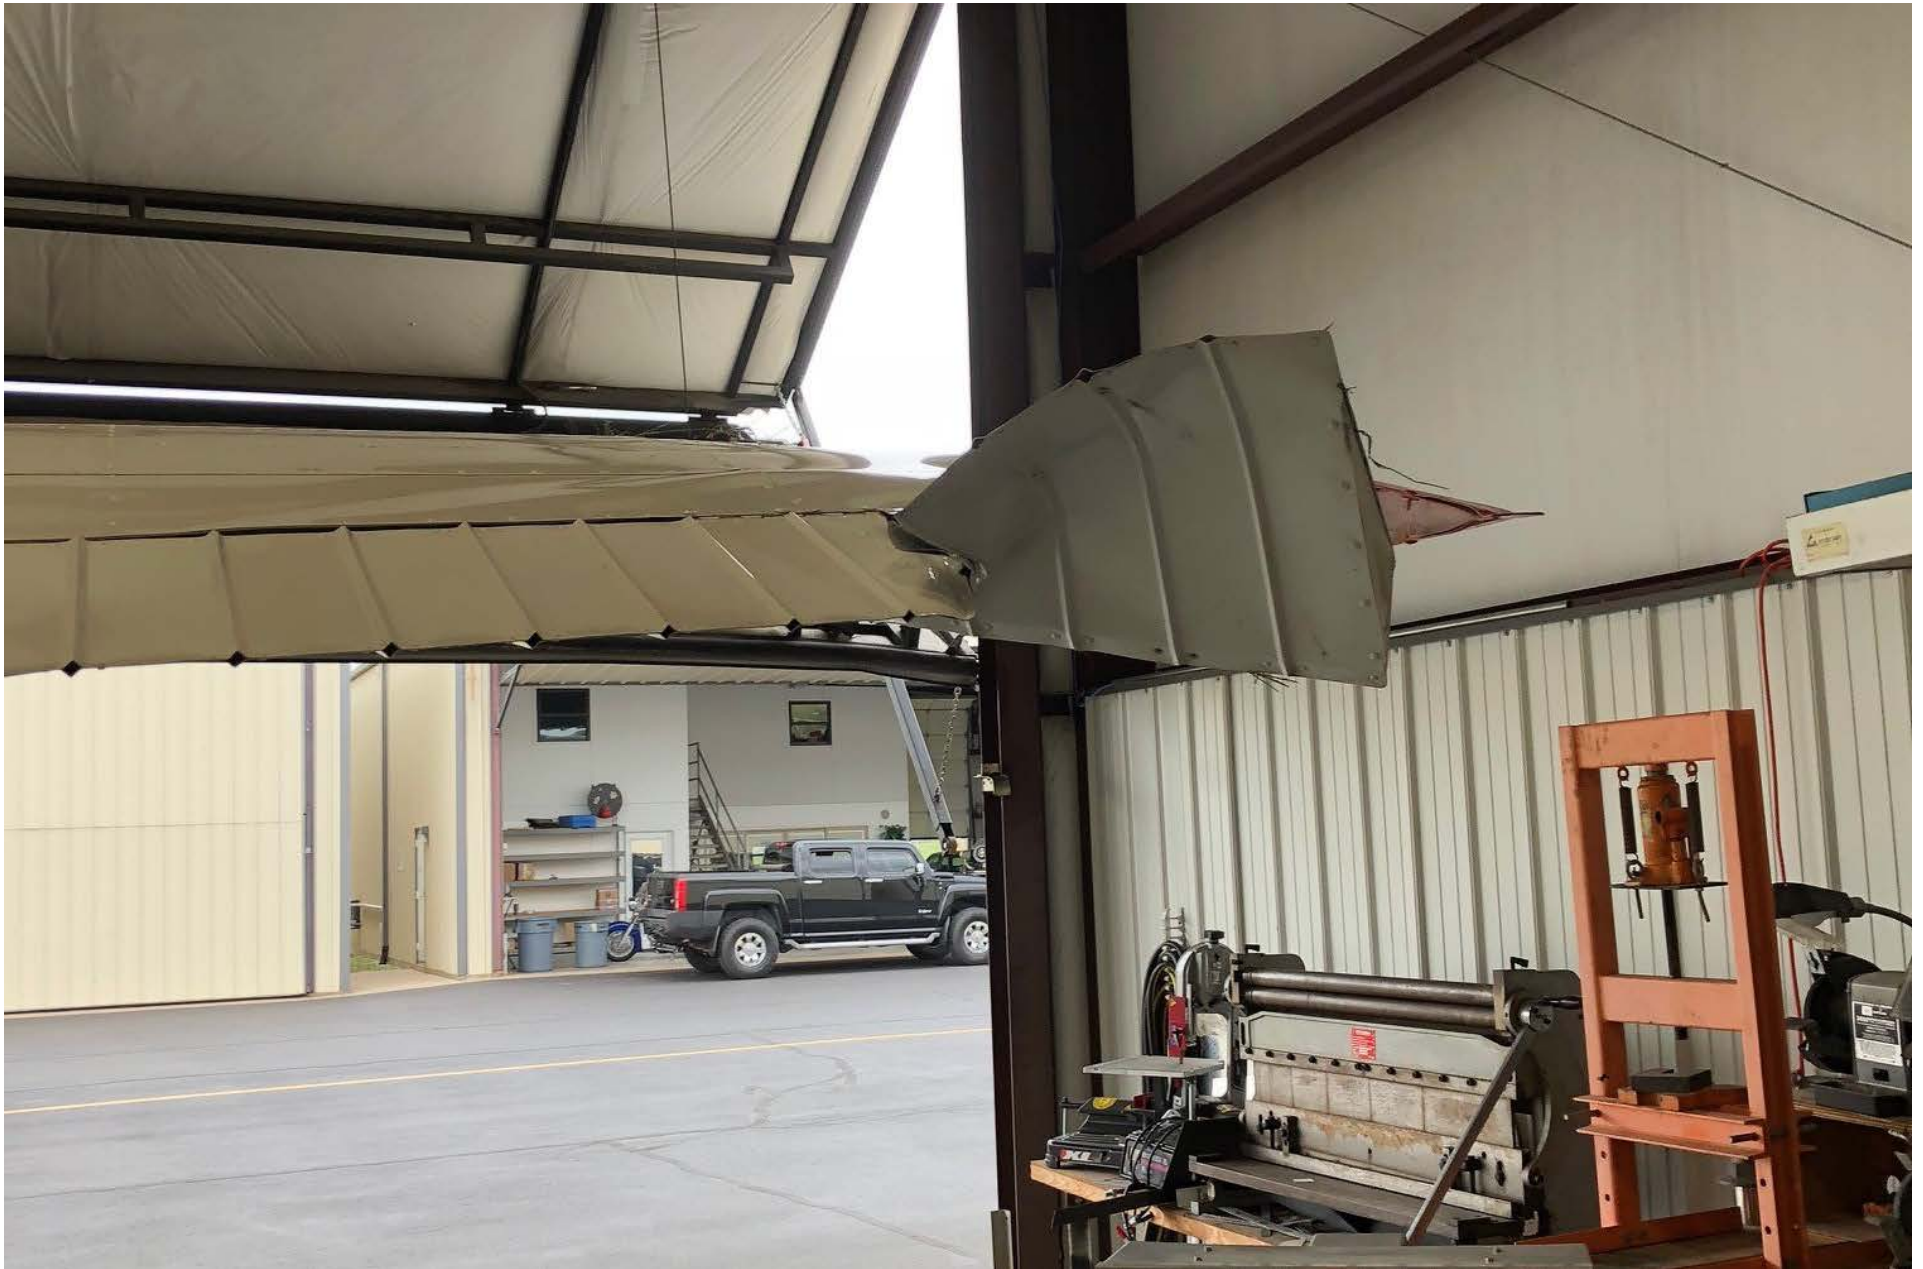
**Photo 2 – View of damaged right aileron (Photo courtesy of the FAA)**
