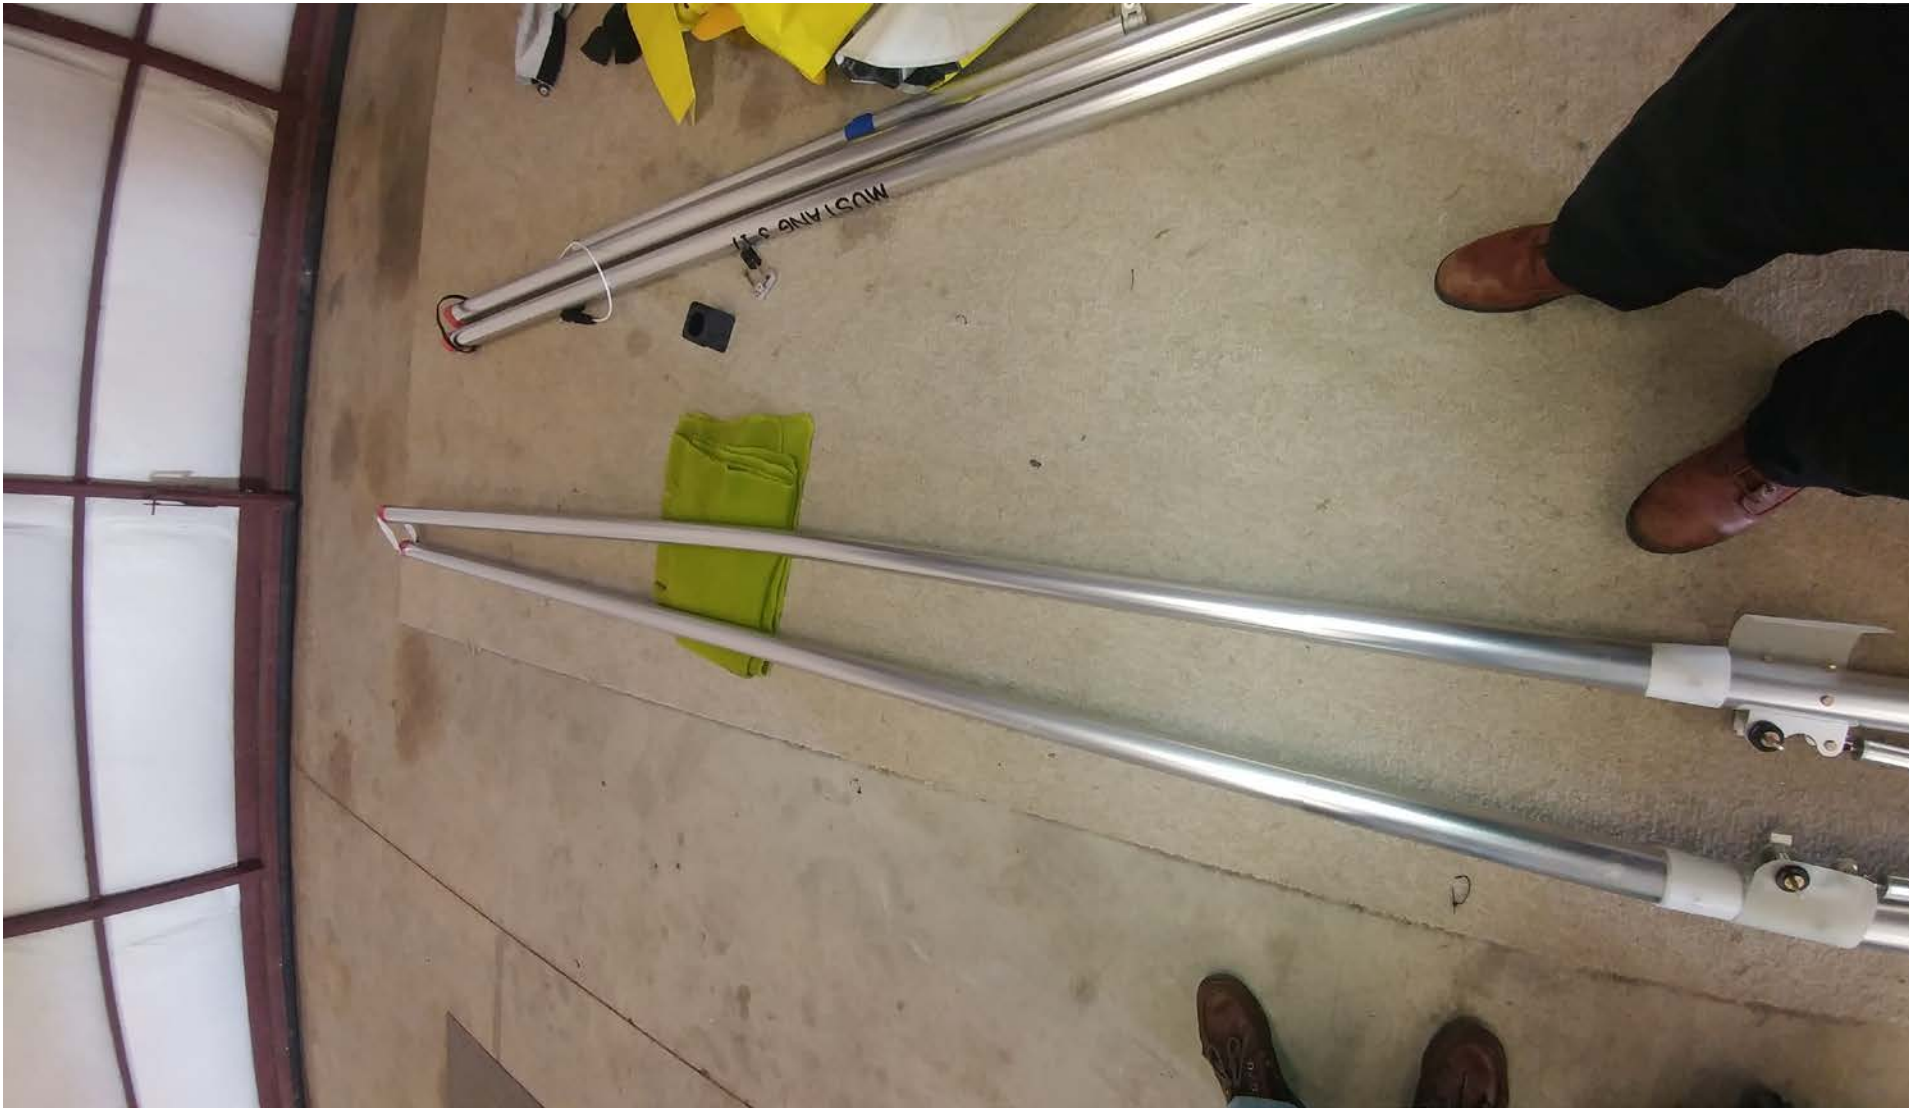
**Photo 1 – View of damage to the left wing tube that was removed from the airframe (Courtesy of Operator)**
