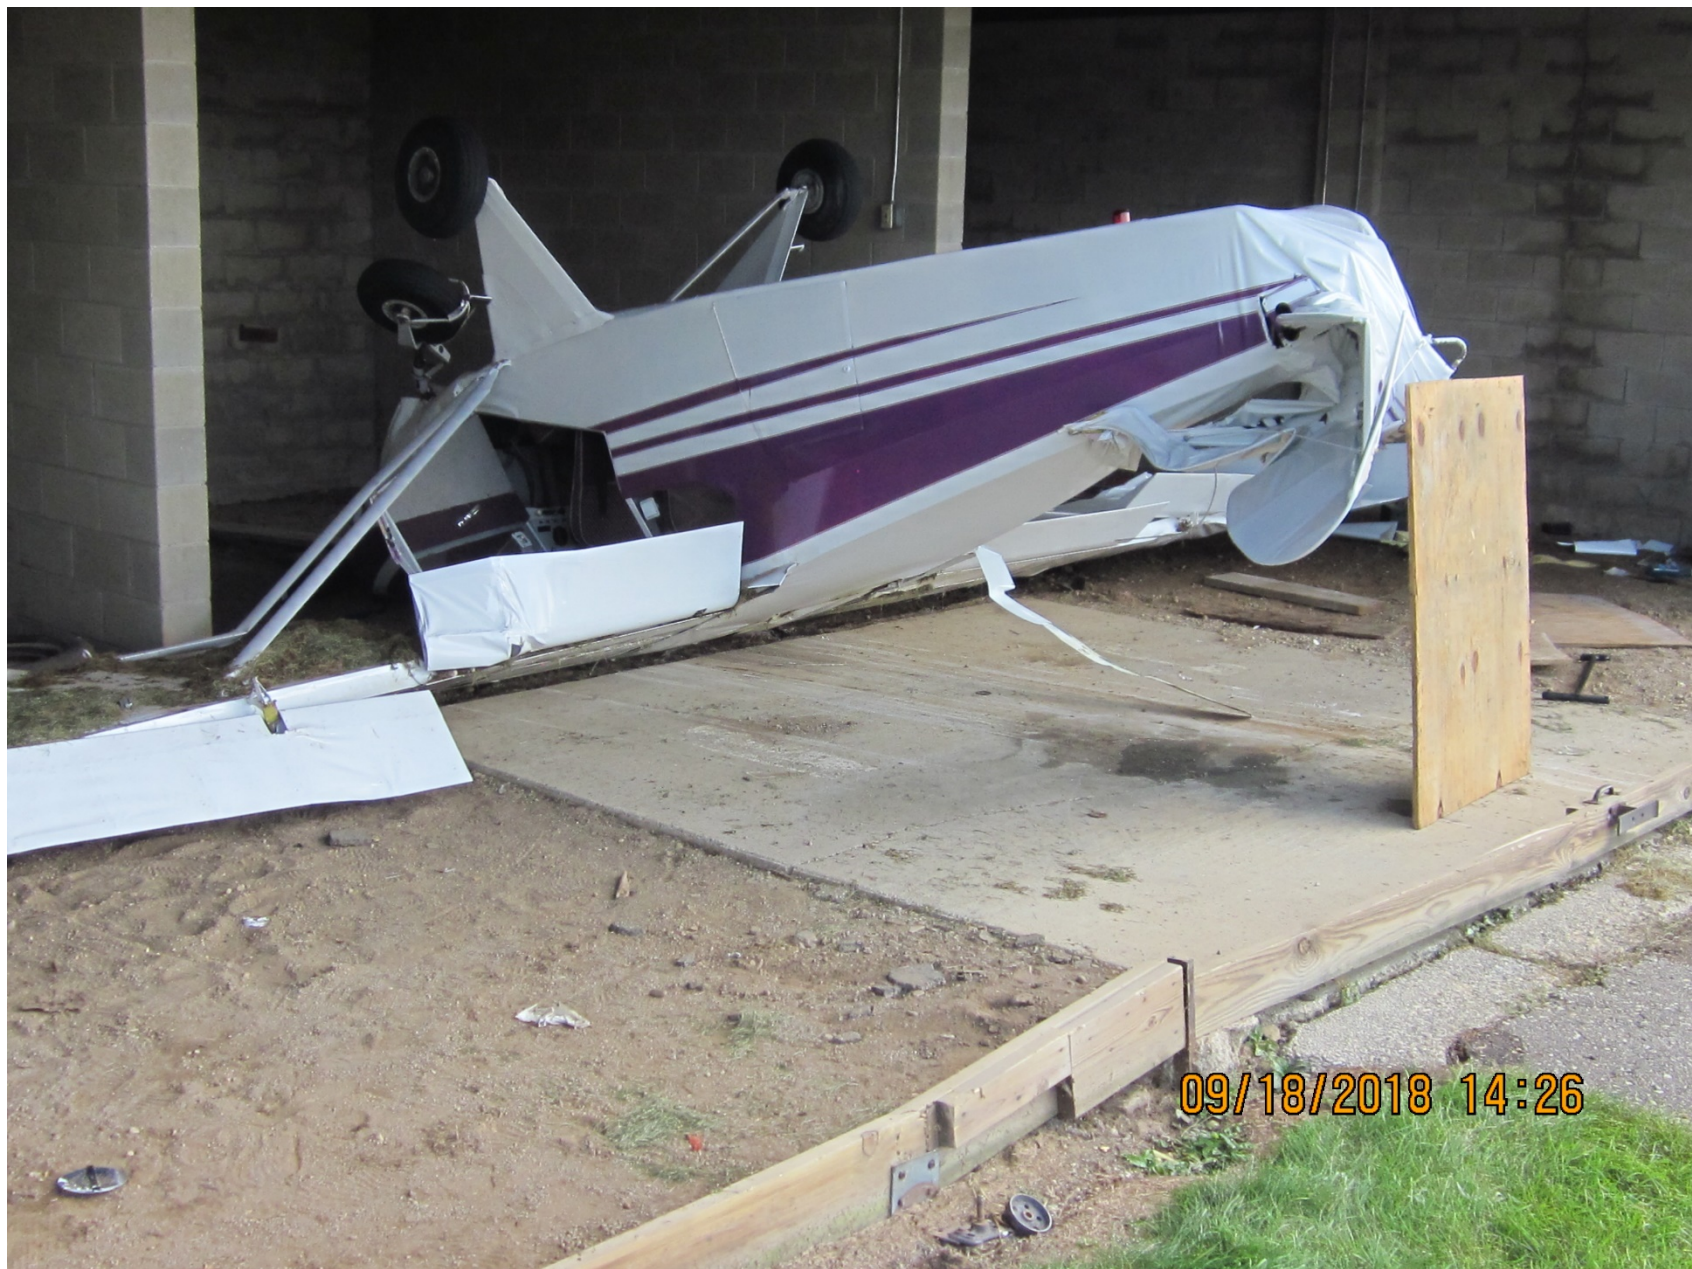
**Photo 1 – View of inverted airplane and wing and empennage damage (Photo courtesy of the FAA)**
