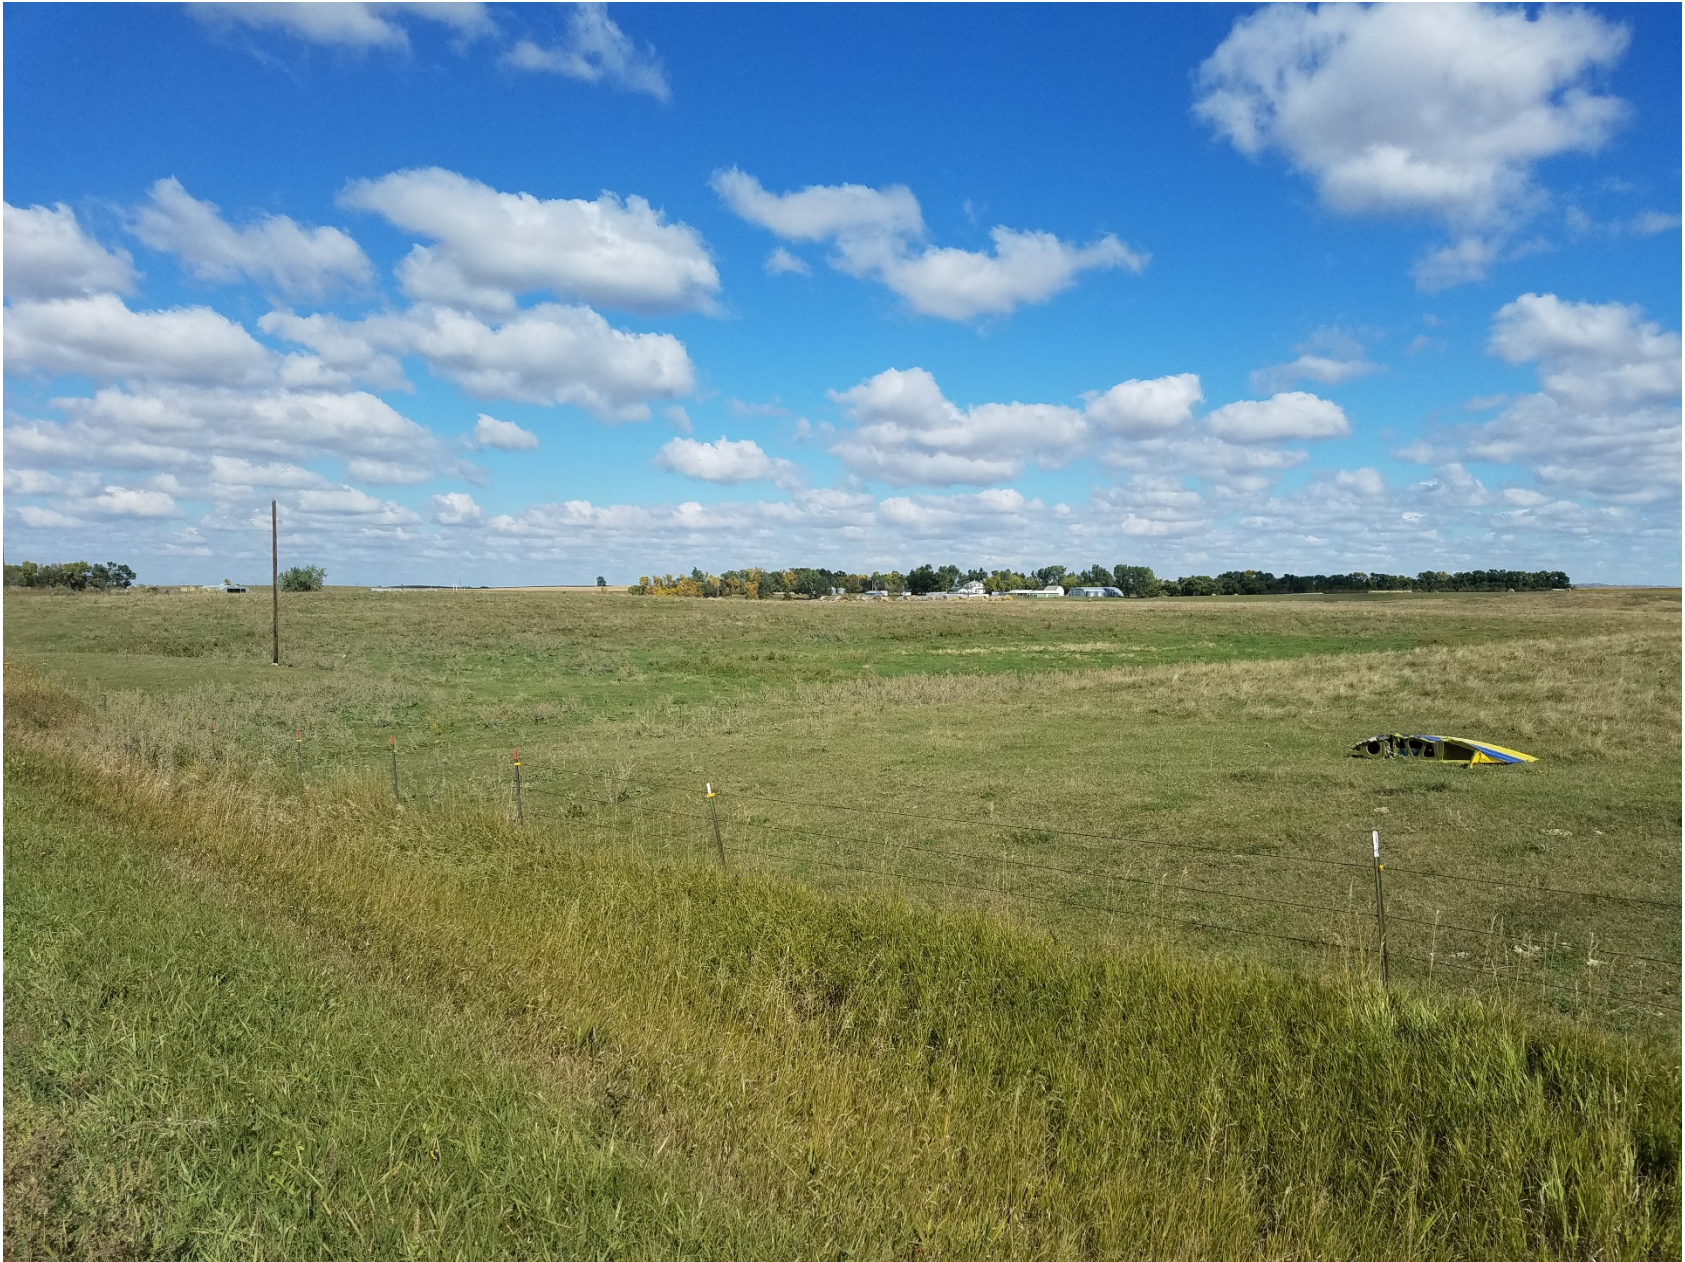
**Photo 1 – View of damaged pole and separated right wing tip (Photo courtesy of the FAA)**

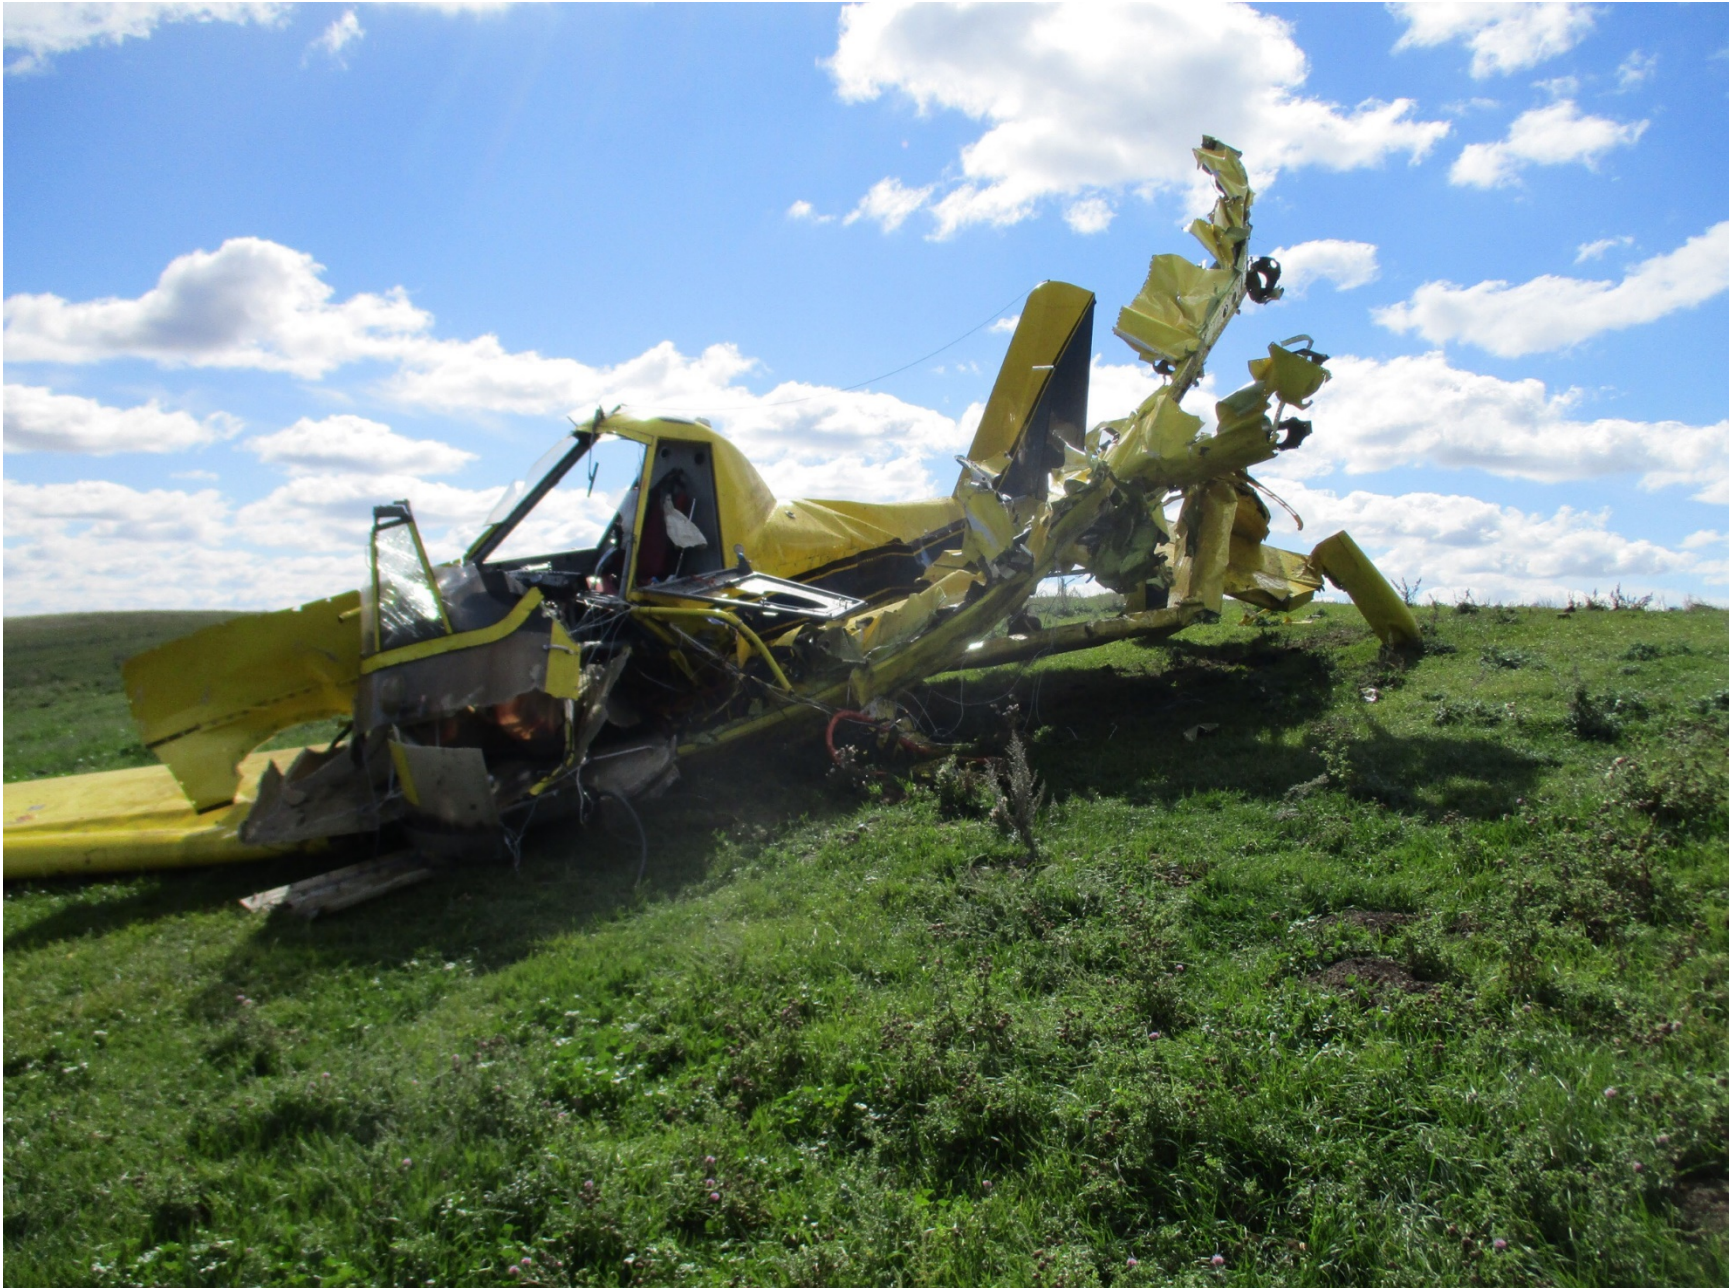
**Photo 2 – View of damaged wings, fuselage, and empennage (Photo courtesy of the FAA)**
