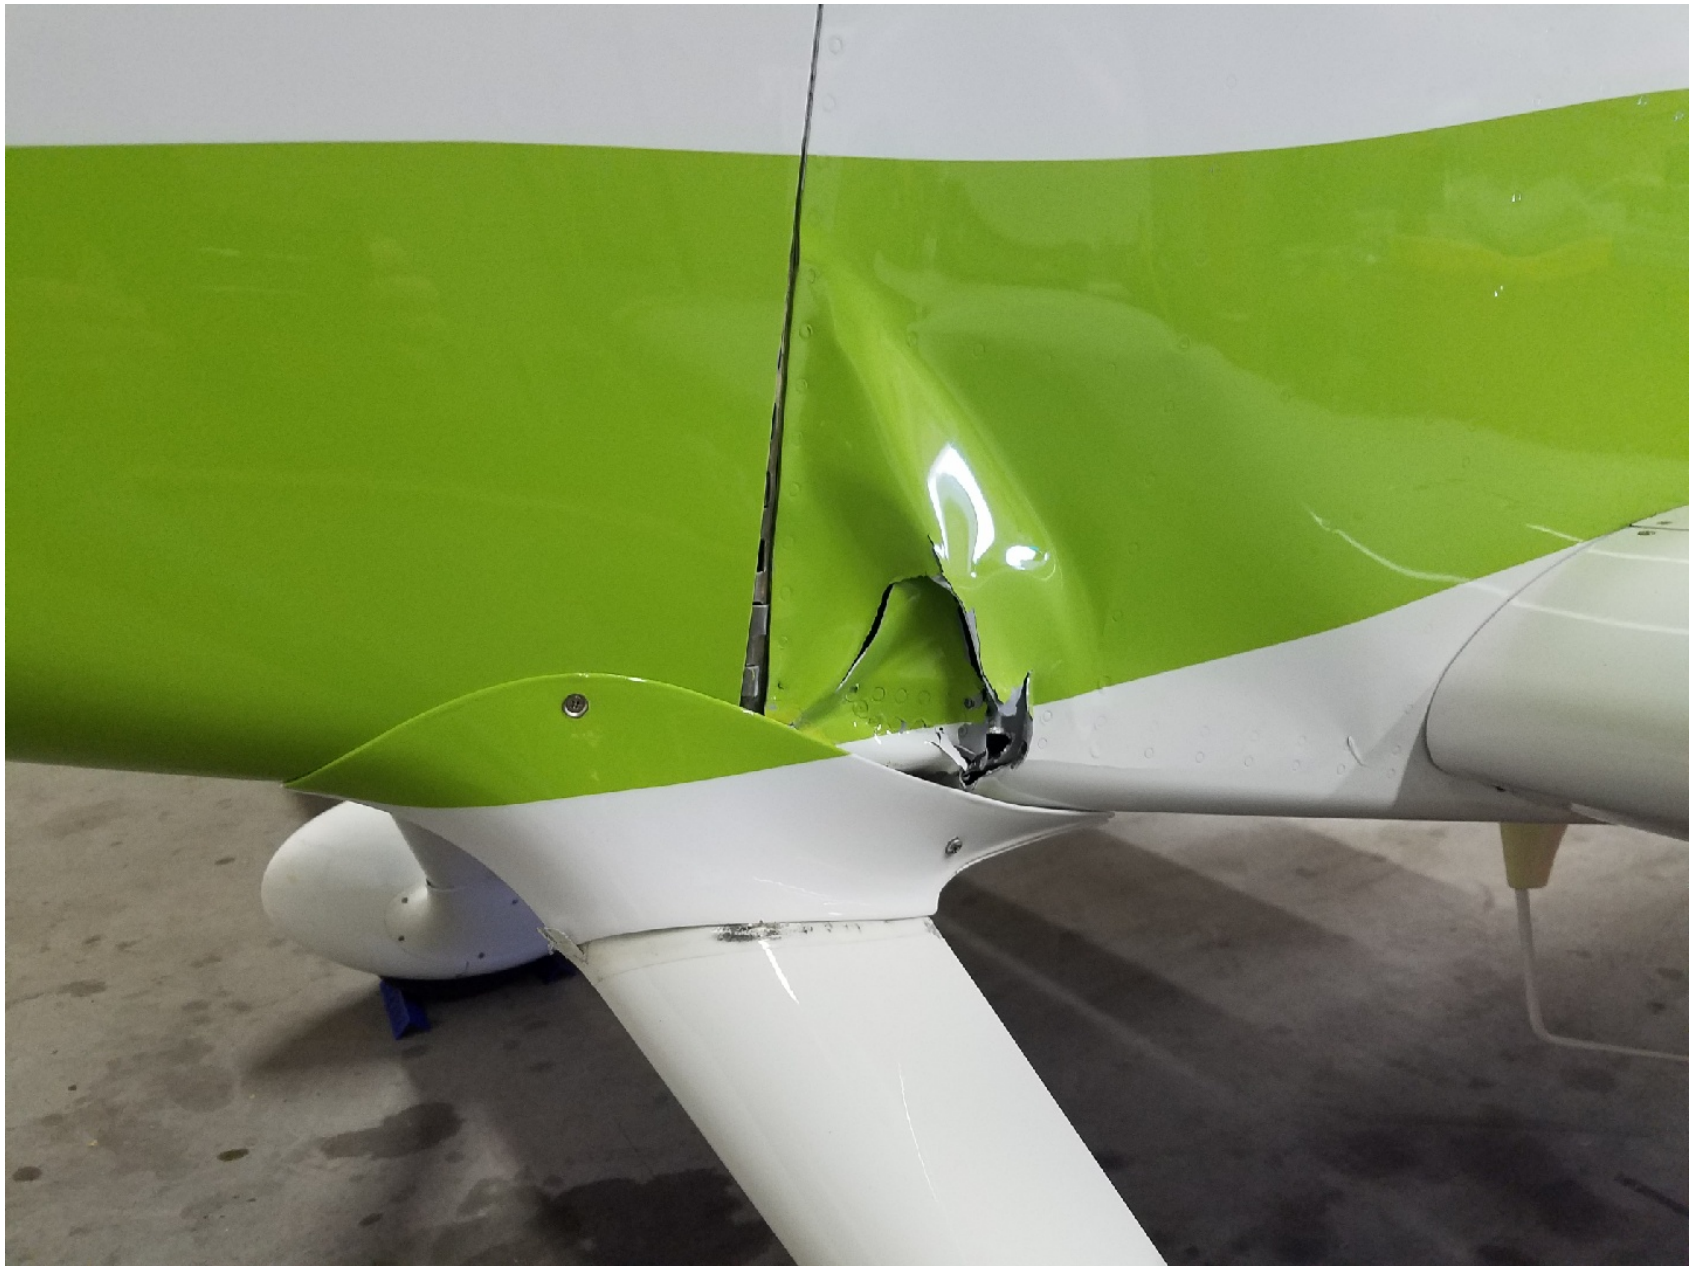
**Photo 1 – View of damage to the landing gear attachment points (Courtesy of FAA)**
