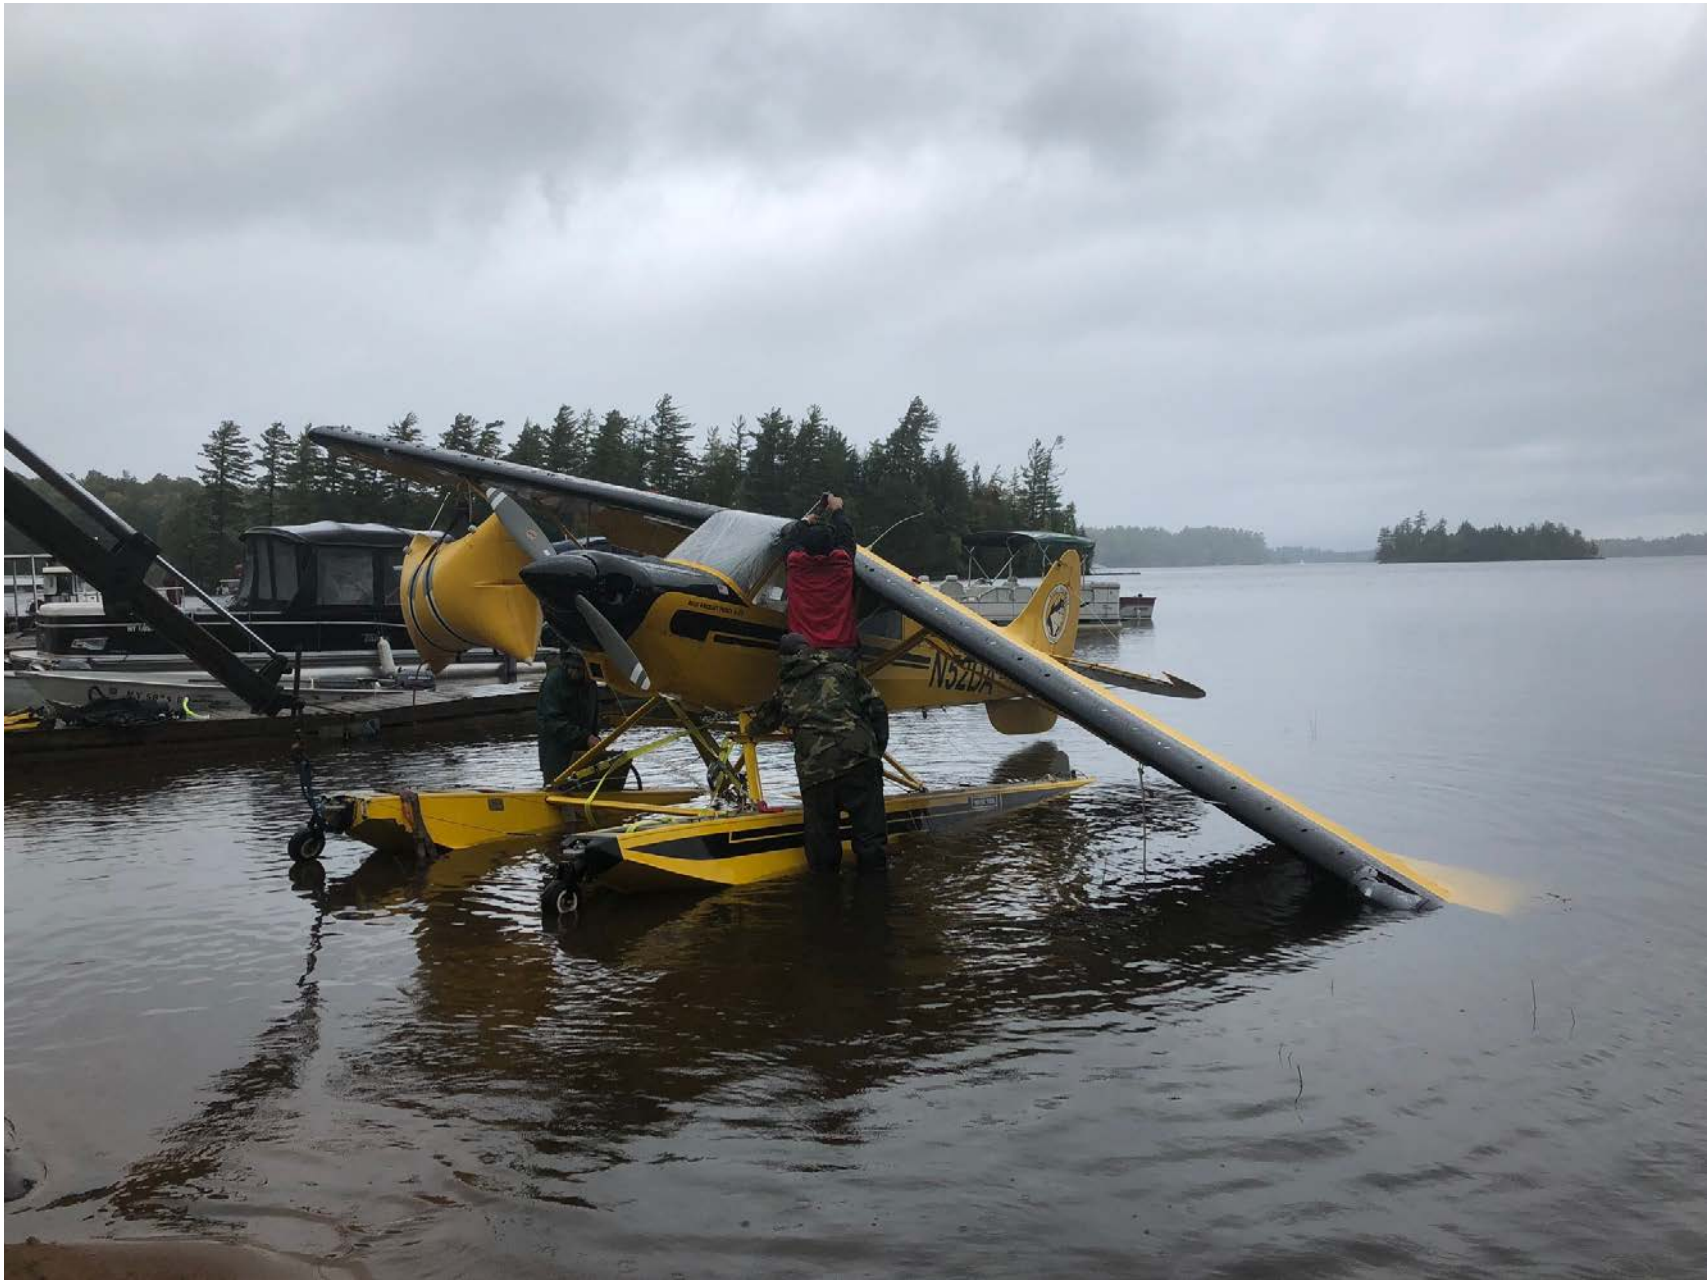
**Photo 1 – View of damaged left wing lift strut (Photo courtesy of the pilot)**
