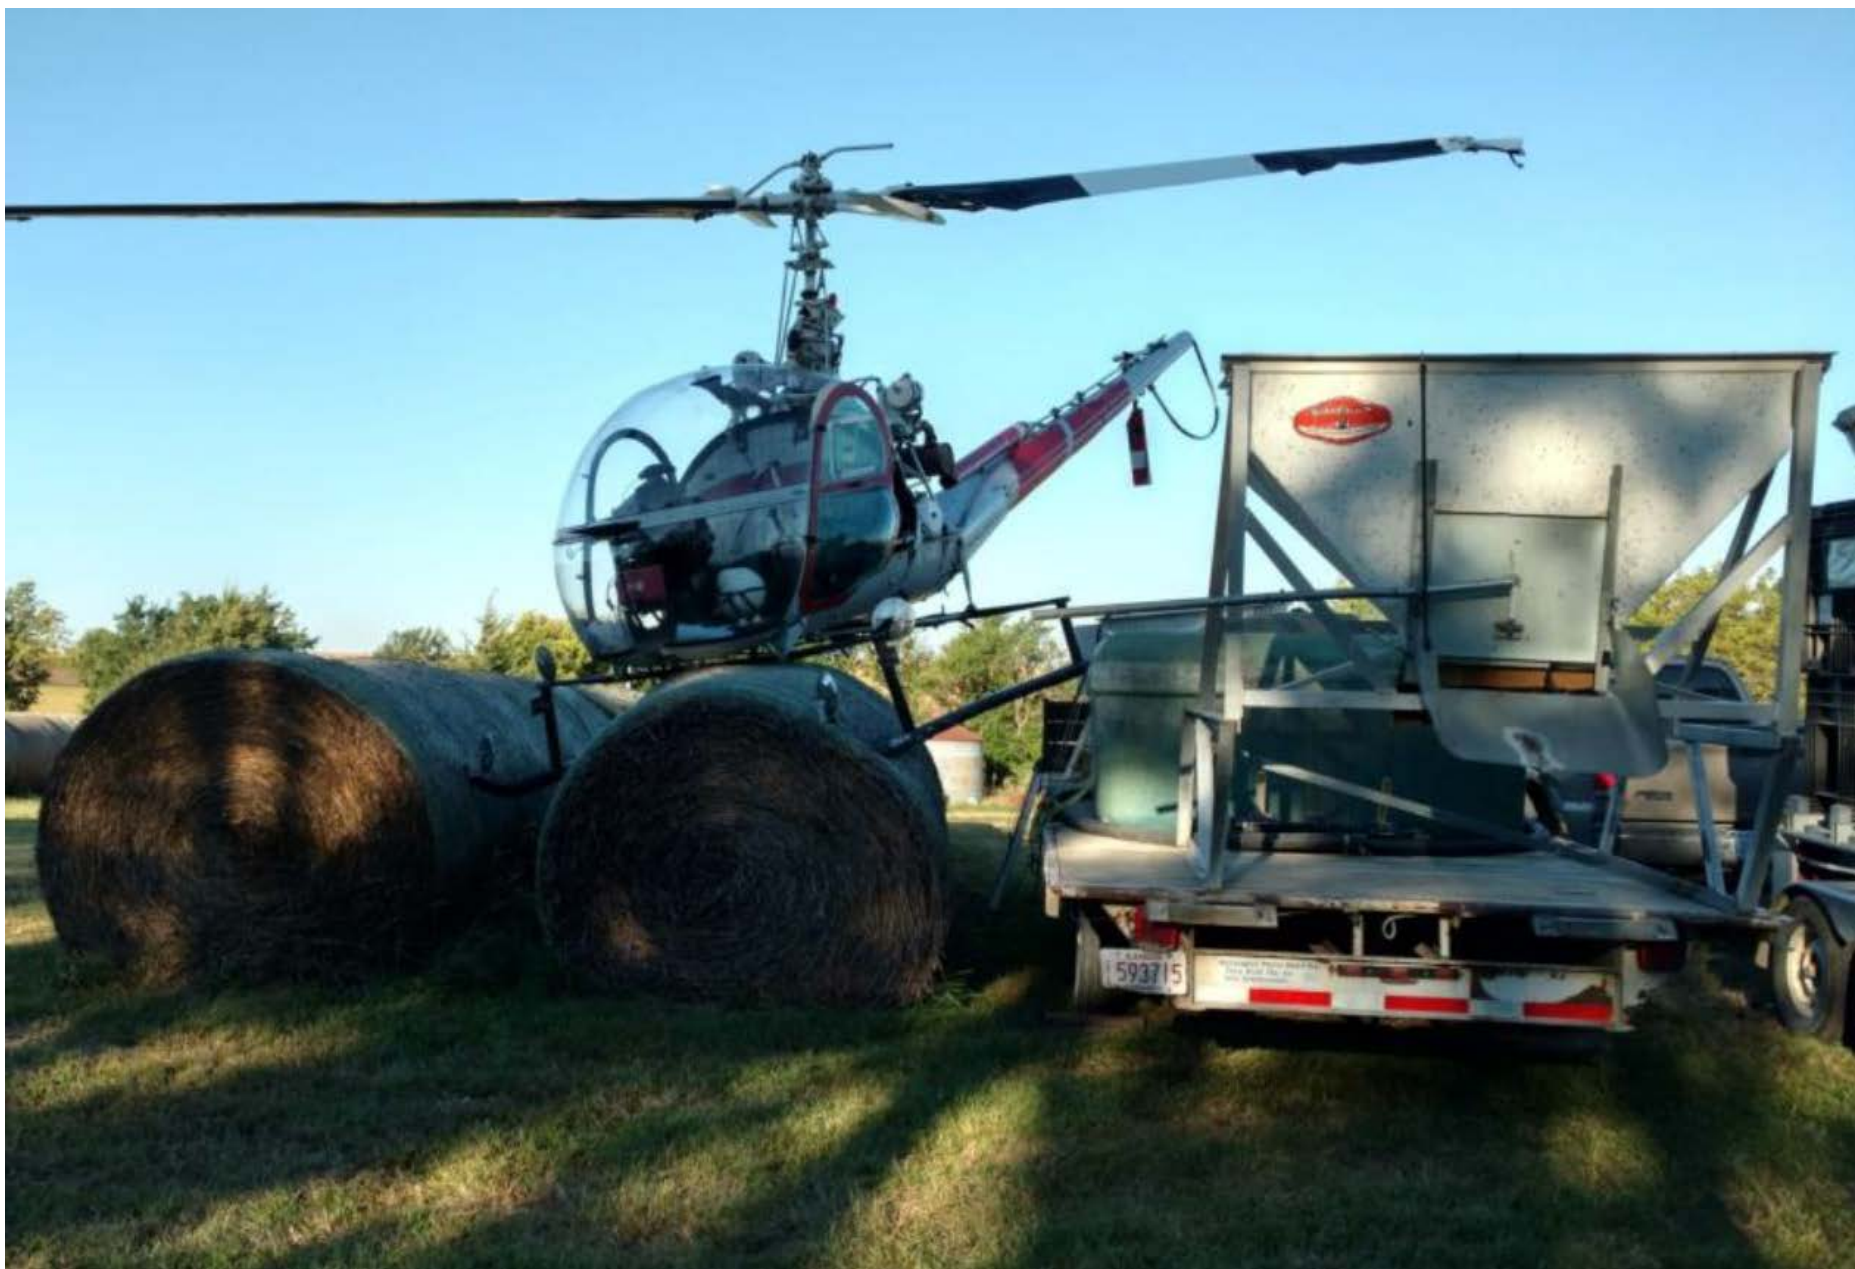
**Photo 1 – View of damage to the tail rotor drive shaft and gear box (Courtesy of FAA)**
