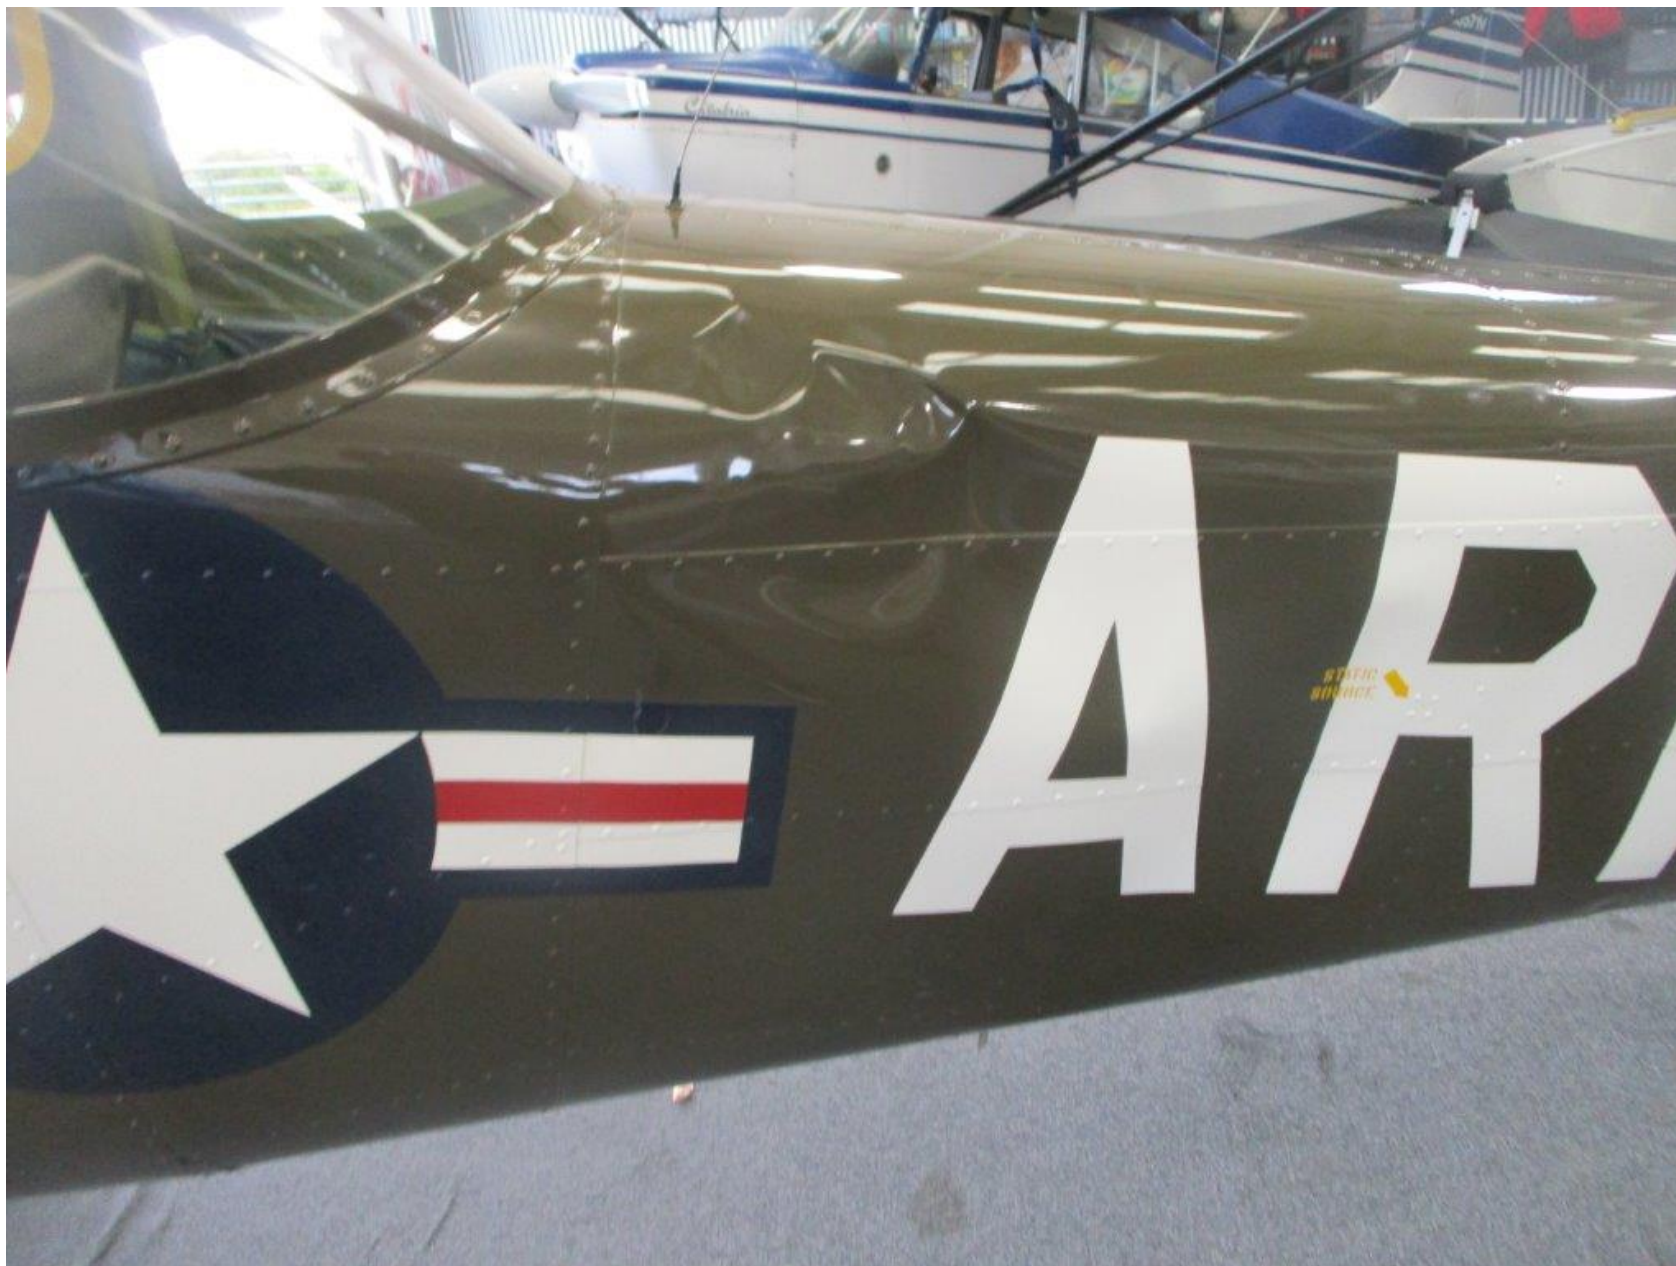
**Photo 1 – View of damaged tailcone (courtesy of the repair station)**

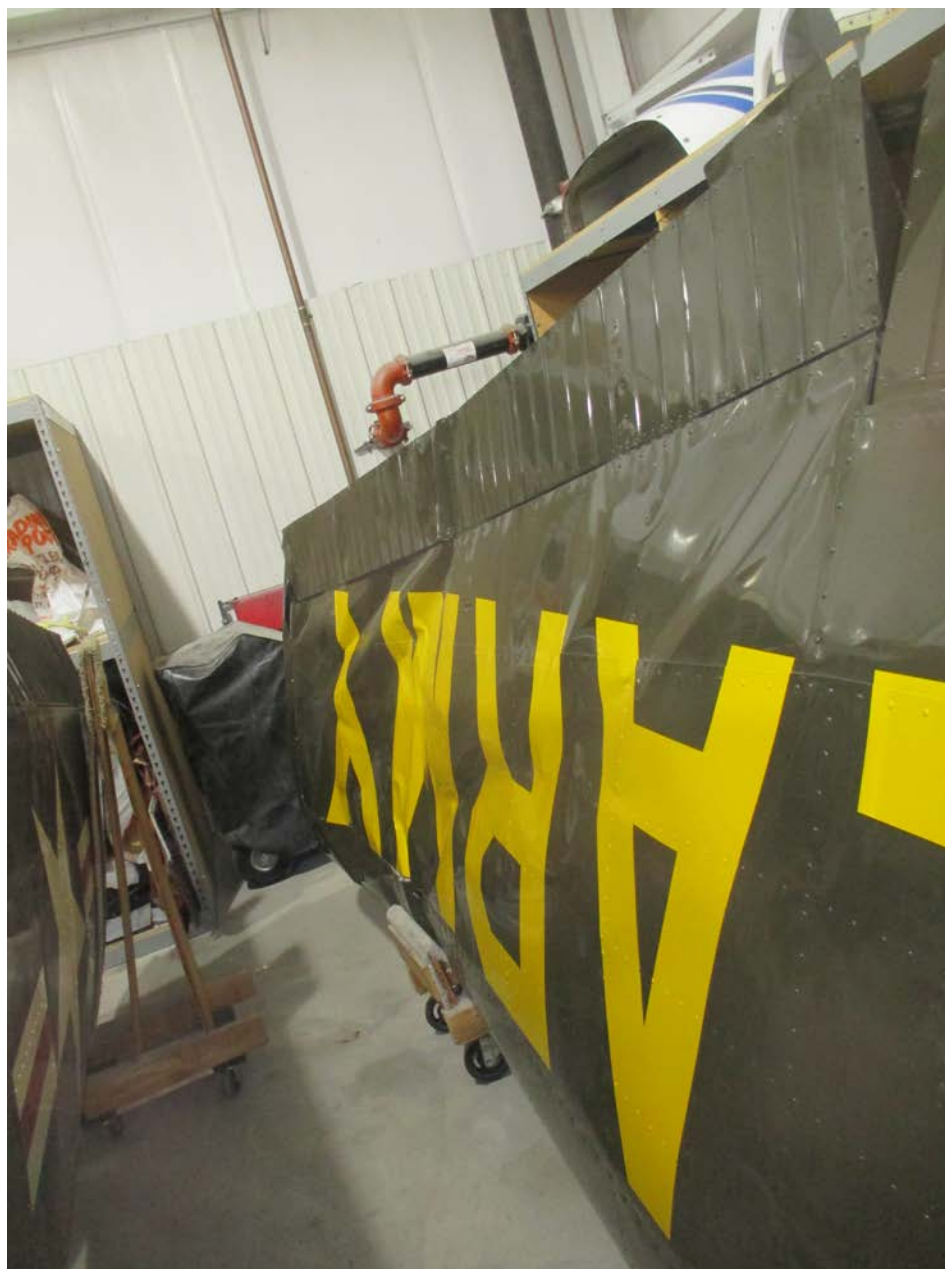
**Photo 2 – View of damaged right wing (courtesy of the repair station)**
