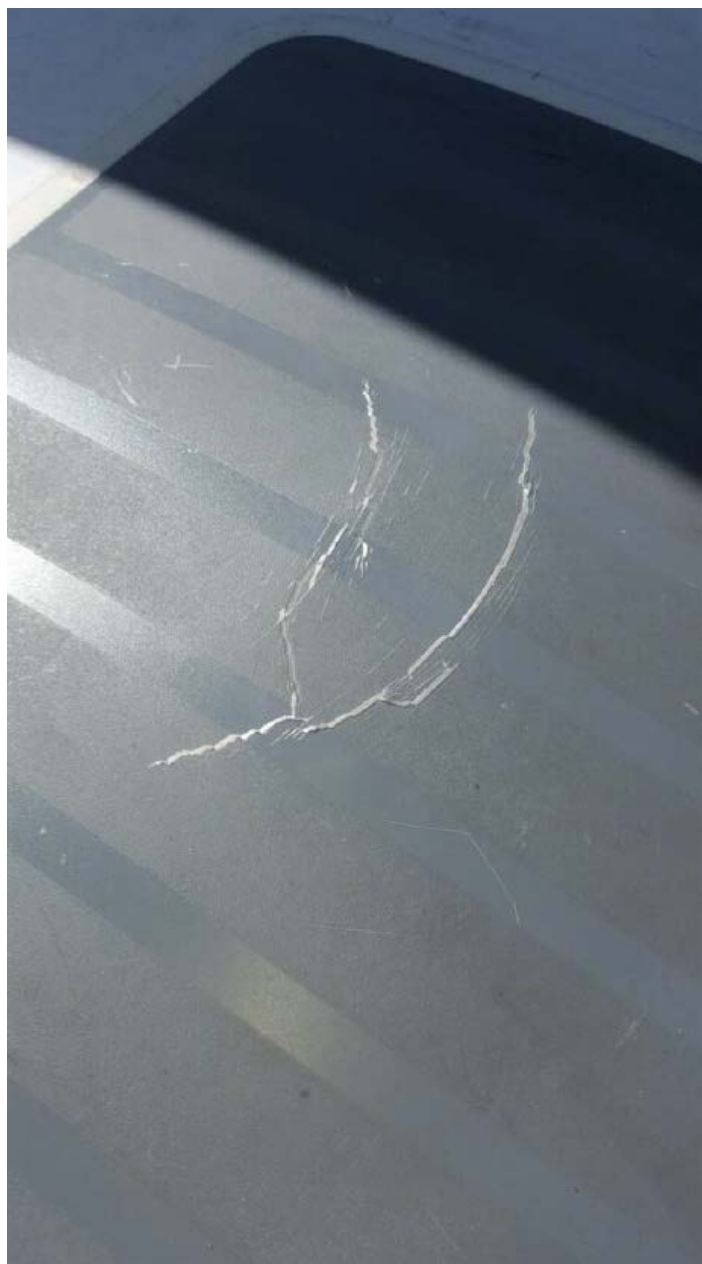
**Photo 1 – View of damage to the wing walk (Courtesy of FAA)**

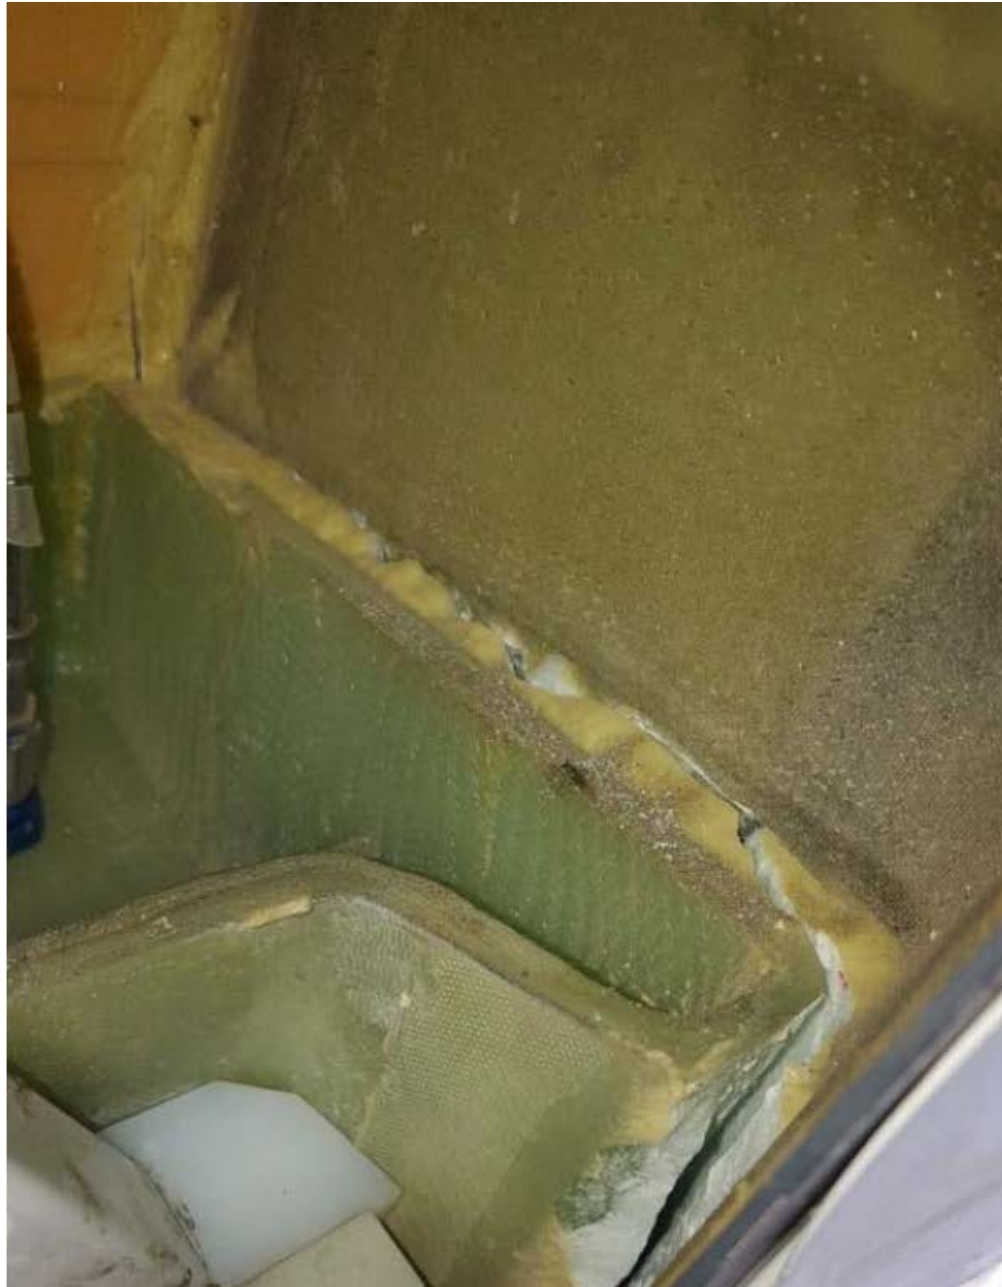
**Photo 2 – View of damage to the right main landing gear attachment mount and composite structure -Image was taken with the tail of the airplane to the right (Courtesy of FAA)**

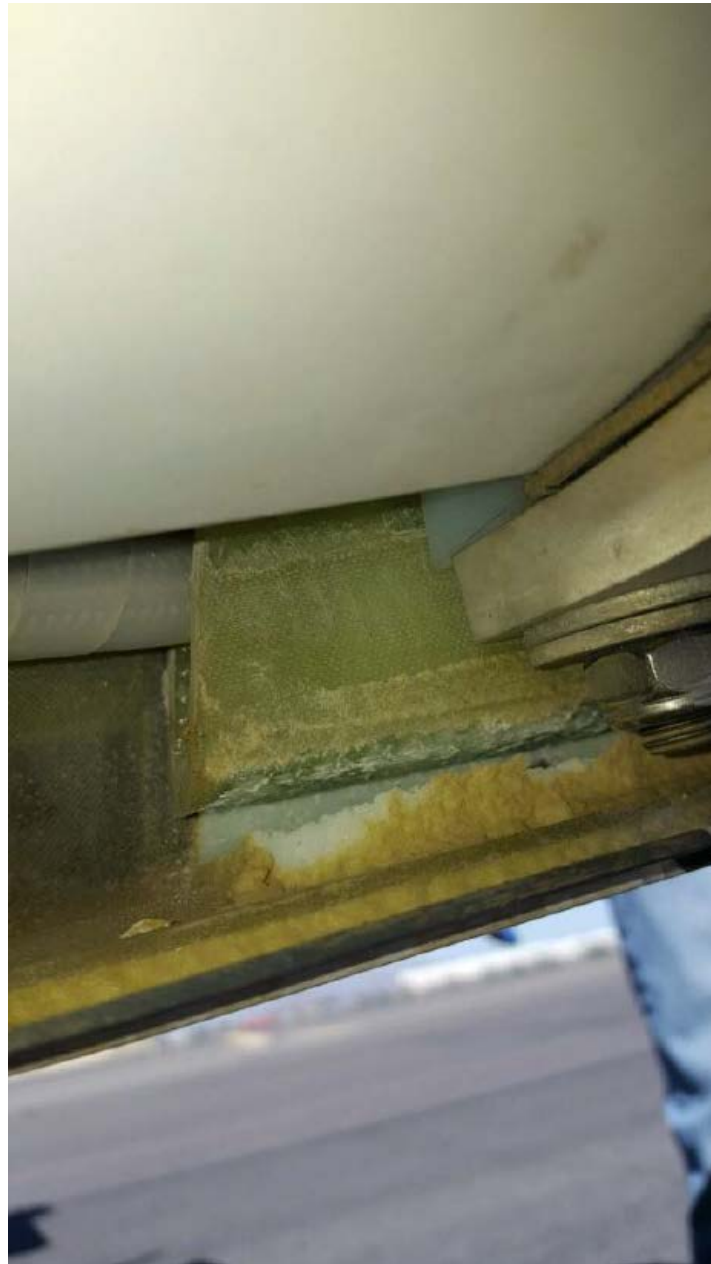
**Photo 3 - View of damage to the right main landing gear attachment mount and airframe structure -Image was taken looking toward the tail of airplane (Courtesy of FAA)**
